TEMPERATURE INVESTIGATION - DATA REVIEW

November 2018
J153825-01

NSW Department
Of Education

Cringila Public School
35 Sheffield St, Cringila NSW 2502

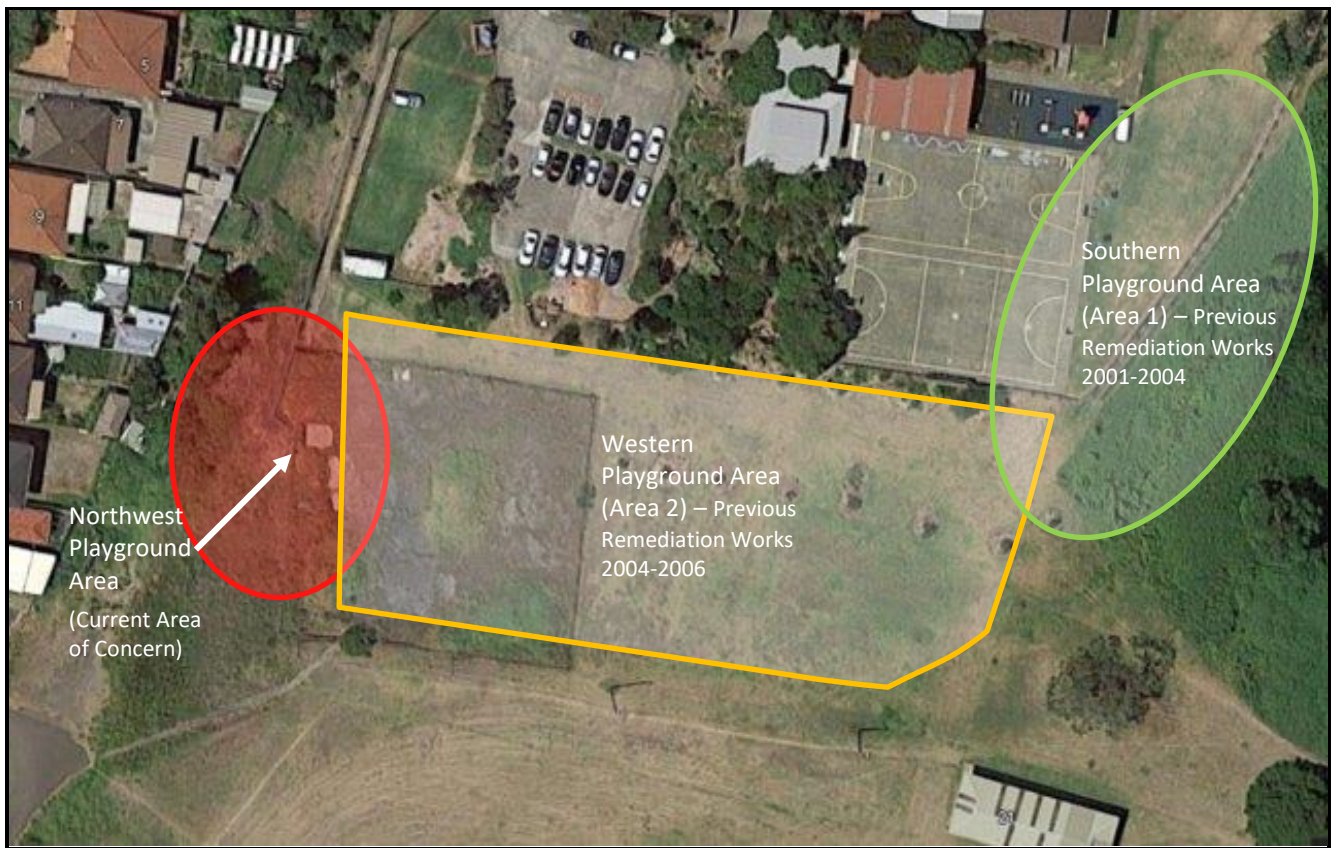
Figure 1: Site Plan 1: Created from historical review of site works – 2001-2018

Following on from the initial site inspection Greencap undertook a desktop assessment of previous temperature investigation and remediation works conducted at the site. Site inspections were also carried out by Greencap to locate temperature monitoring wells from previous remediation works and to assess their feasibility to use. A review of the site remediation history indicated that the site is historically split into three areas which have had remediation works undertaken at various times since 2001 (refer to **Figure 1** below).

- Prior to 2001 – Area was infilled with waste products from local industry. From previous investigations and remediation by New Environment and Avopiling, much of the fill is coal wash with some blast furnace (slag-like) materials.
- 2001 – Hotspot identified in Southern Playground Area (Area 1);
- 2001-2003 – Investigation and successful remediation program of Southern Playground Area (Area 1). Three (3) Hotspots identified Eastern, Central, and Western Hotspots. Works Undertaken by New Environment – Bentonite slurry injection.

- 2003-2004 – Investigation of Western Area of Playground (Area 2).
- 2004-2006 – Remediation of Western Area of Playground (Area 2). Works undertaken by Avopiling – Inert gas injection.
- September 2017 – Evidence of steam/smoke emanating from Northwest Area of Playground within fenced area of site. NSW Fire Services, NSW EPA and NSW Department of Education attended Site.

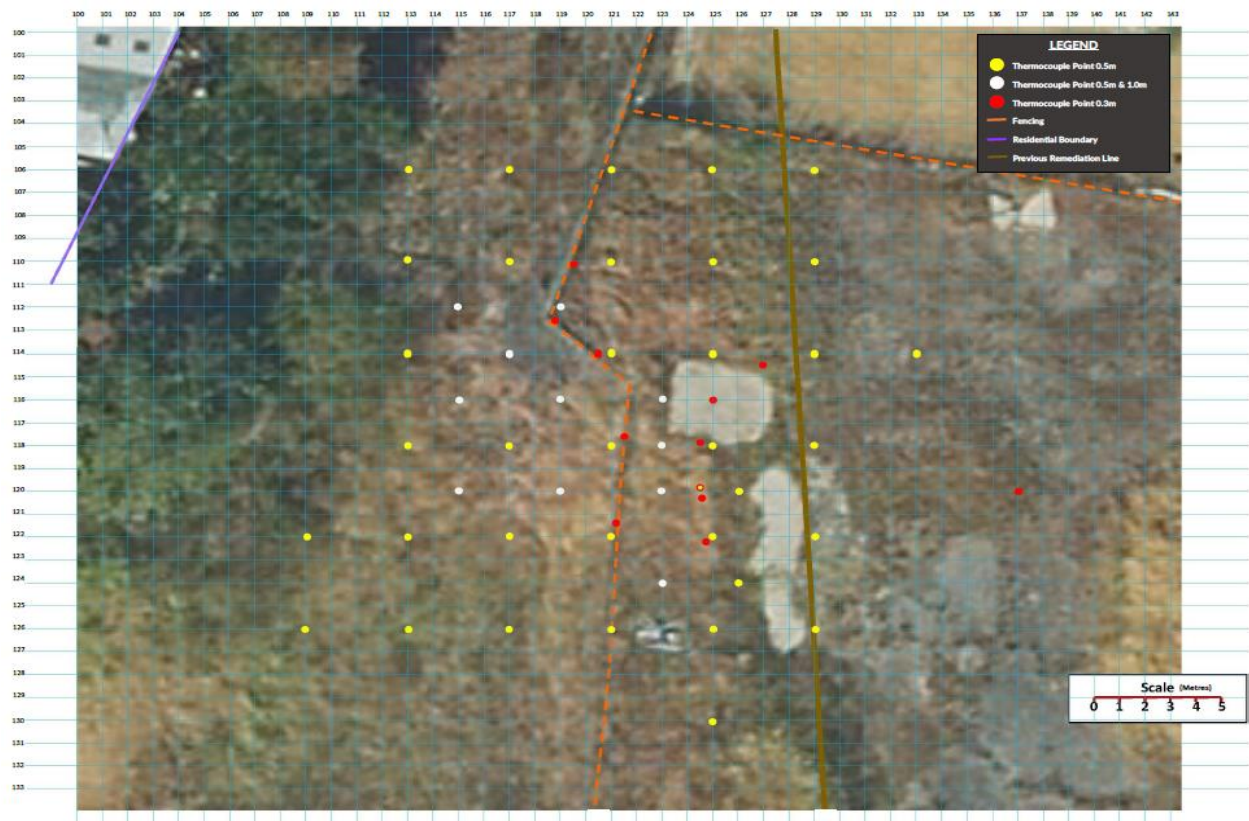
Near surface thermocouples were installed at various locations to target depths of 0.5m and 1m. Thermocouples were installed on a cross-sectional grid format across the area of concern (refer to **Figure 2** below).

- During the period of monitoring, near surface (0.5m depth) temperatures in the hotspot area generally ranged from 25-200°C with the highest temperatures usually recorded on the northern side of the small mound directly west of the concrete pad.
- Temperatures recorded at 1m depth correlated with those recorded at 0.5m depth, indicating that greater temperatures may have been associated with greater depth.

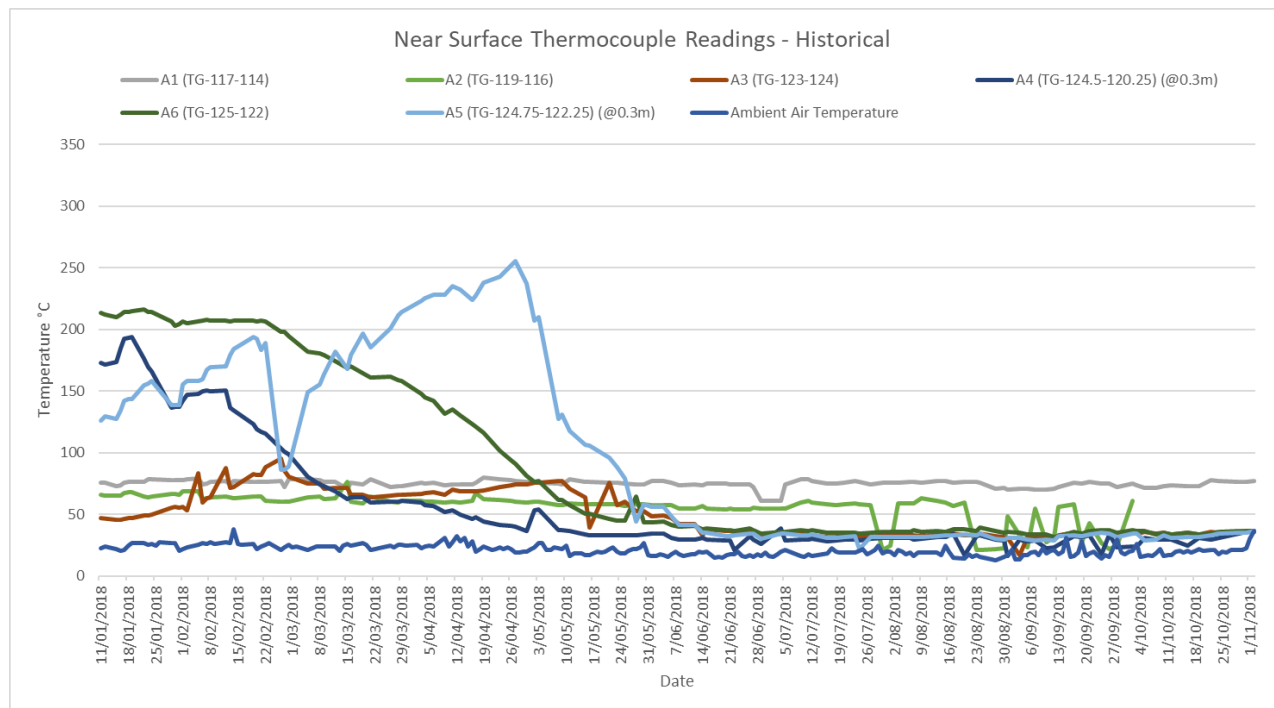
Prior to the placement of sand, near surface temperatures generally ranged between 40-130°C with the highest temperatures usually recorded adjacent to the small mound directly west of the concrete pad (Reference points TA124.75-122.25 @ 0.3m depth and TA-125-122 @ 0.5m depth). Following the placement of sand across the north western hotspot in April 2018, surface and near surface (0.3m, 0.5m and 1m depth) temperatures in the hotspot area all appear to have decreased markedly and stabilised. As of 2nd November 2018, near surface temperatures at 0.5m depth in the hotspot area generally range from 20-73°C, with the highest temperatures usually recorded on the embankment in the northern portion of the site (reference point TA-121-110-0.5m). Currently, near surface temperatures at 1m depth generally range from 35-84°C, with the peak temperature recorded on the embankment in the northern portion of the site (reference point TA-115-116-1m).

Fluctuations in surface temperature are evident following significant rain events. Surface temperature also correlates with the ambient air temperature and the range of direct sunlight throughout the day.

Historical data from selected near surface thermocouple monitoring points have been collated and present below in **Figure 3**.

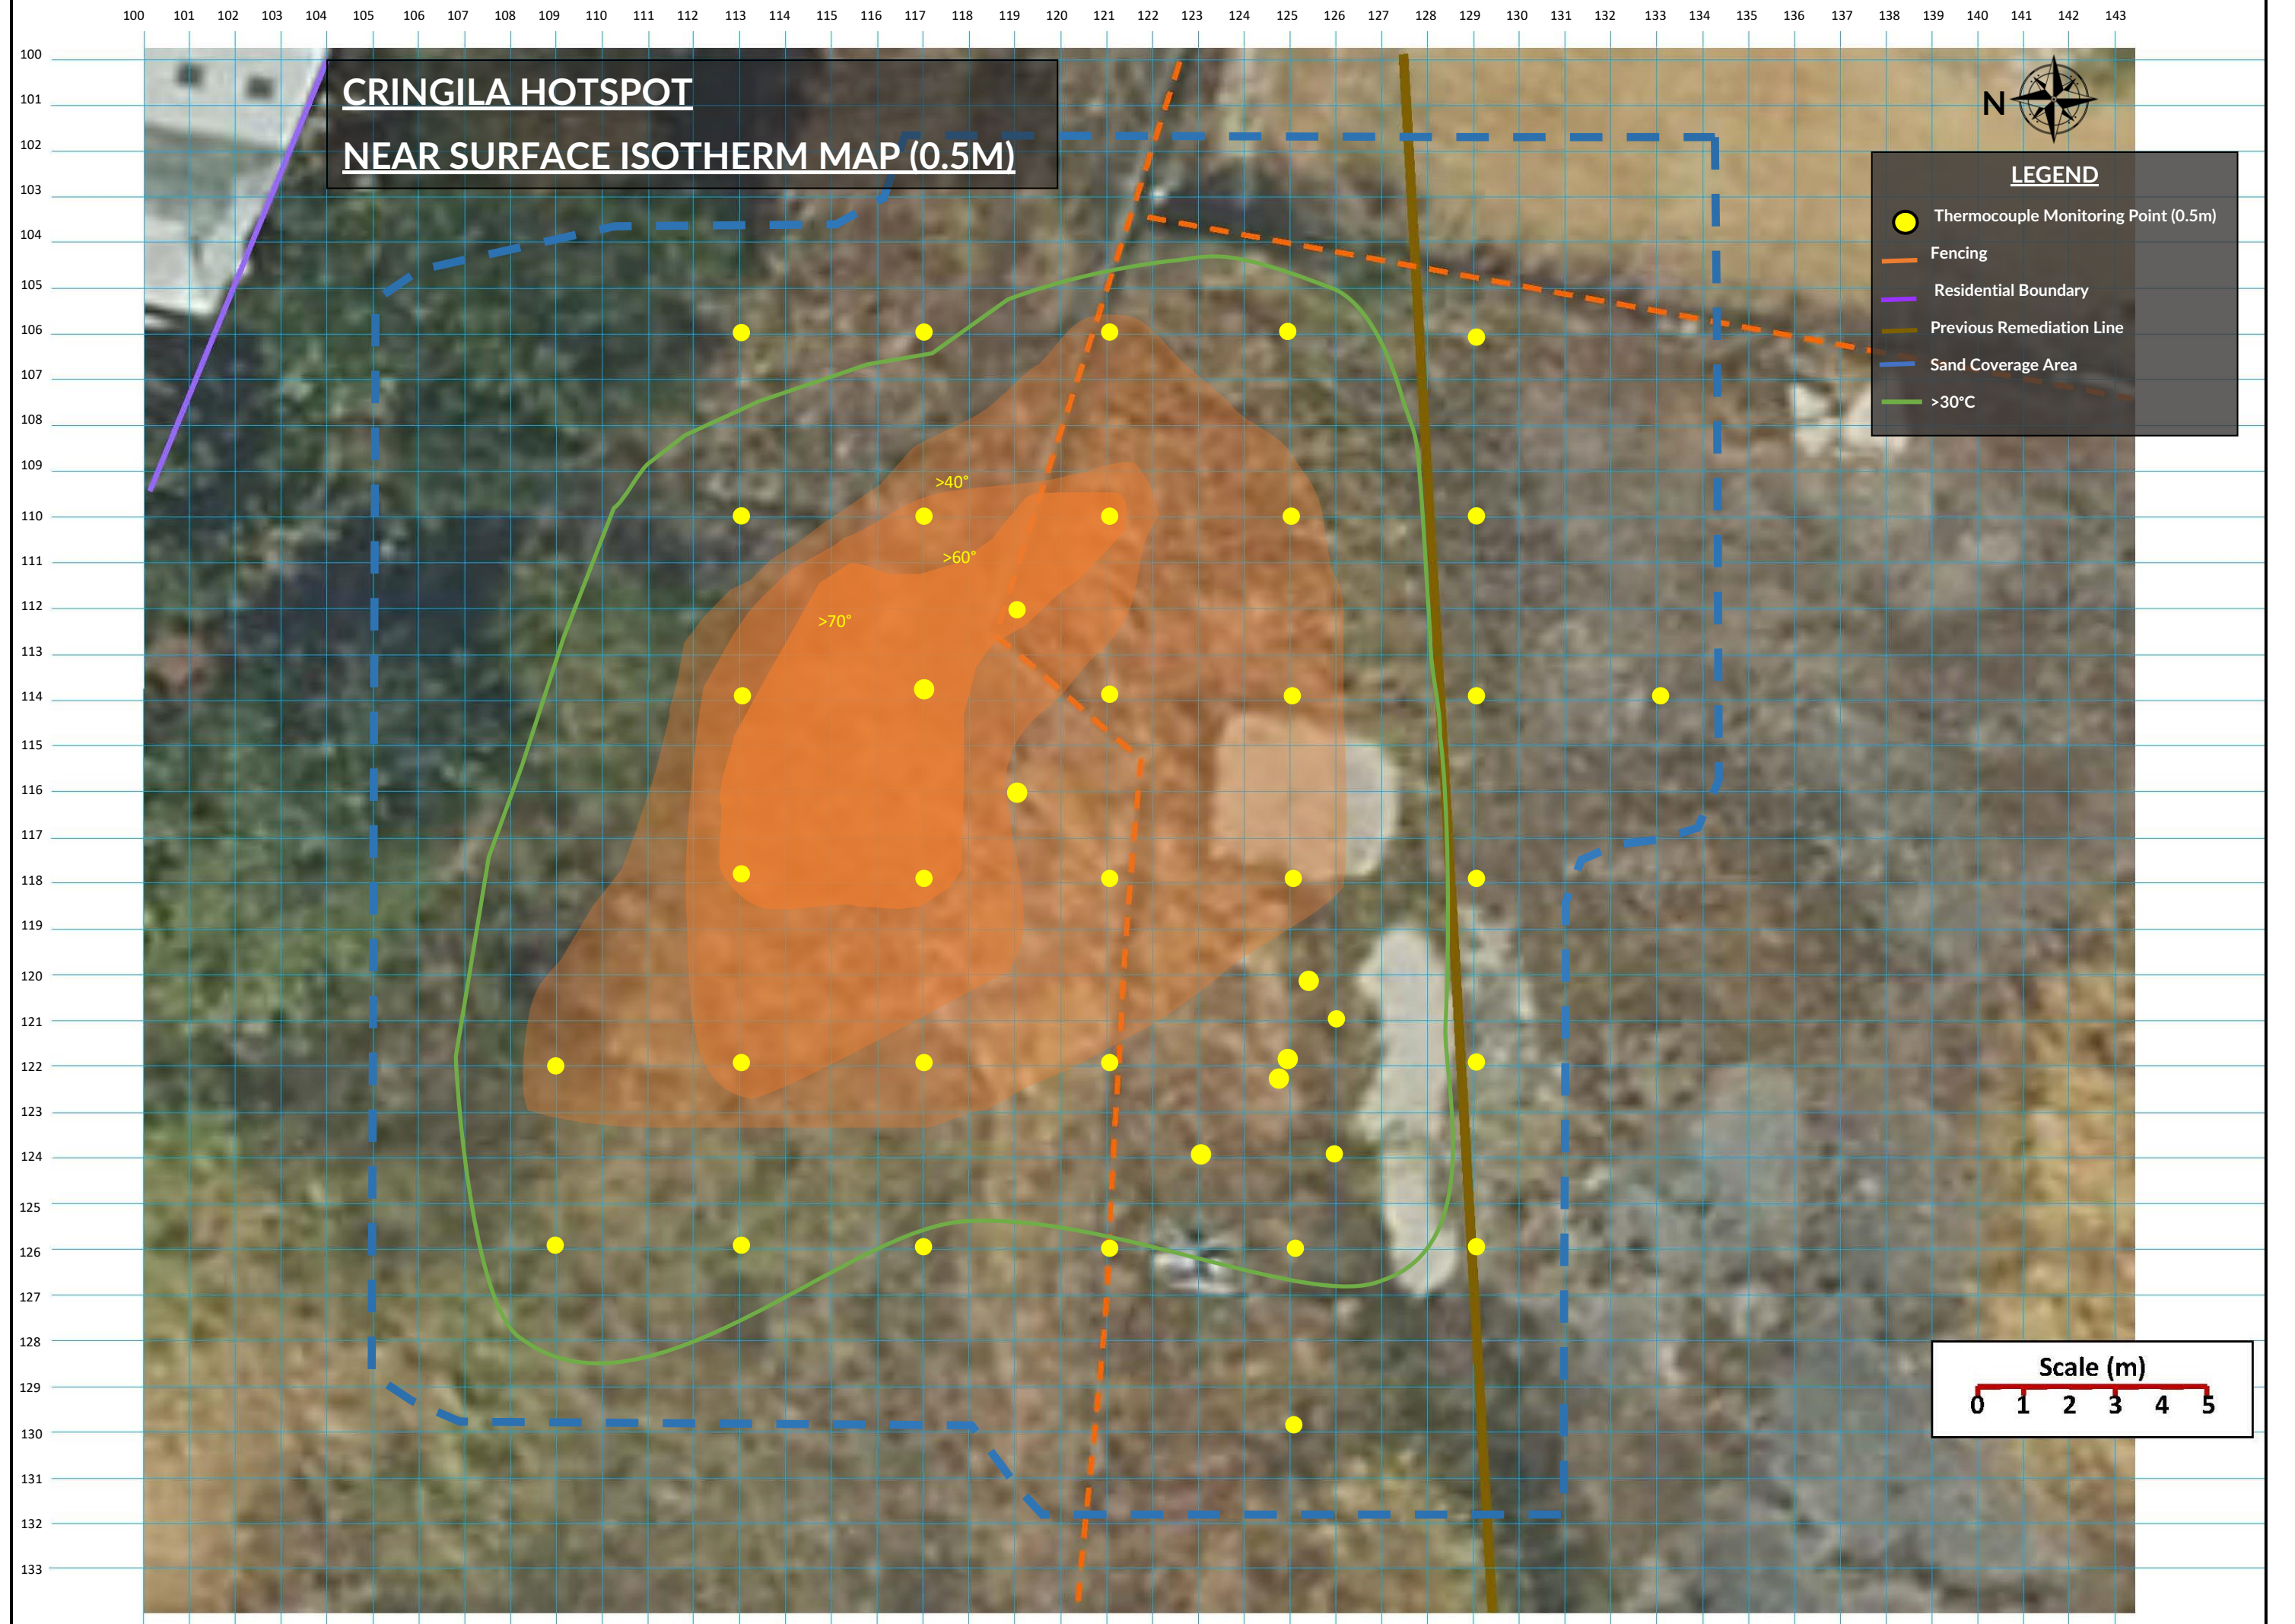
Temperature isotherms have been plotted on a site map to show an illustration of the near surface temperatures in a spatial context. Refer to **Appendix B: Near Surface Temperature Isotherm Map (0.5m depth)**.

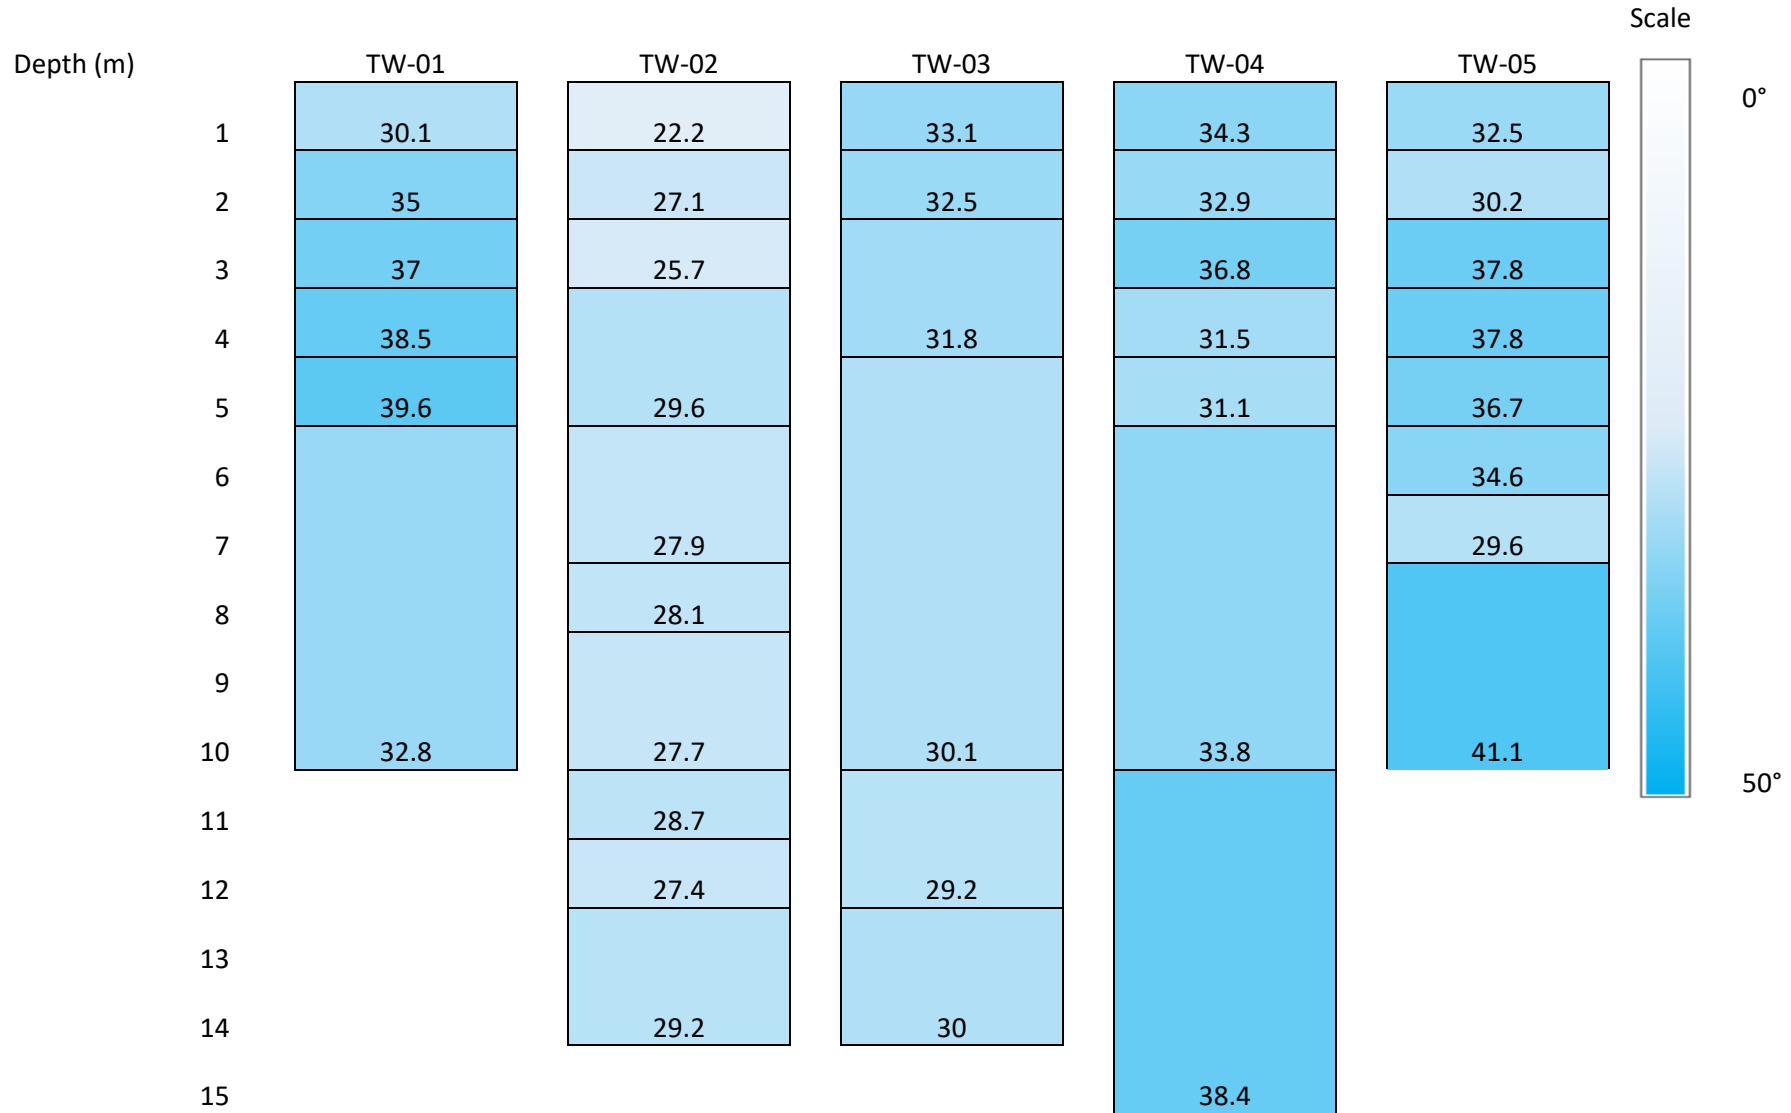
Appendix C – Pre-existing Avopiling Thermocouple Well Monitoring Graph (Averages)

Greencap continue to take periodical temperature recordings from five (5) pre-existing Avopiling thermocouple monitoring wells installed across the north western and western playground areas at the site. An analysis of the average temperatures recorded over a 12-month period is presented in **Appendix C: Pre-existing Avopiling Thermocouple Well Monitoring Graph**. Average temperatures ranged between 22-39°C. Temperatures over the period of monitoring appear to be consistent with expected background temperatures within the subsurface.

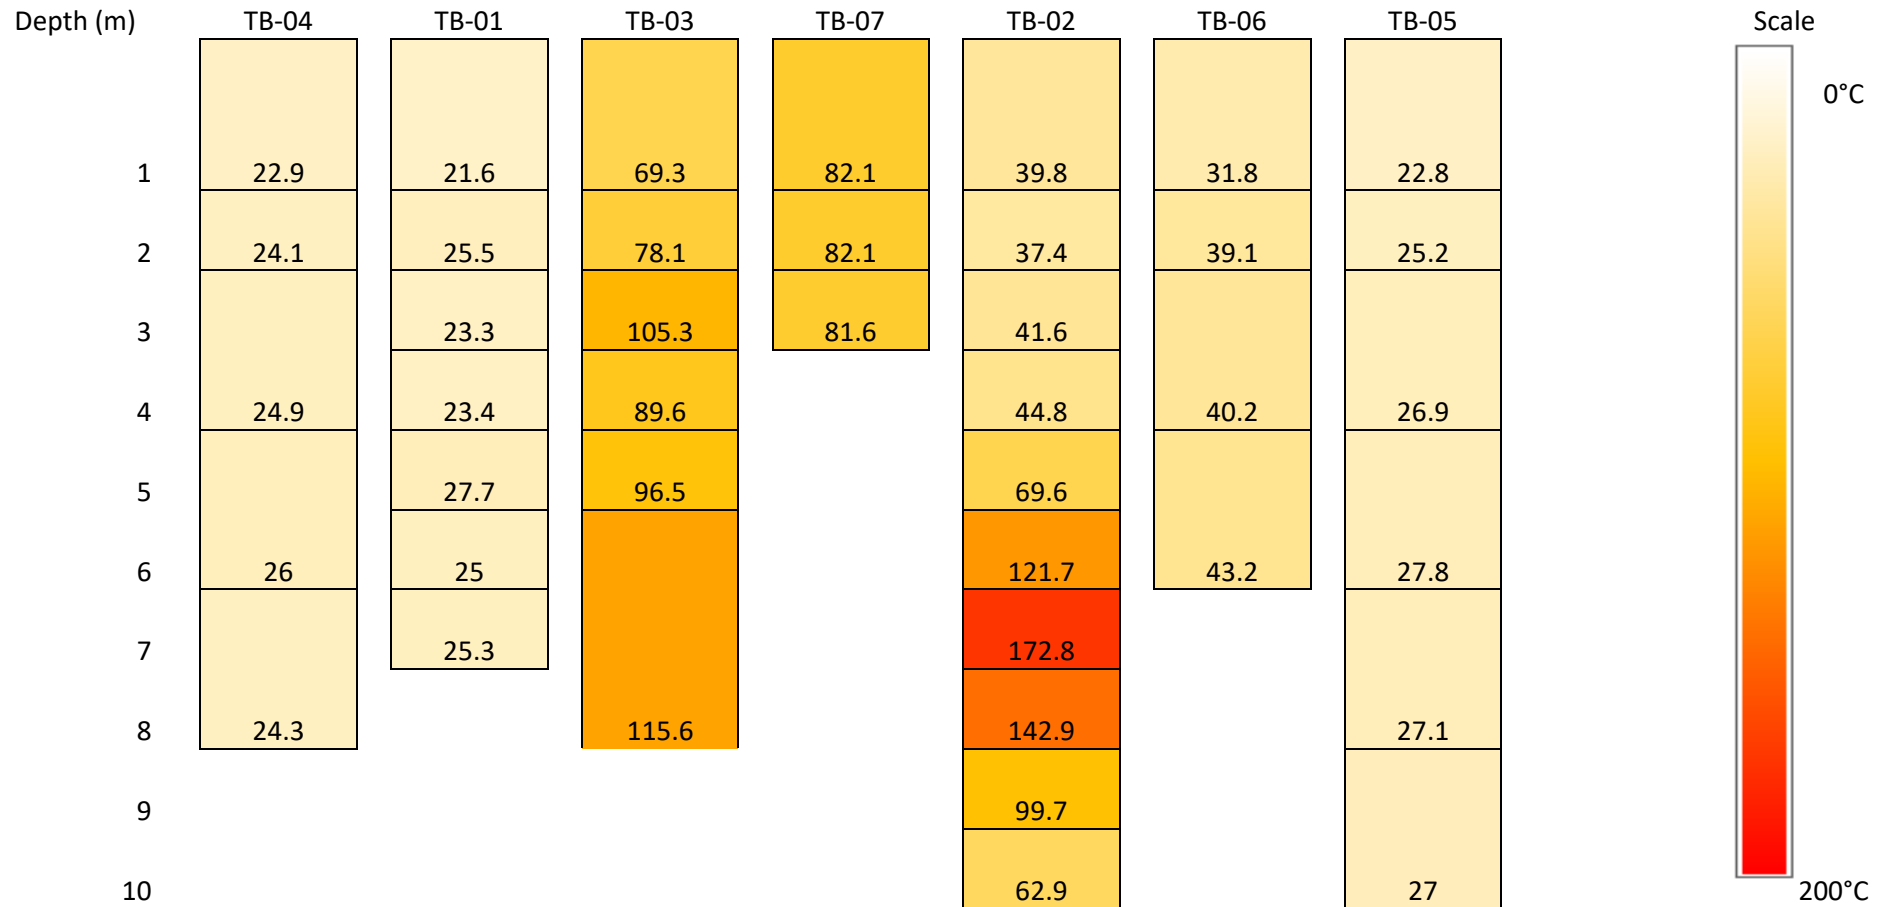
Appendix D – Subsurface Temperature Well Monitoring Graph (Averages)

Average subsurface temperatures within the hotspot area ranged from 22-172°C, with the highest temperatures usually recorded on the embankment in the northern portion of the site (reference points TB-02 and TB-03) at depths of 7-8mBGL. Elevated temperature readings within the near surface (i.e. 1-3mBGL) were observed to be correlated with elevated temperatures at greater depths.

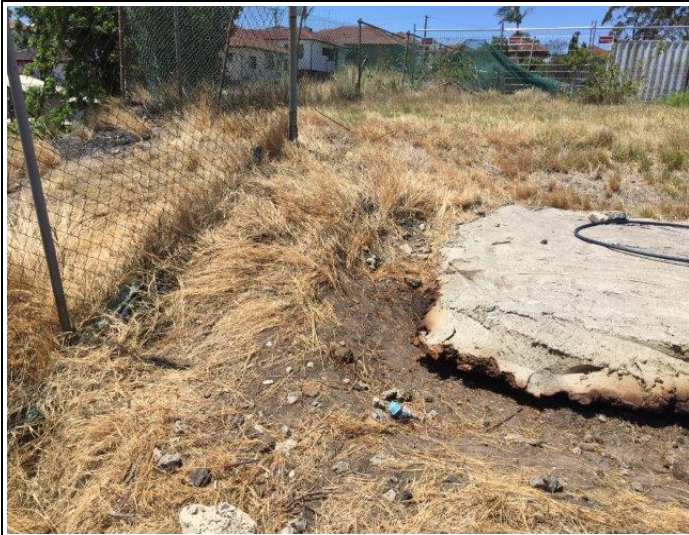
- Grass around the concrete pad was very brown indicative of deterioration due to heat exposure;
- Elevated surface temperatures in the vicinity of the concrete pad, small mound and old internal fence-line;
- No visual smoke or vapours were evident at the time of the inspection; and
- The site was adequately secure with a temporary fence installed around the area of concern.

Photo 1. Initial Site Assessment - 31st October 2017 - Area of Concrete Pad

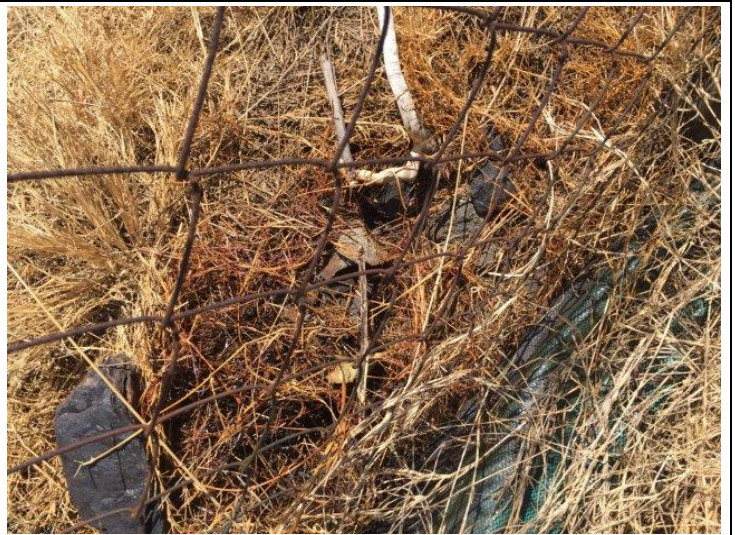
Photo 2. Initial Site Assessment - 31st October 2017 - Area of Concrete Pad

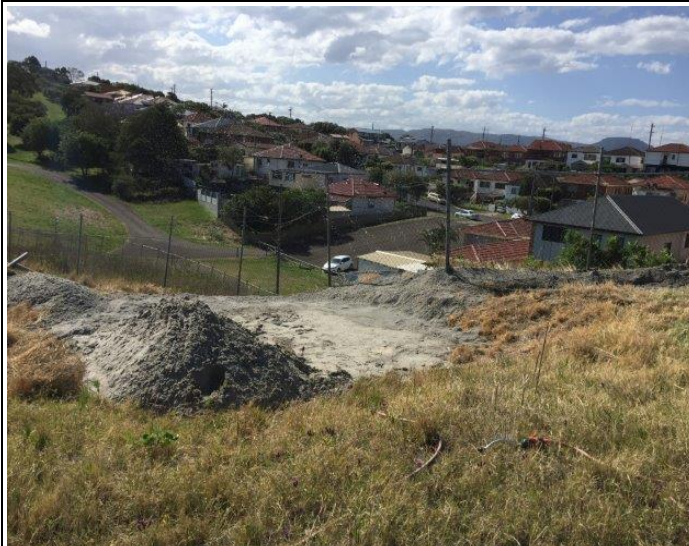
Photo 3. Initial Site Assessment - 31st October 2017 - Area of Concrete Pad covered with wet sand

- Remove vegetation from immediate areas adjacent the area of concern;
- Place sand across the surface of the areas of concern within the north western portion of the site to immediately reduce potential ignition of dried vegetation/grass;
- Schedule daily site inspections to monitor and assess the identified risk factors at the site; and
- Investigate appropriate temperature monitoring equipment and methods to be implemented at the site.

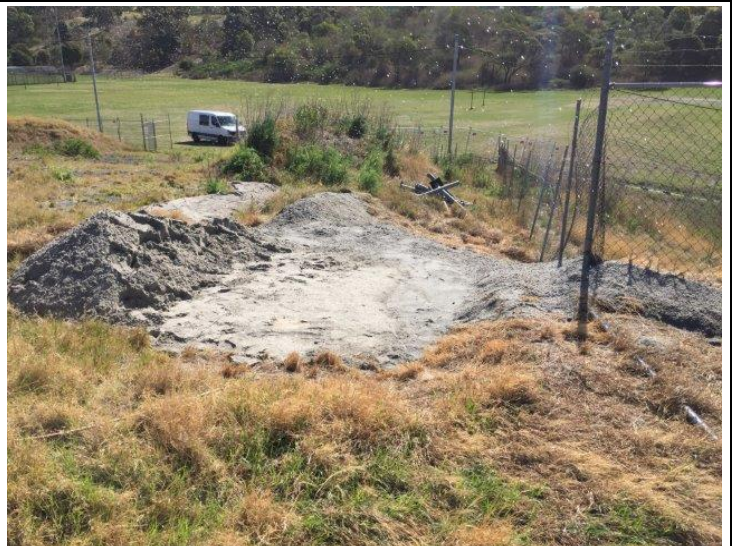
Photo 4. Initial Site Assessment - 31st October 2017 - Area of Concrete Pad covered with wet sand

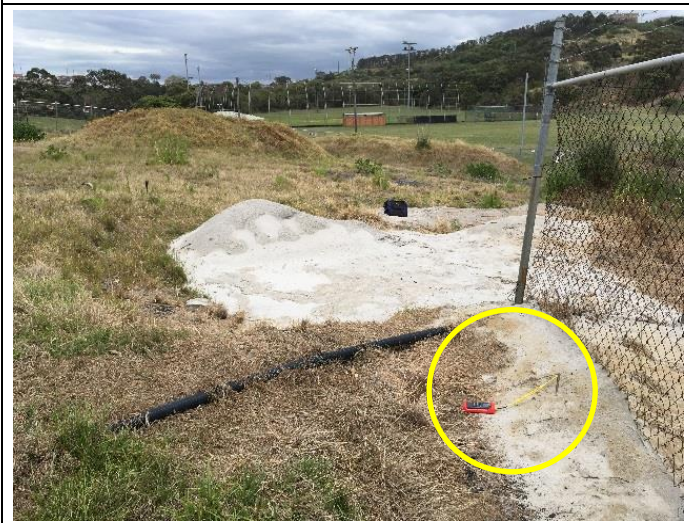
Photo 5. Hand-held Temperature Probe - Near Surface (0.3m depth) - November 2017 - internal northern fence line

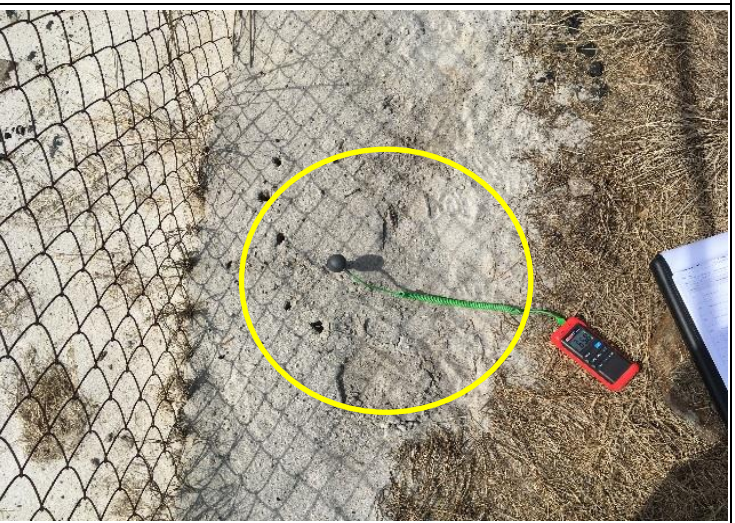
Photo 6. Hand-held Temperature Probe - Near Surface - November 2017 - internal northern fence line

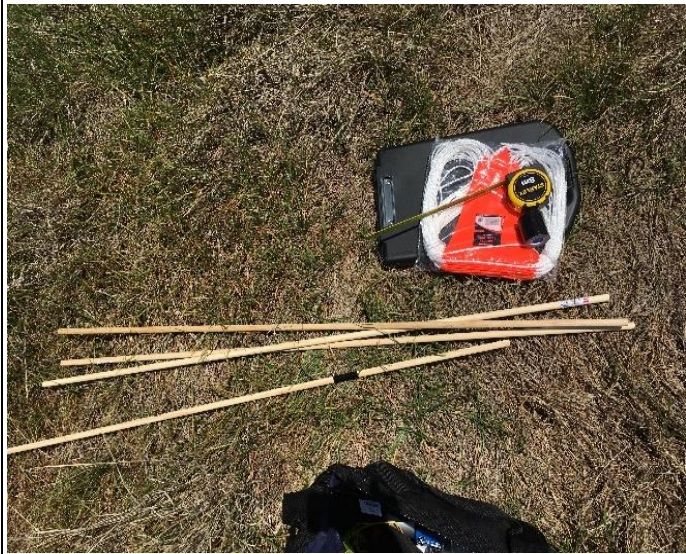
Photo 7. Construction and Installation of Thermocouples - (0.3m depth) - November 2017

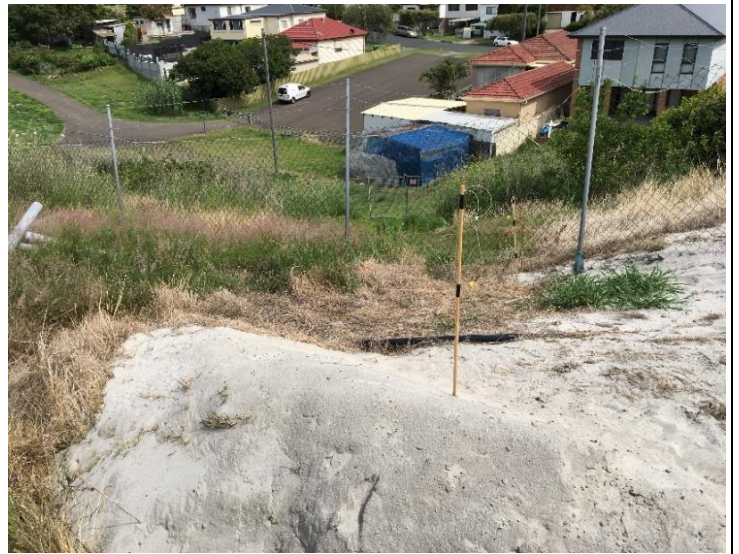
Photo 8. Monitoring of Thermocouples - (0.3m depth) - internal northern fence line

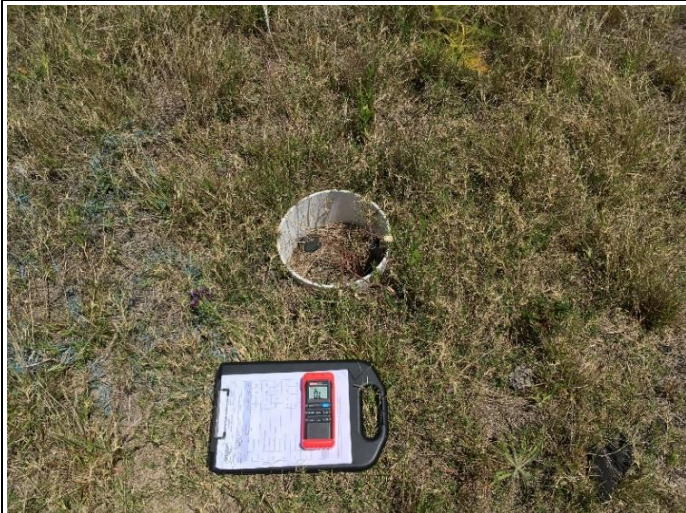
Photo 9. Monitoring of pre-existing Avopiling Thermocouple Wells - Western Playground area

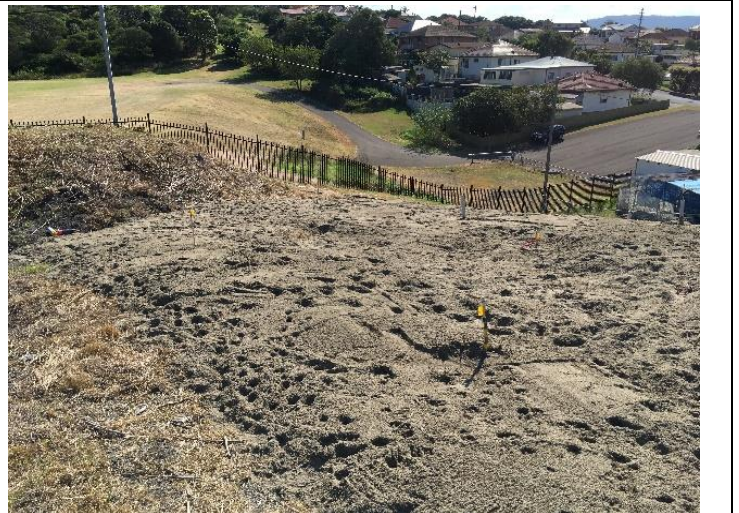
Photo 10. Placement of Sand across area of concern - April 2018

- Remove vegetation from areas within the area of concern;
- Placement of sand (approximately 100mm) across the surface of the area of concern to reduce the potential for ignition of dried vegetation/grass;
- Install a permanent and secure fence around the boundary of the site;
- Reinforce the exclusion zone around the north western hotspot; and
- Continue to undertake regular inspections to monitor the condition of the site.

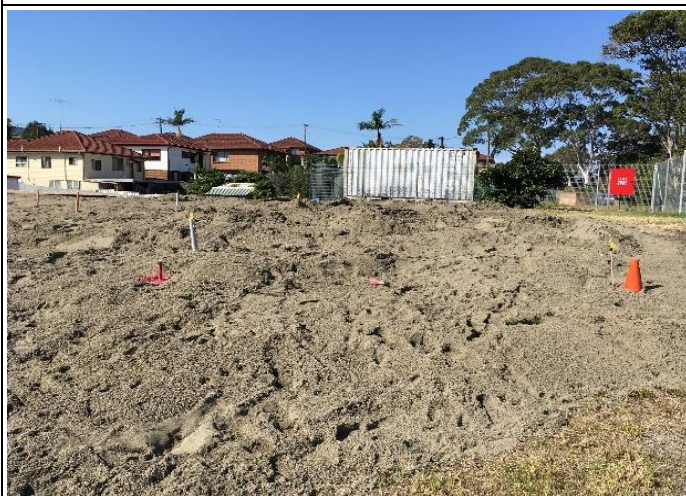
Photo 11. Placement of Sand across area of concern - April 2018

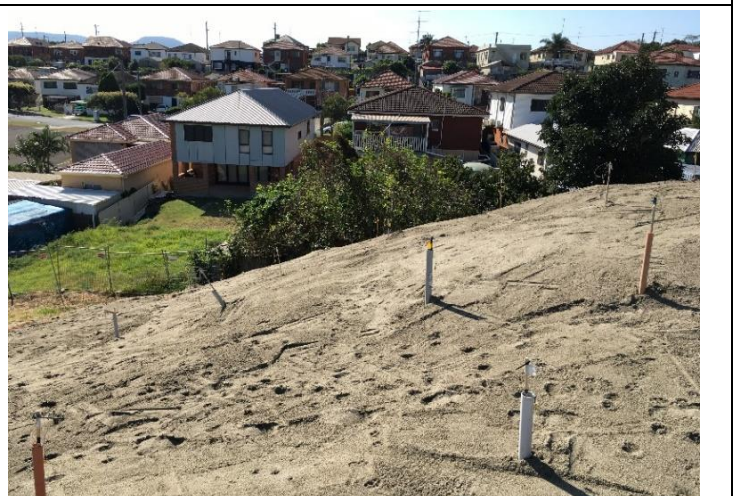
Photo 12. Ongoing near surface temperature monitoring across area of concern - April 2018

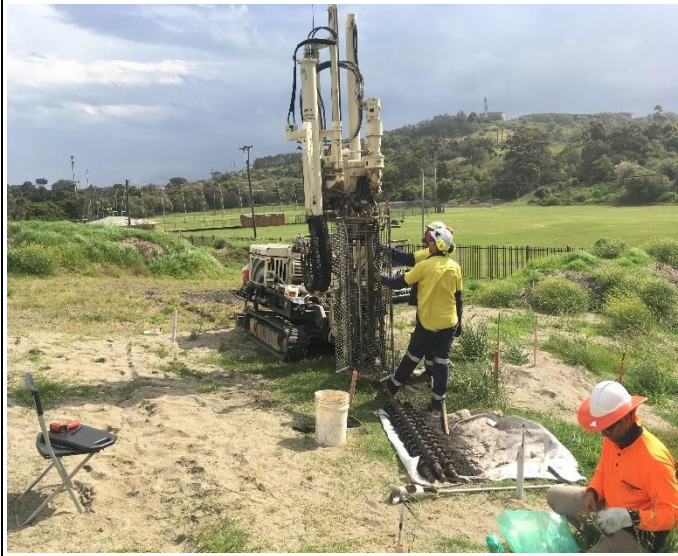
Photo 13. Geotechnical investigation and Installation of Subsurface Thermocouples – October 2018

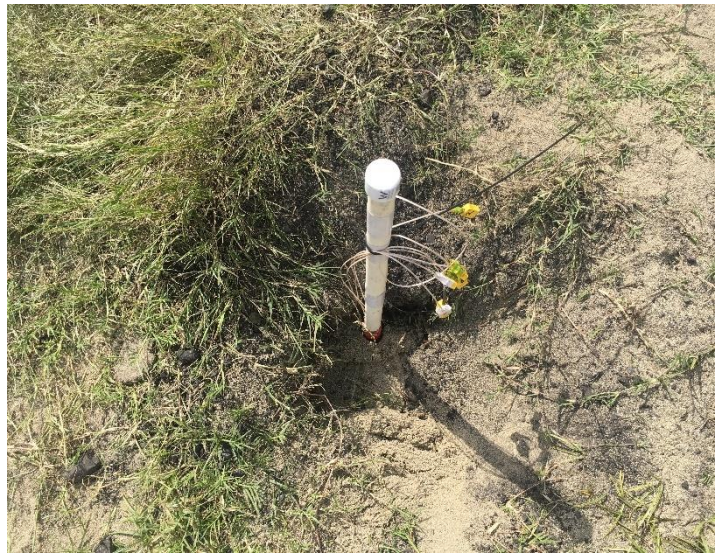
Photo 14. Installation and Monitoring of Subsurface Thermocouples – October 2018
