# Asbestos in Grounds, Asbestos Management Plan, Albion Park Public School, Albion Park, NSW

July 2013

NSW Public Works

**PARSONS  
BRINCKERHOFF**

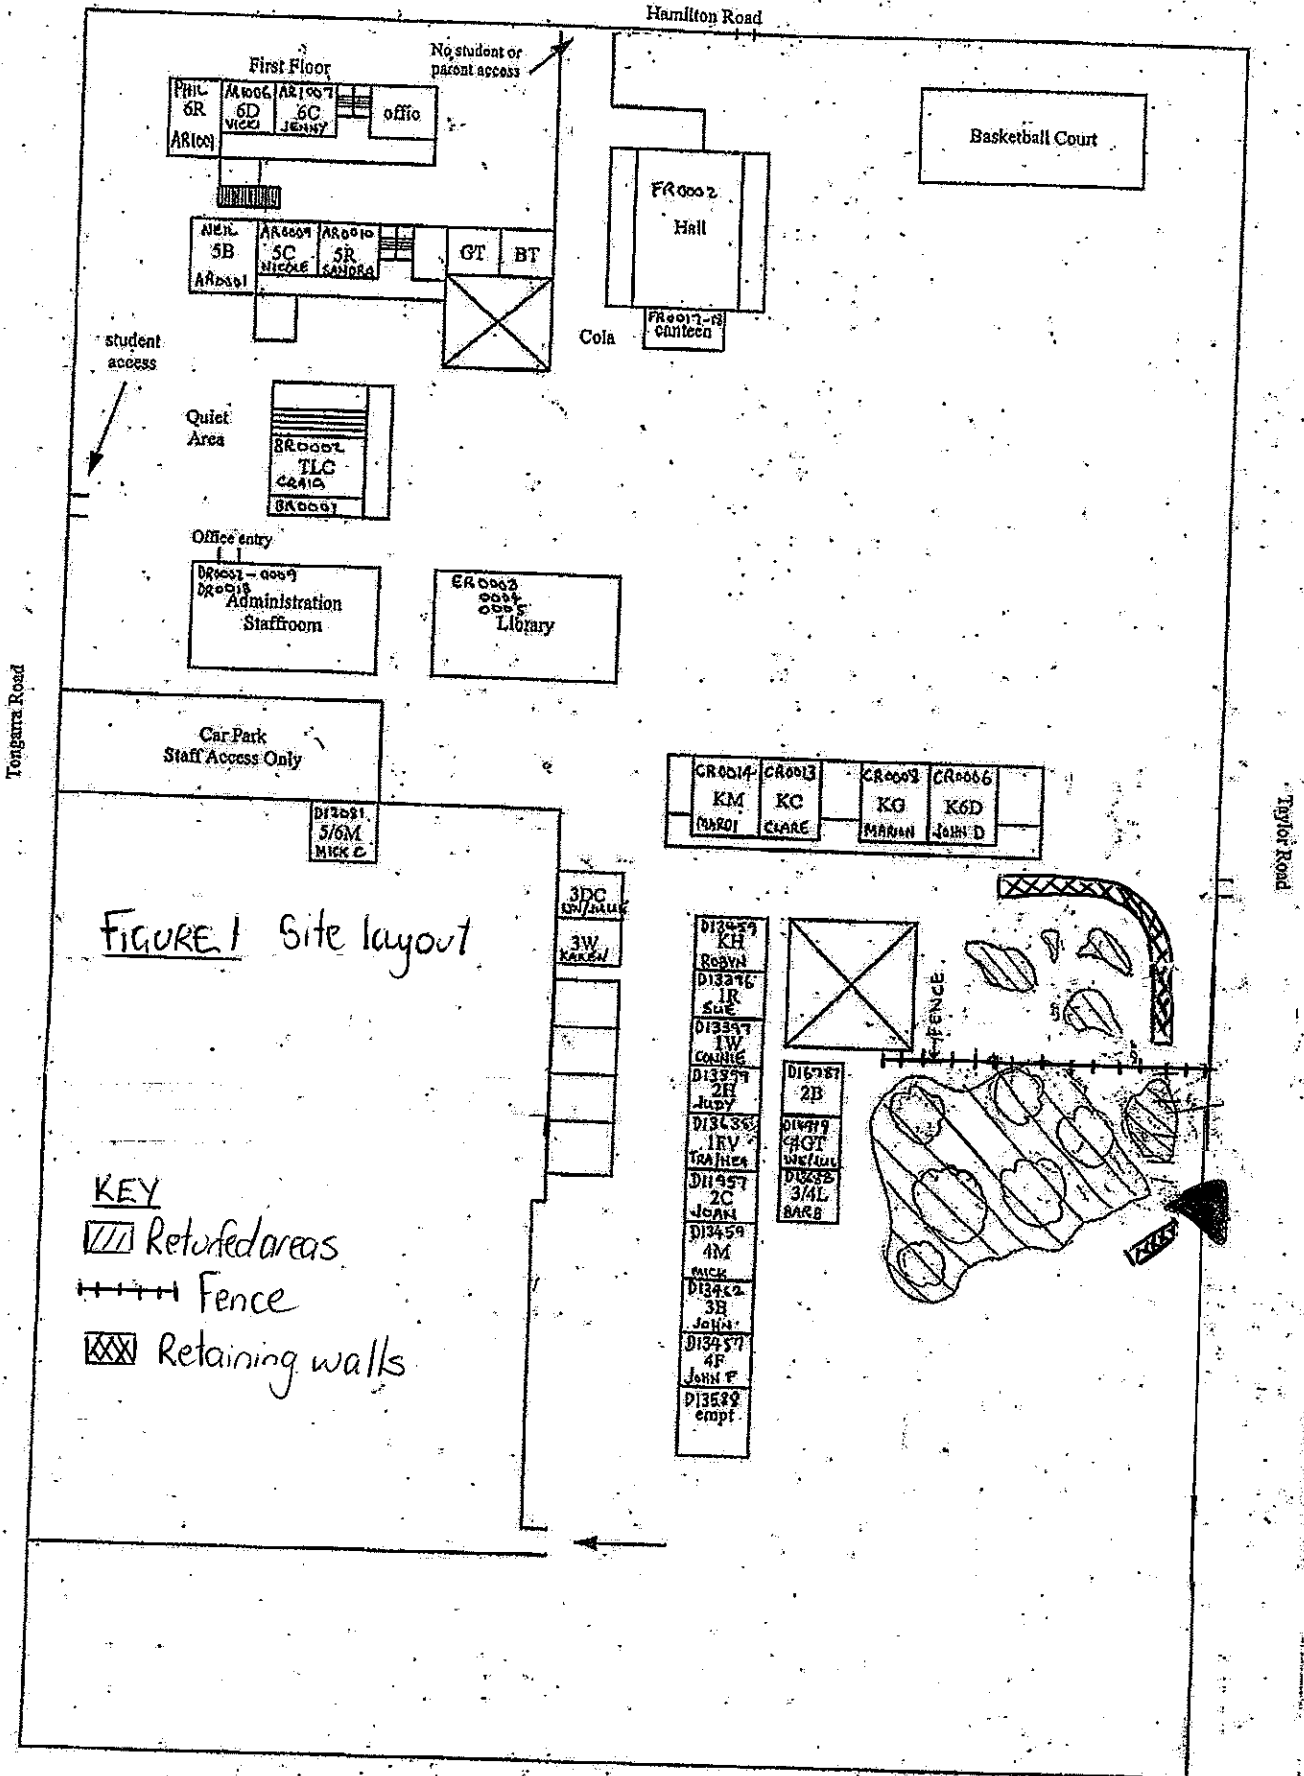
FIGURE 1 Site layout

The remediated area is shown in Figure 1.

Event	Location	Description of Material	Extent	Condition	Risk Status	Control Priority	Control Recommendation/Comments
<b>School Grounds*</b>							
A	Grassed area adjacent to Taylor Road	Possible buried asbestos cement fragments	Throughout – below ground surface	Unknown	Low	Low	Maintain existing surface/ new surface in a good condition. Do not disturb soil surface. Inspect annually or after adverse weather conditions for signs of surface wear and possible fragments at surface.

\* Refer to Figure 1 for detail of area locations
