Asbestos in Grounds, Asbestos Management Plan, Avalon Public School, Avalon Beach, NSW

March 2013

NSW Public Works

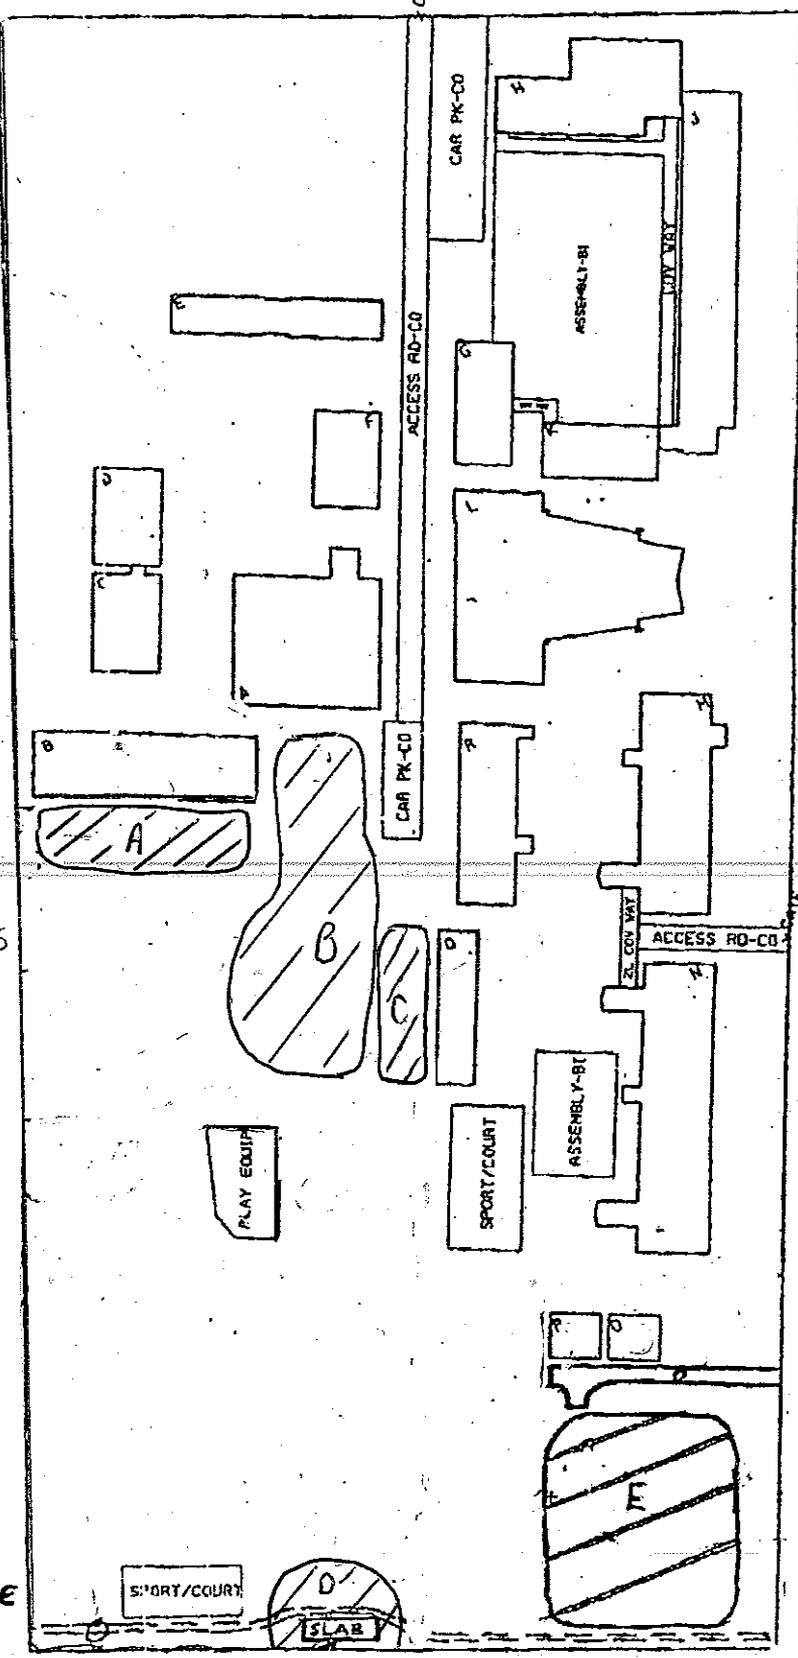
3792 – Avalon Public School
Site Plan (11890)

Asbestos cement fragments may be present as a component of buried fill within the asbestos zone areas. Refer to Figure 1 site plan. A hygienist should be engaged to determine whether the asbestos within the Asbestos Zones is considered *non friable* or *friable* in accordance with the NSW WorkCover Authority 'Working with Asbestos, 2008'. This contains safety guidelines and requirements for work involving asbestos.

Event	Location	Description of Material	Extent	Condition	Risk Status	Control Priority	Control Recommendation/Comments
School Grounds*							
A	Bund area south of Block B	Possible buried asbestos cement fragments	Throughout – below ground surface	Unknown	Low	Low	Maintain existing surface/ new surface. Do not disturb soil surface Inspect every three months or after adverse weather conditions for signs of surface wear and possible fragments at surface.
B	Tree area south of Block A	Possible buried asbestos cement fragments	Throughout – below ground surface	Unknown	Low	Low	Maintain existing surface/ new surface. Do not disturb soil surface Inspect every three months or after adverse weather conditions for signs of surface wear and possible fragments at surface.
C	Area west of Block Q	Possible buried asbestos cement fragments	Throughout – below ground surface	Unknown	Low	Low	Maintain existing surface/ new surface. Do not disturb soil surface Inspect every three months or after adverse weather conditions for signs of surface wear and possible fragments at surface.

D	Concrete slab and area by southern perimeter	Possible buried asbestos cement fragments	Throughout – below ground surface	Unknown	Low	Low	Maintain existing surface/ new surface. Do not disturb soil surface Inspect every three months or after adverse weather conditions for signs of surface wear and possible fragments at surface.
E	South eastern treed recreation area	Possible buried asbestos cement fragments	Throughout – below ground surface	Unknown	Low	Low	Maintain existing surface/ new surface. Do not disturb soil surface Inspect every three months or after adverse weather conditions for signs of surface wear and possible fragments at surface.
A (2012)	South western playground area.	Possible buried asbestos cement fragments	Throughout – below ground surface	Unknown	Low	Low	Maintain existing surface/ new surface. Do not disturb soil surface Inspect every three months or after adverse weather conditions for signs of surface wear and possible fragments at surface.

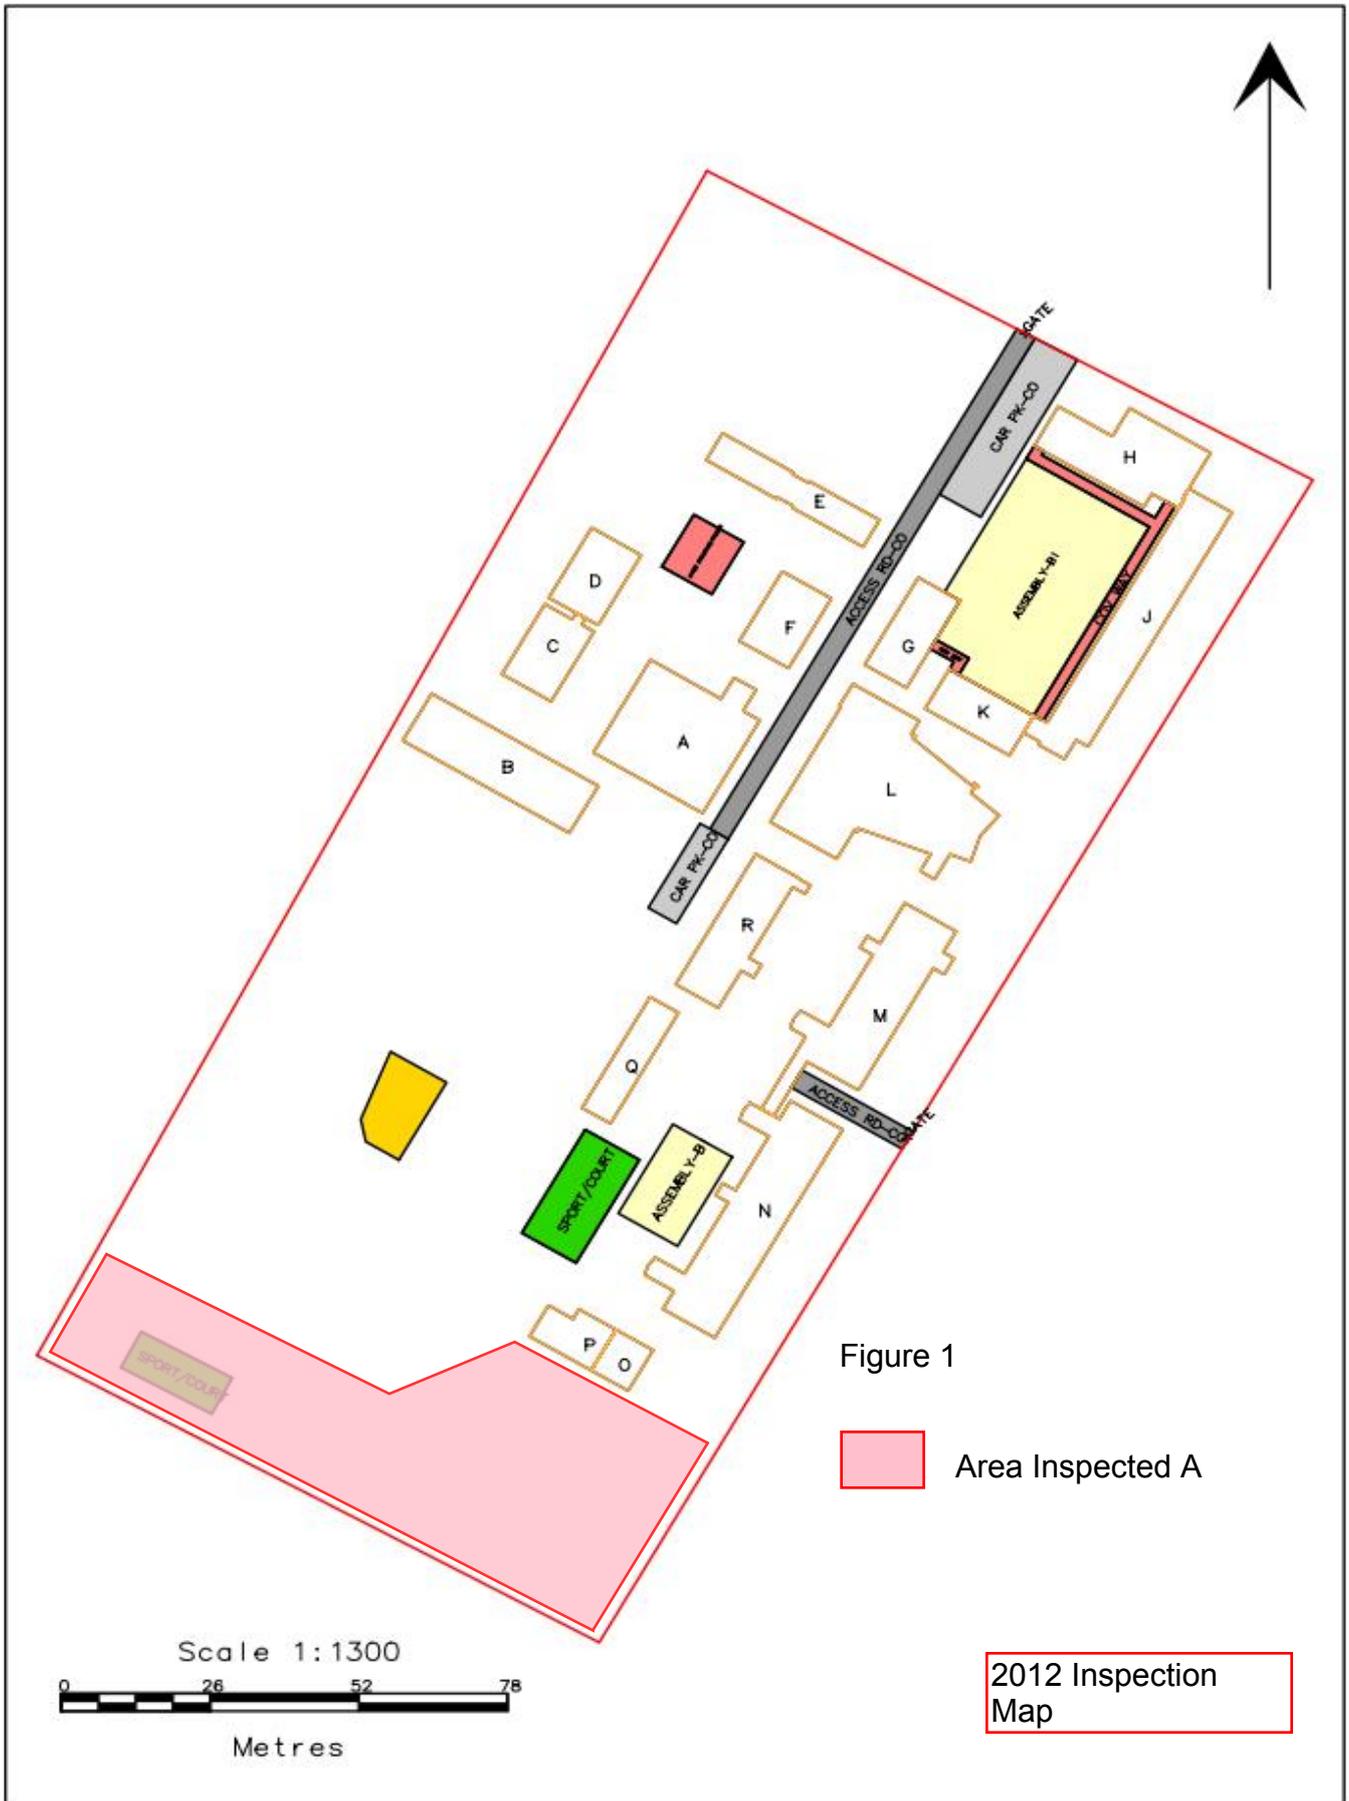
Figure 1

Area A (2012) - south-western playground area

Area Inspected A

2012 Inspection
Map

- Area should be regularly monitored for fragments and a record kept of how many are found and at what frequency.
- Consideration should be given to the repair of surface coverage to the area using mulching, re-turfing and/or paving as appropriate.
