Asbestos in Grounds, Asbestos Management Plan, Bulahdelah Central School, Bulahdelah, NSW

November 2012

NSW Public Works

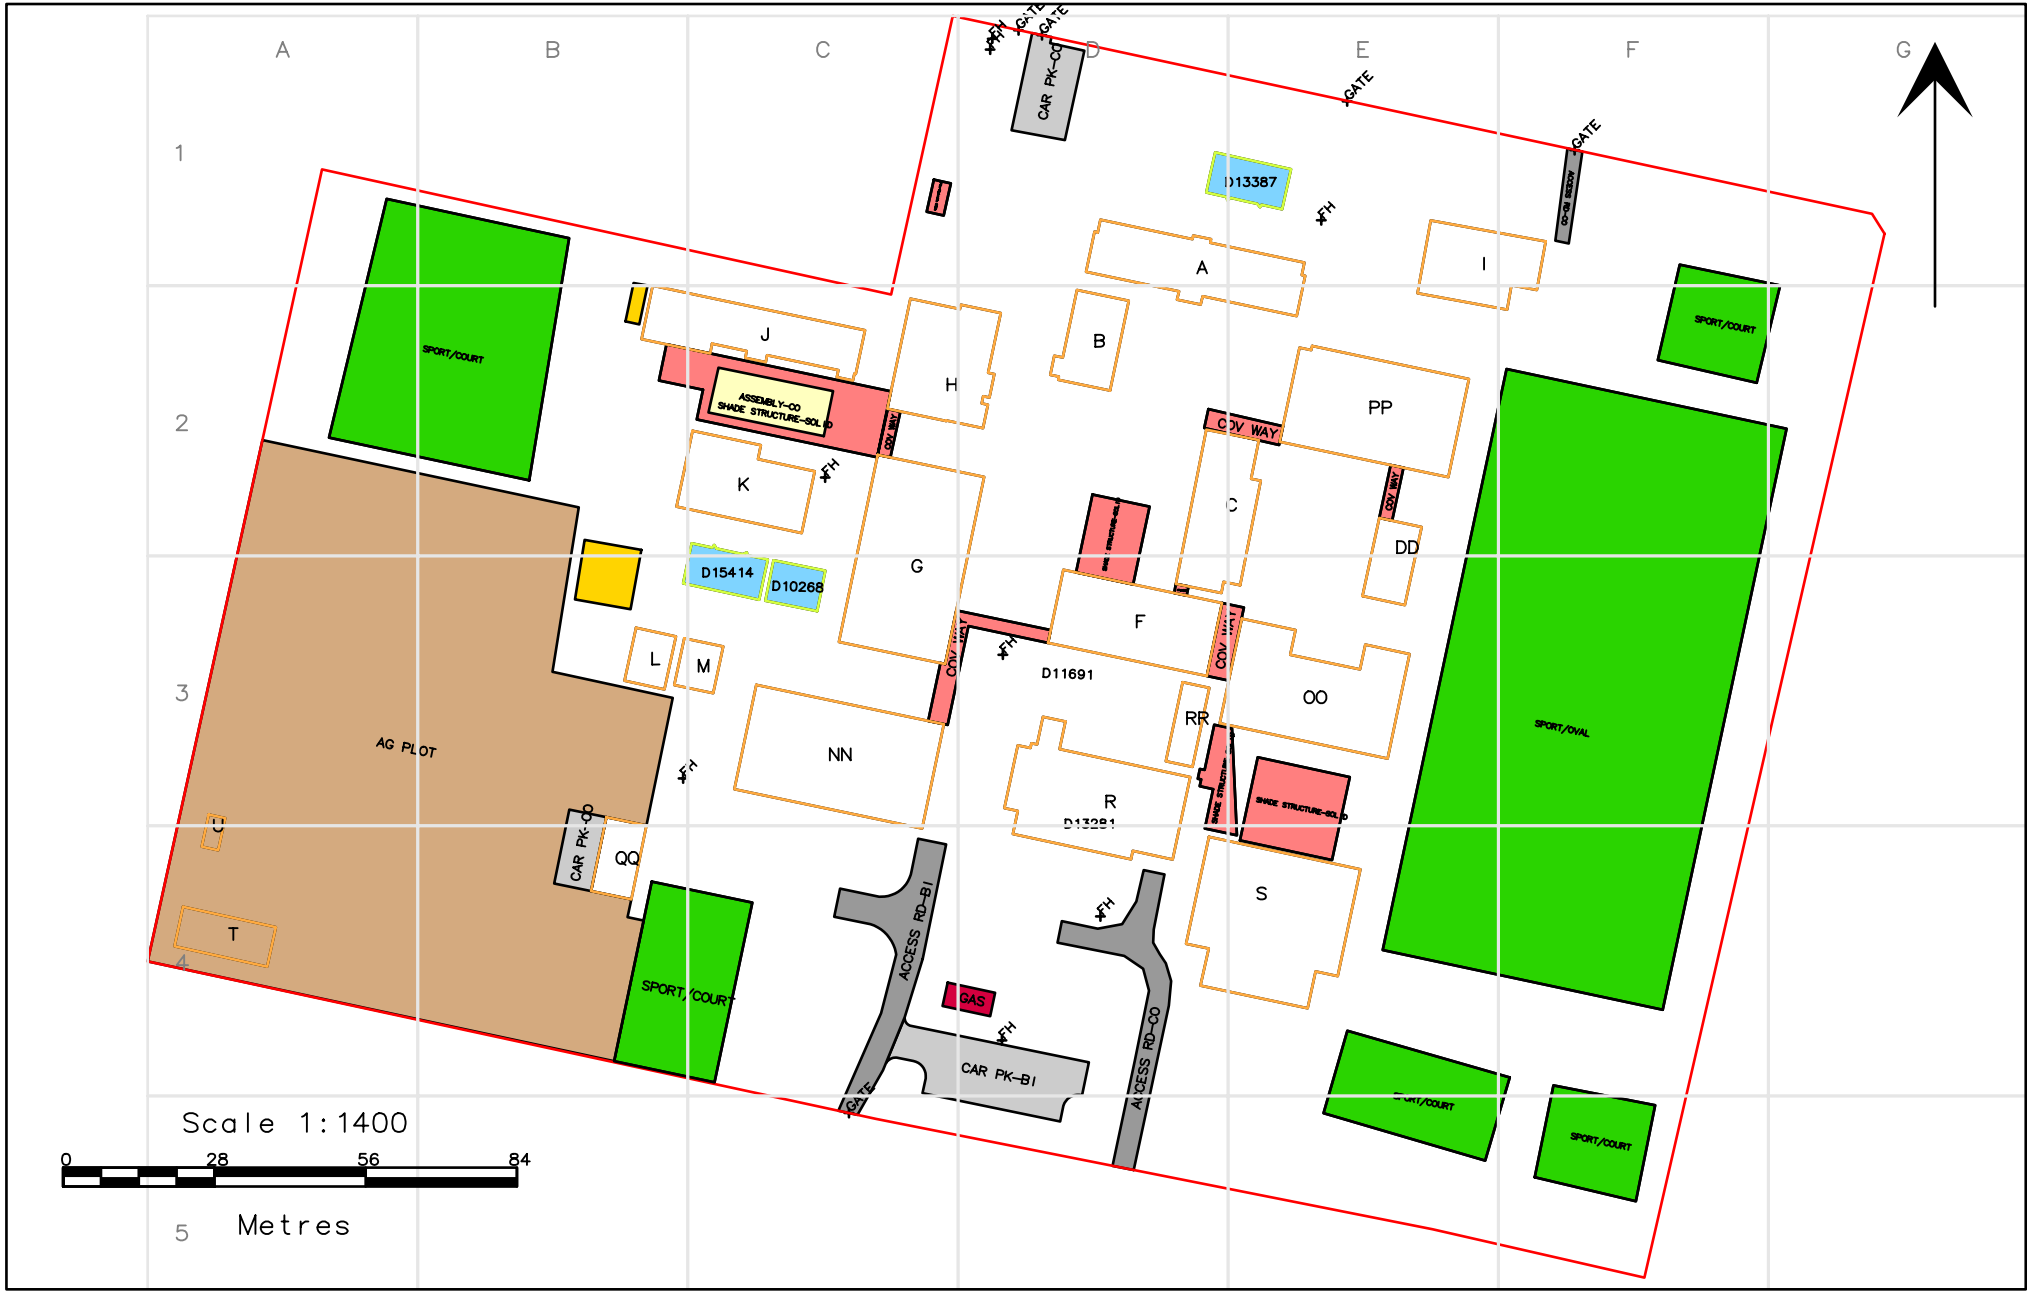
1402 – Bulahdelah Central School Site Plan (13369)

The school site plan is shown in Figure 1. However the exact location of the asbestos impacted area is not known by PB at this time.

Asbestos cement fragments may be present as a component of buried fill within the asbestos zone areas. Refer to Figure 1 site plan. A hygienist should be engaged to determine whether the asbestos within the Asbestos Zones is considered *non friable* or *friable* in accordance with the NSW WorkCover Authority 'Working with Asbestos, 2008'. This contains safety guidelines and requirements for work involving asbestos.
