Asbestos in Grounds, Asbestos Management Plan, Burwood Public School, Burwood, NSW

March 2013

NSW Public Works

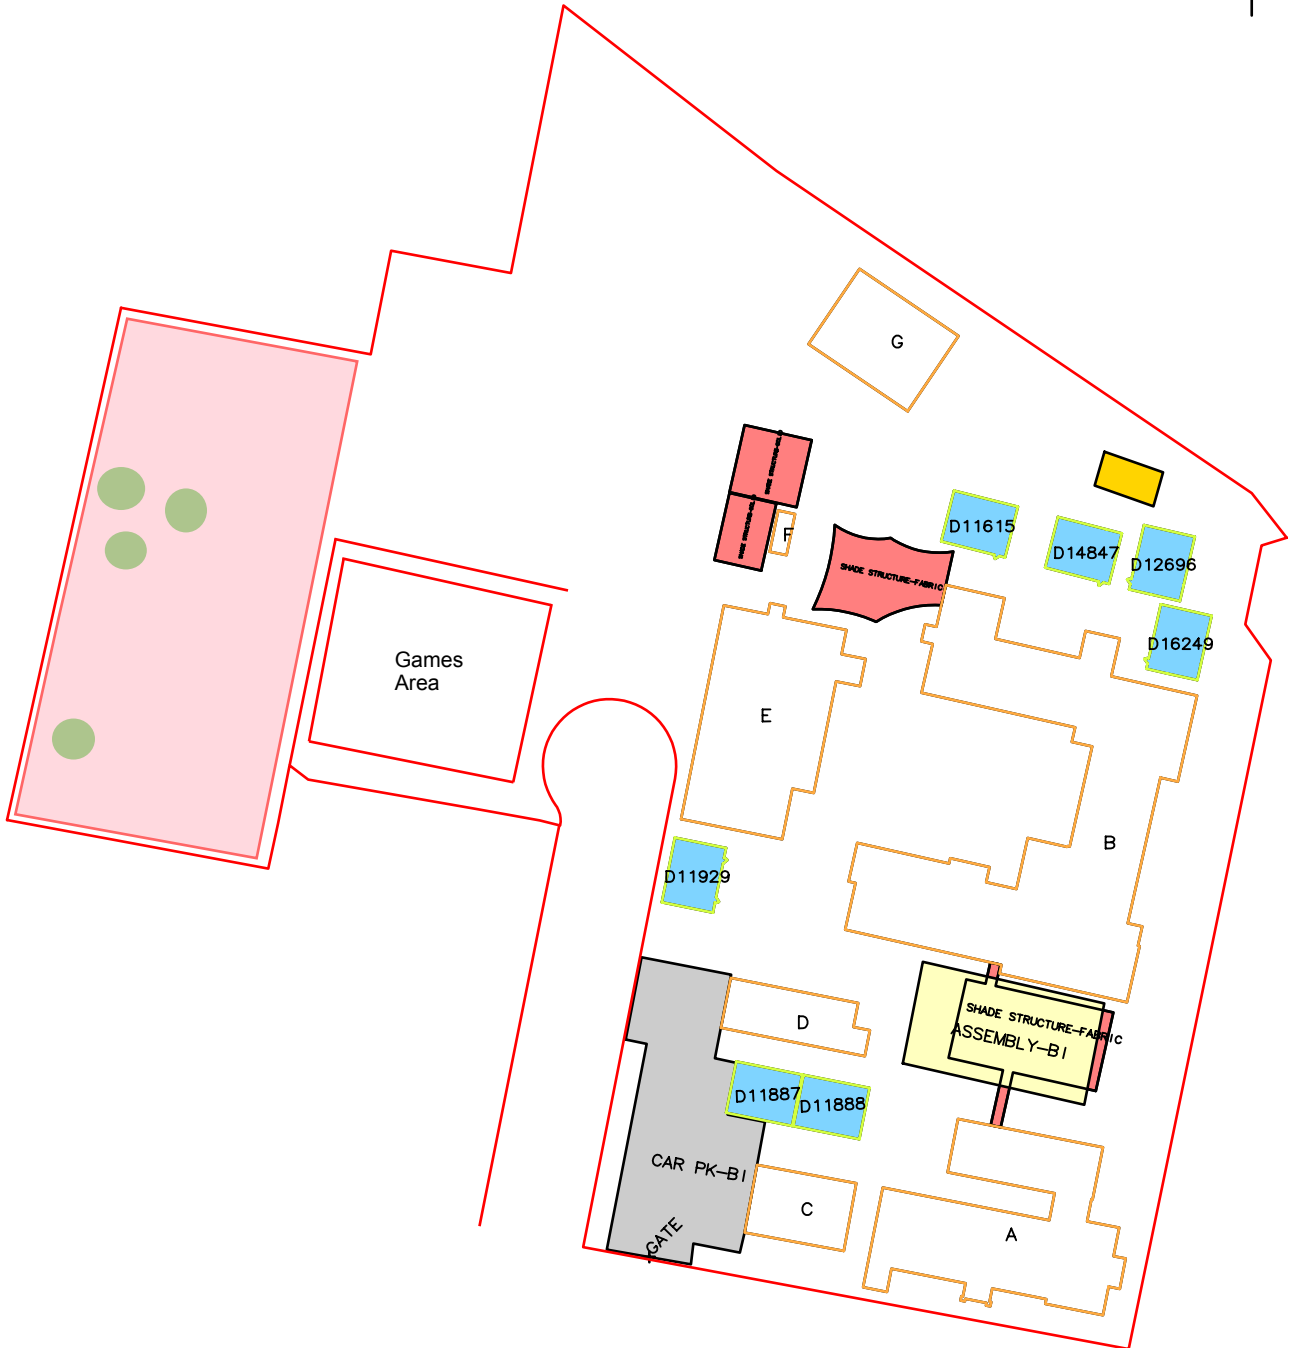
1455 – Burwood Public School Site Plan (12415)

2011 Inspection Map

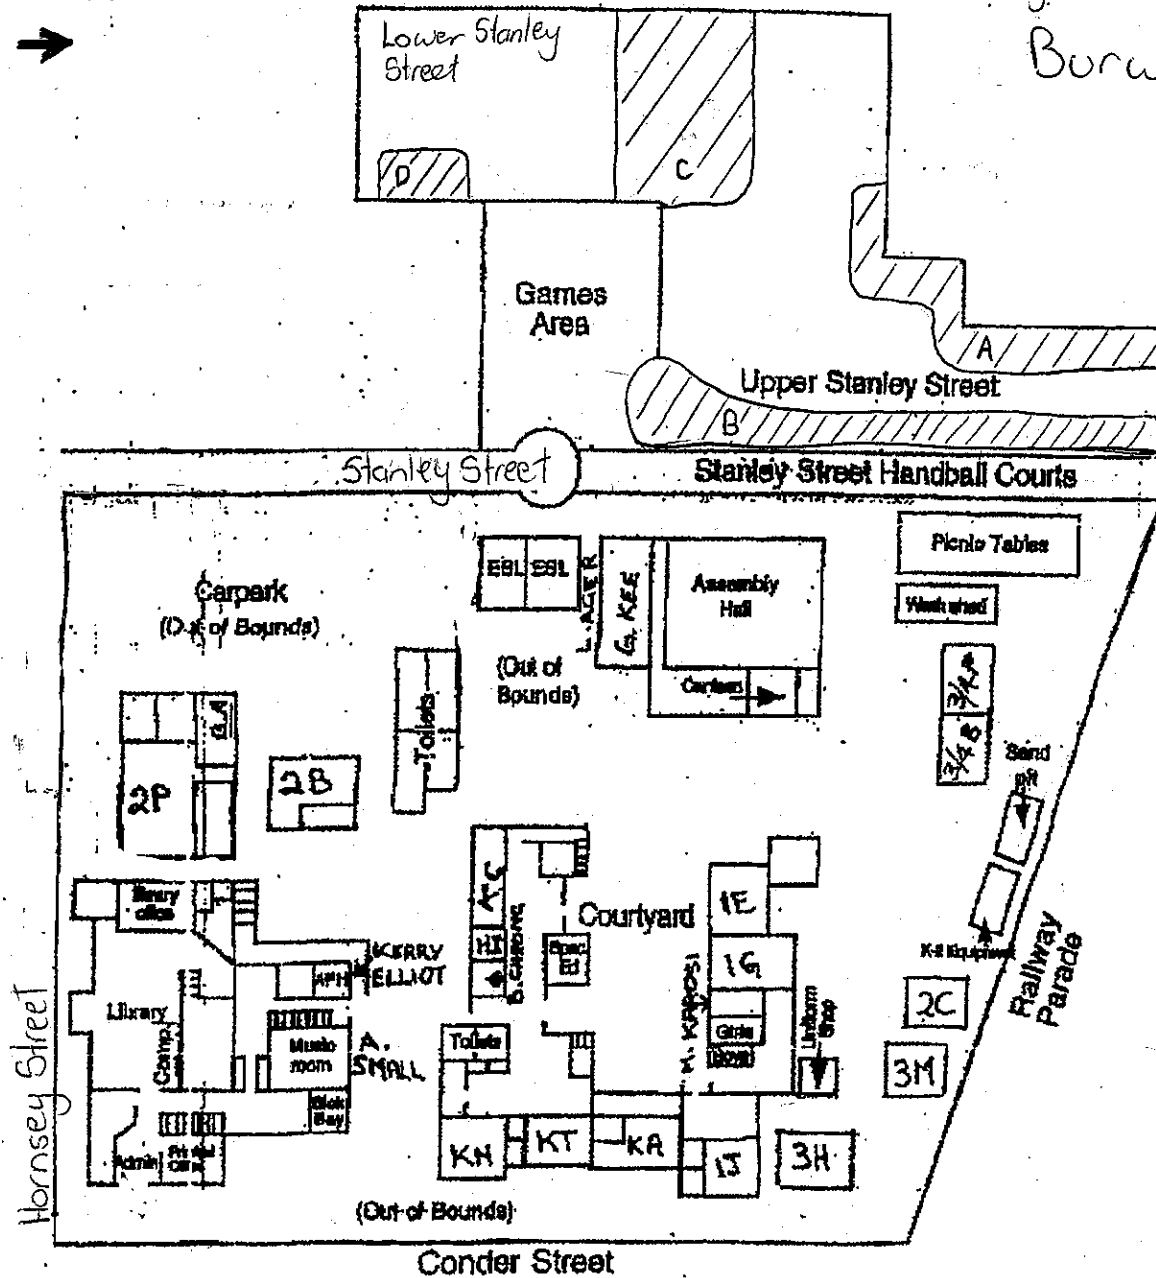
The remediated areas are shown in Figure 1.

*Refer to Figure 1 for detail of area locations
