Asbestos in Grounds, Asbestos Management Plan, Blakehurst High School, Blakehurst, NSW

March 2014

NSW Public Works

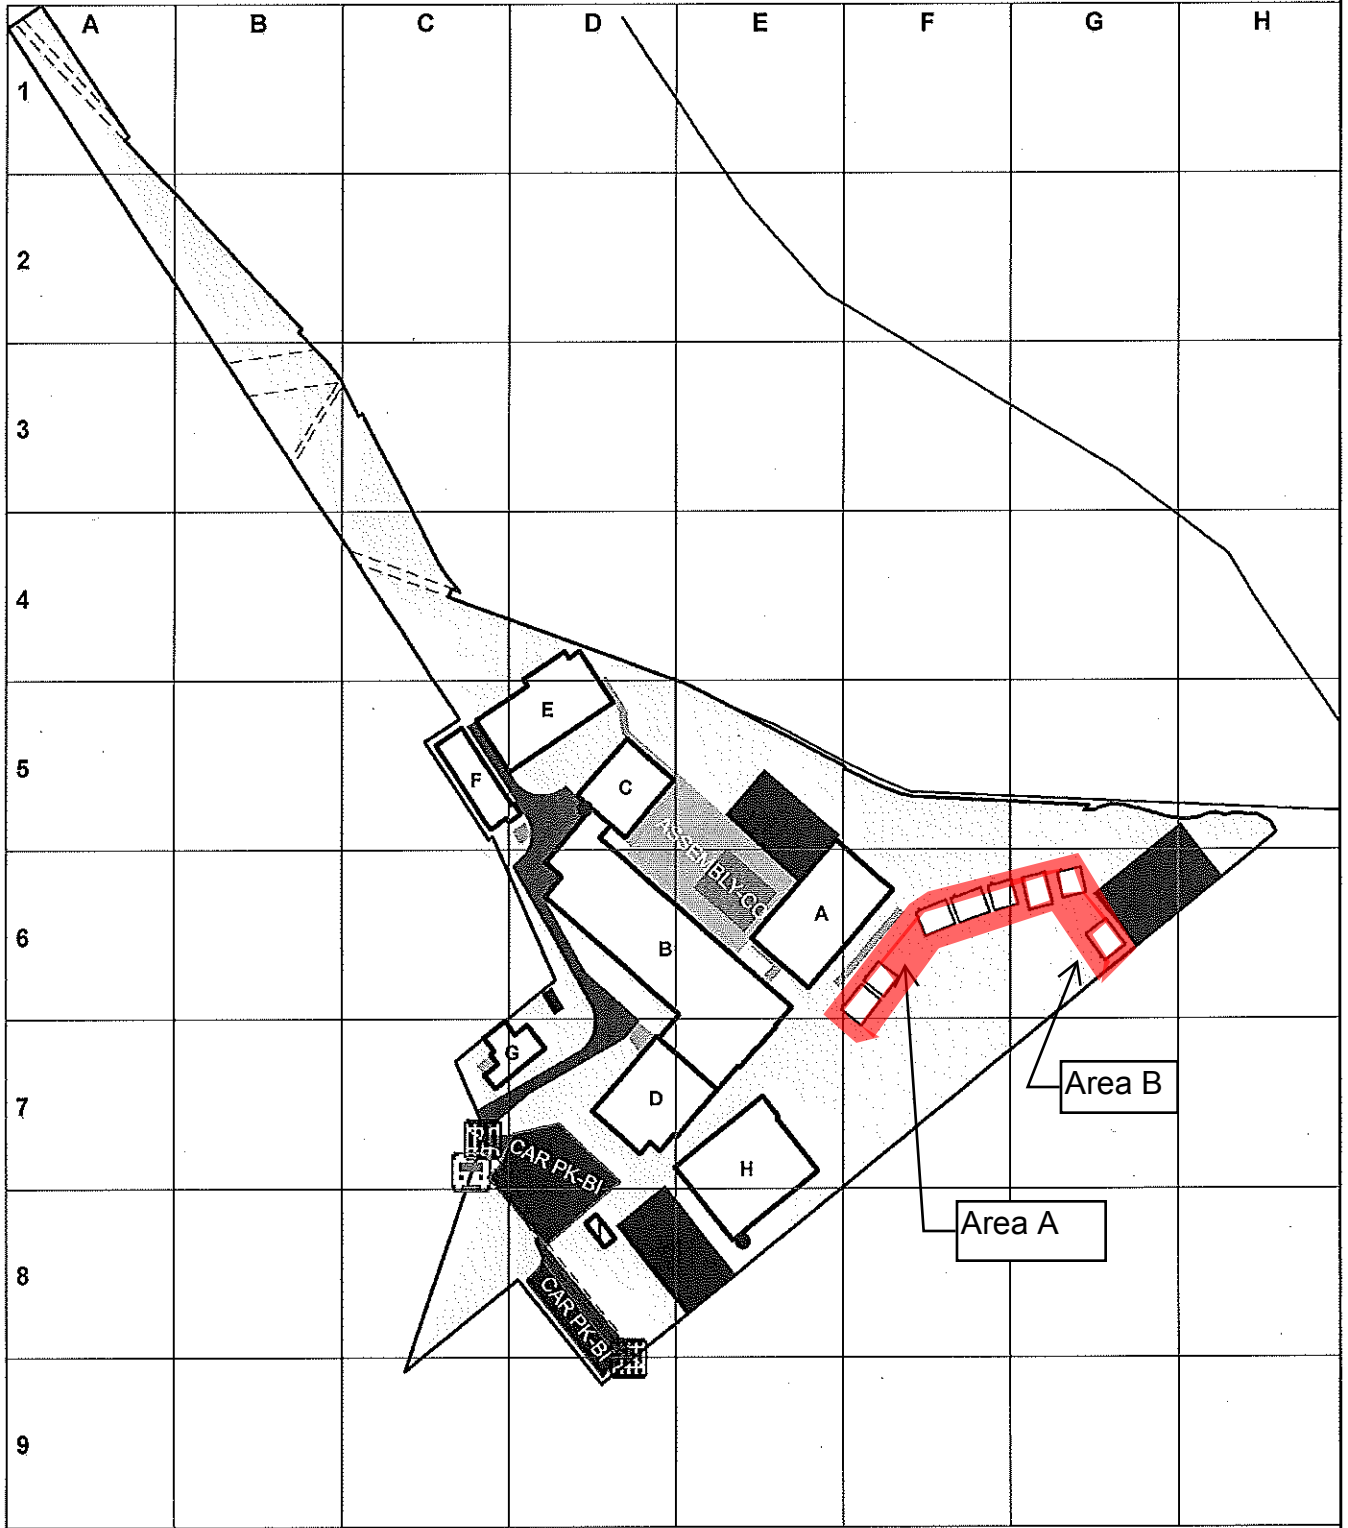
2014 Inspection Map

- **Area A:** South-eastern corner of the school, beneath and around the demountable buildings

During the January inspection, a skip-bin containing asbestos cement sheeting debris was noted and added to the investigation register as **Area B**.

Event	Location	Description of Material	Extent	Condition	Risk Status	Control Priority	Control Recommendation/Comments
A (2014)	South-eastern corner of the school, beneath and around the demountable buildings	Possible buried asbestos cement fragments	Throughout – below ground surface	Unknown	Low	Low	of as asbestos waste. The area should be regularly monitored for any fragments and a record kept of how many are found and at what frequency. Fragments should be collected and disposed of as asbestos waste. It's recommended that access to areas beneath the demountables be restricted through the use of fencing and mesh, which would capture debris before it can travel from beneath the buildings after periods of heavy rainfall, without hindering the movement of water. By isolating the debris that exists beneath the buildings, the chances of future unexpected finds due to water movement can be decreased or prevented

B (2014)	Stockpiled fill in bins, south-east of school boundary fence, to demountables	Possible buried asbestos cement fragments	Throughout – below ground surface	Unknown	Low	Low	The stockpiled material should not be used for any purpose and must be disposed of as asbestos waste. Until such time when it can be removed, it should be covered with 200µm thick polythene plastic sheeting to prevent any material from impacting school grounds after periods of heavy rain

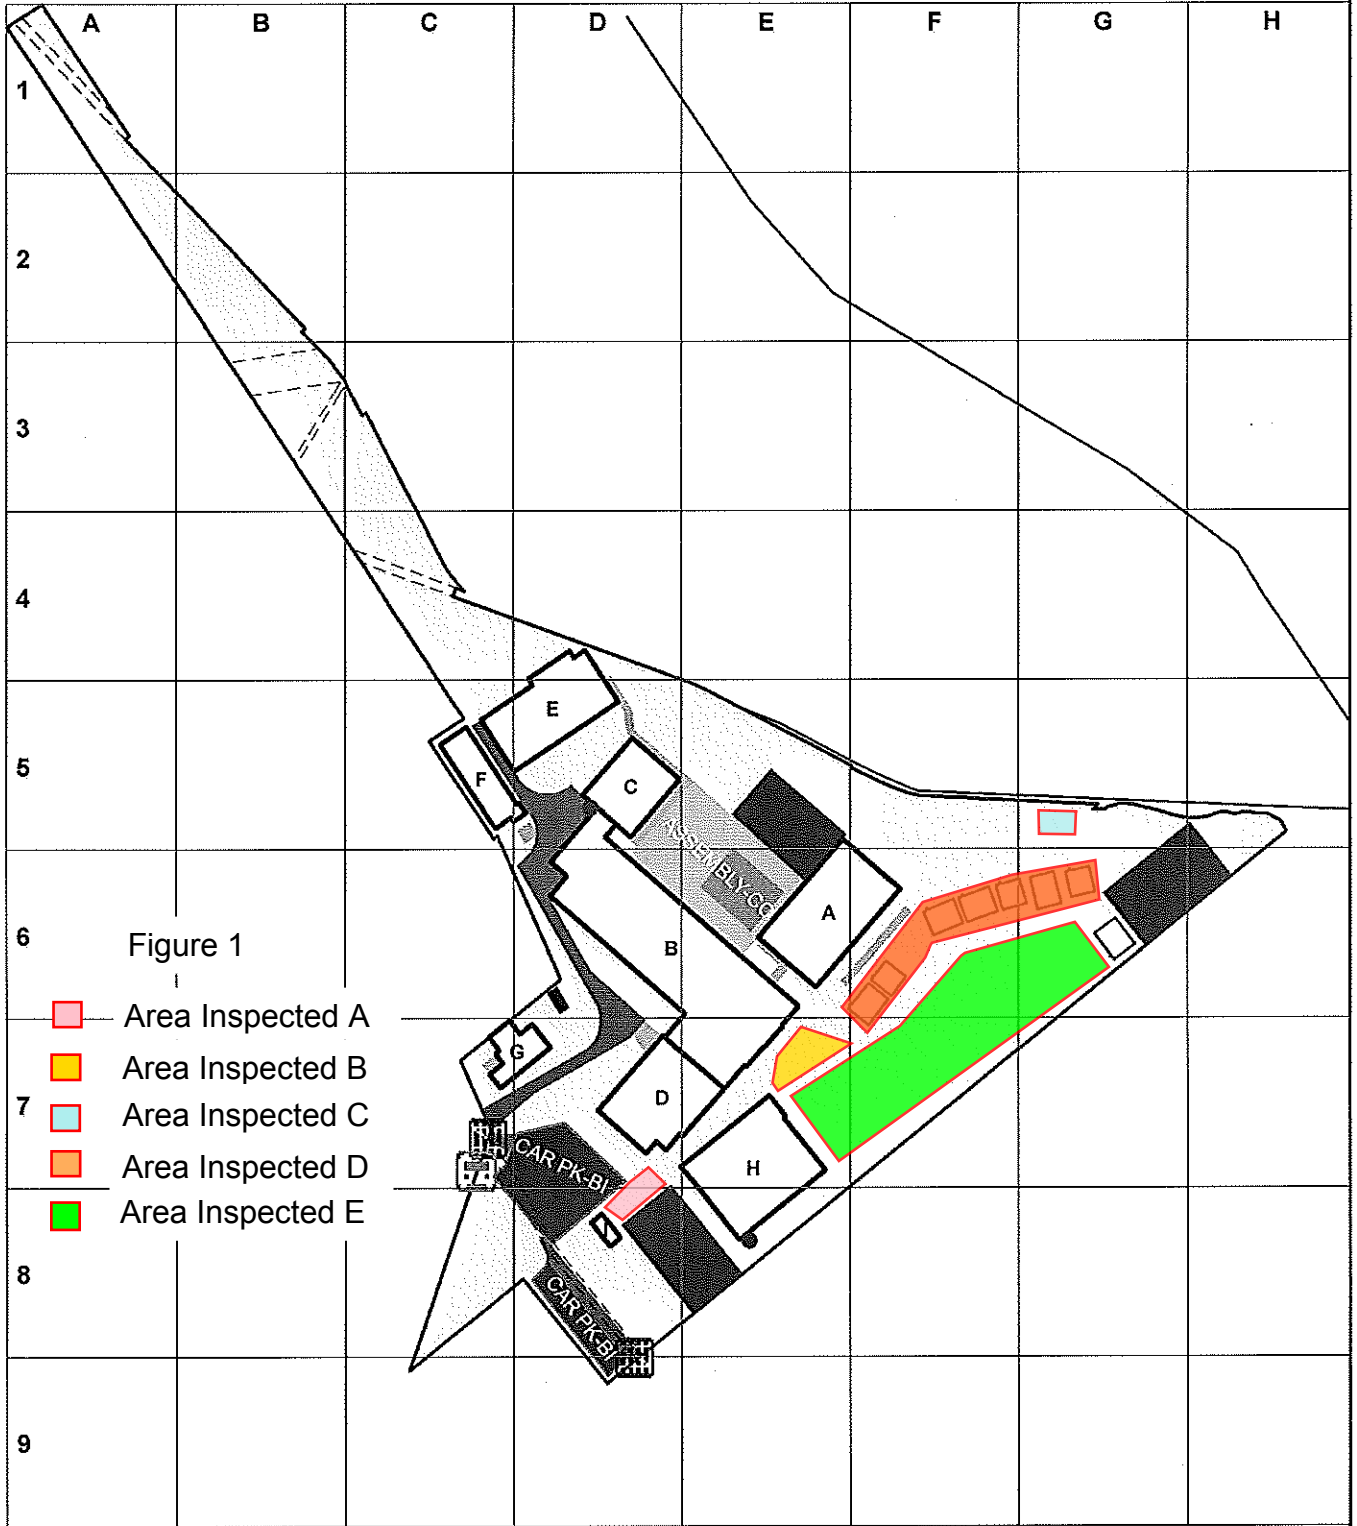
Figure 1

- Area Inspected A
- Area Inspected B
- Area Inspected C
- Area Inspected D
- Area Inspected E

B (2012)	Seating area located west of H Block	Possible buried asbestos cement fragments	Throughout – below ground surface	Unknown	Low	Low	The area should be regularly monitored for any fragments and a record kept of how many are found and at what frequency. Fragments should be collected and disposed of as asbestos waste. Consideration should be given to the installation of raised garden beds covered with mulch which will prevent foot traffic and

Event	Location	Description of Material	Extent	Condition	Risk Status	Control Priority	Control Recommendation/Comments
							reduce erosion caused by water runoff.
C (2012)	Area surrounding the storm water drain located north west of the demountable buildings	Possible buried asbestos cement fragments	Throughout – below ground surface	Unknown	Low	Low	<p>The area should be regularly monitored for any fragments and a record kept of how many are found and at what frequency. Fragments should be collected and disposed of as asbestos waste.</p> <p>Consideration should be given to the repair of surface coverage to the area using re-turfing as appropriate.</p> <p>If large numbers of fragments continue to be identified then an additional inspection should be carried out to determine if further, more extensive remediation is required.</p>
D (2012)	Area immediately surrounding the demountable buildings.	Possible buried asbestos cement fragments	Throughout – below ground surface	Unknown	Low	Low	<p>The area should be regularly monitored for any fragments and a record kept of how many are found and at what frequency. Fragments should be collected and disposed of as asbestos waste.</p> <p>If large numbers of fragments continue to be identified then the area should be remediated by installing a hard stand material or re-turfing.</p>

E (2012)	Playing fields	Possible buried asbestos cement fragments	Throughout – below ground surface	Unknown	Low	Low	<p>It is understood from discussion with the School Principal and representatives from the Soil Conservation Service that the area is to re-profiled which includes encapsulating the area with top soil and grass coverage.</p> <p>The area should still be regularly monitored for any fragments and a record kept of how many are found and at what frequency. Fragments should be collected and disposed</p>

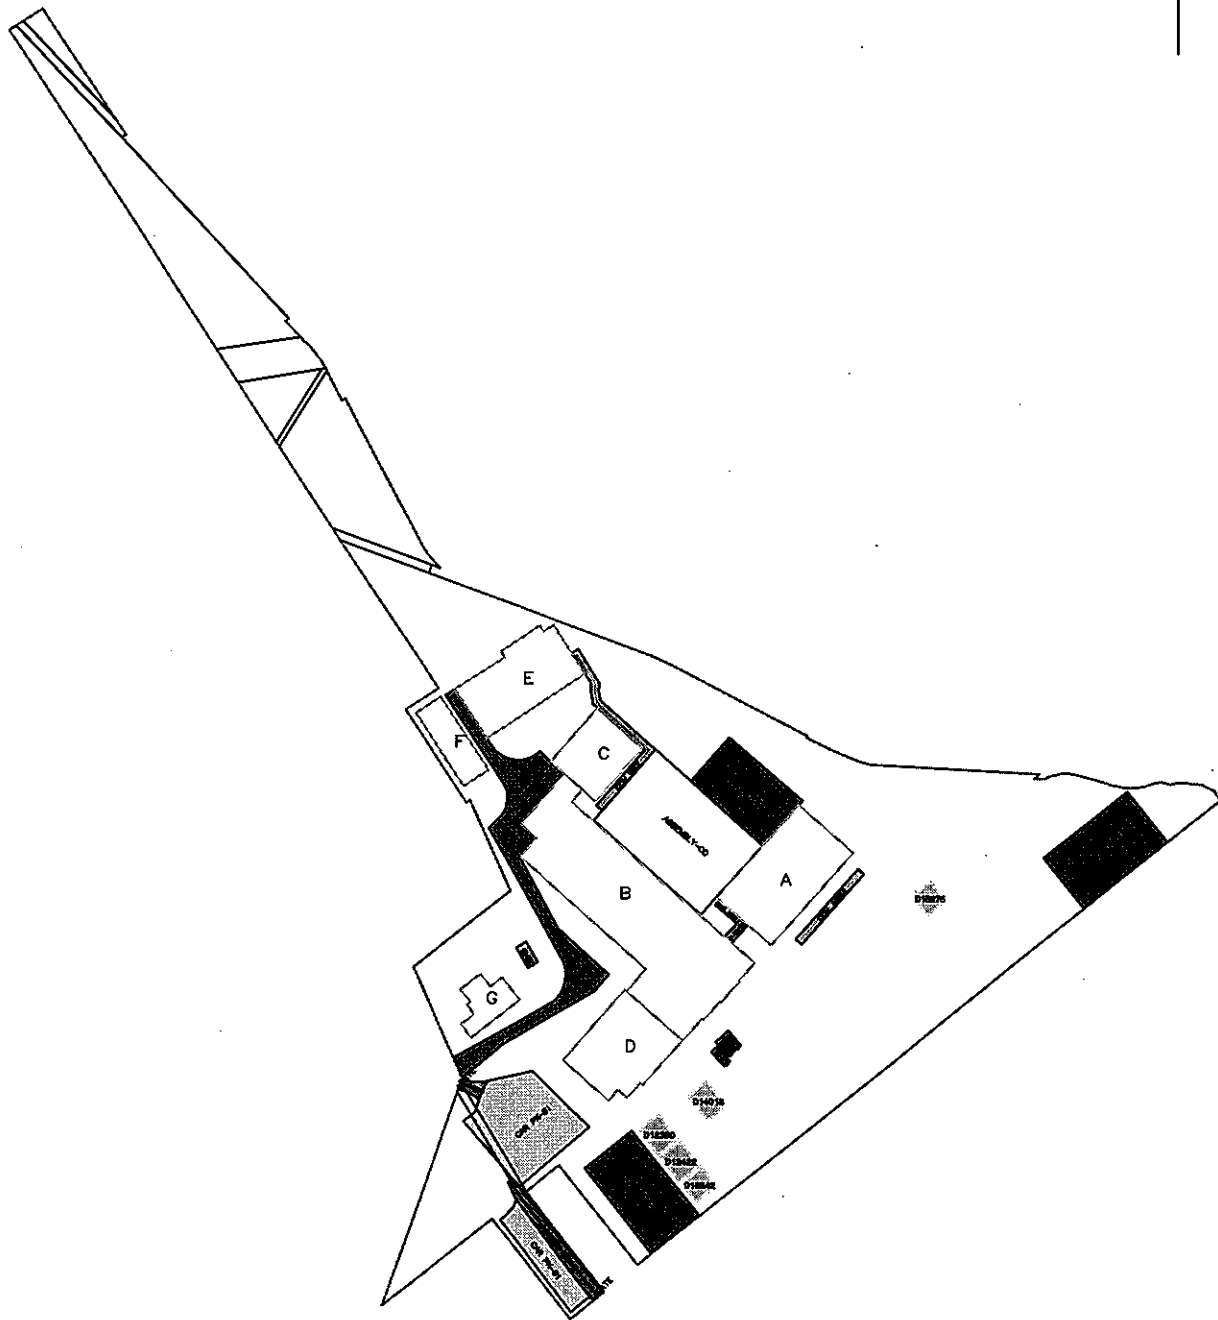
2006 AMP Map

In June 2006, areas of possible asbestos impacted fill material and exposed fill were identified to the playing field at Blakehurst High School, Woniora Road, Blakehurst NSW 2221.

Event	Location	Description of Material	Extent	Condition	Risk Status	Control Priority	Control Recommendation/Comments
<i>School Grounds*</i>							
A (2006)	Playing field	Possible buried asbestos cement fragments	Throughout – below ground surface	Unknown	Low	Low	No further fibrous cement fragments have been identified since the clearance was undertaken. The area should be inspected on an annual basis for fibrous cement fragments
A (2012)	Area south west of southern sport/court	Possible buried asbestos cement fragments	Throughout – below ground surface	Unknown	Low	Low	The area should be regularly monitored for any fragments and a record kept of how many are found and at what frequency. Fragments should be collected and disposed of as asbestos waste. The garden area to the west of the footpath should be stabilised to prevent further erosion. Consideration should be given to the installation of raised garden beds with mulch covering.
