# Asbestos in Grounds, Asbestos Management Plan, Birrong Girls High School, Birrong, NSW

July 2013

NSW Public Works

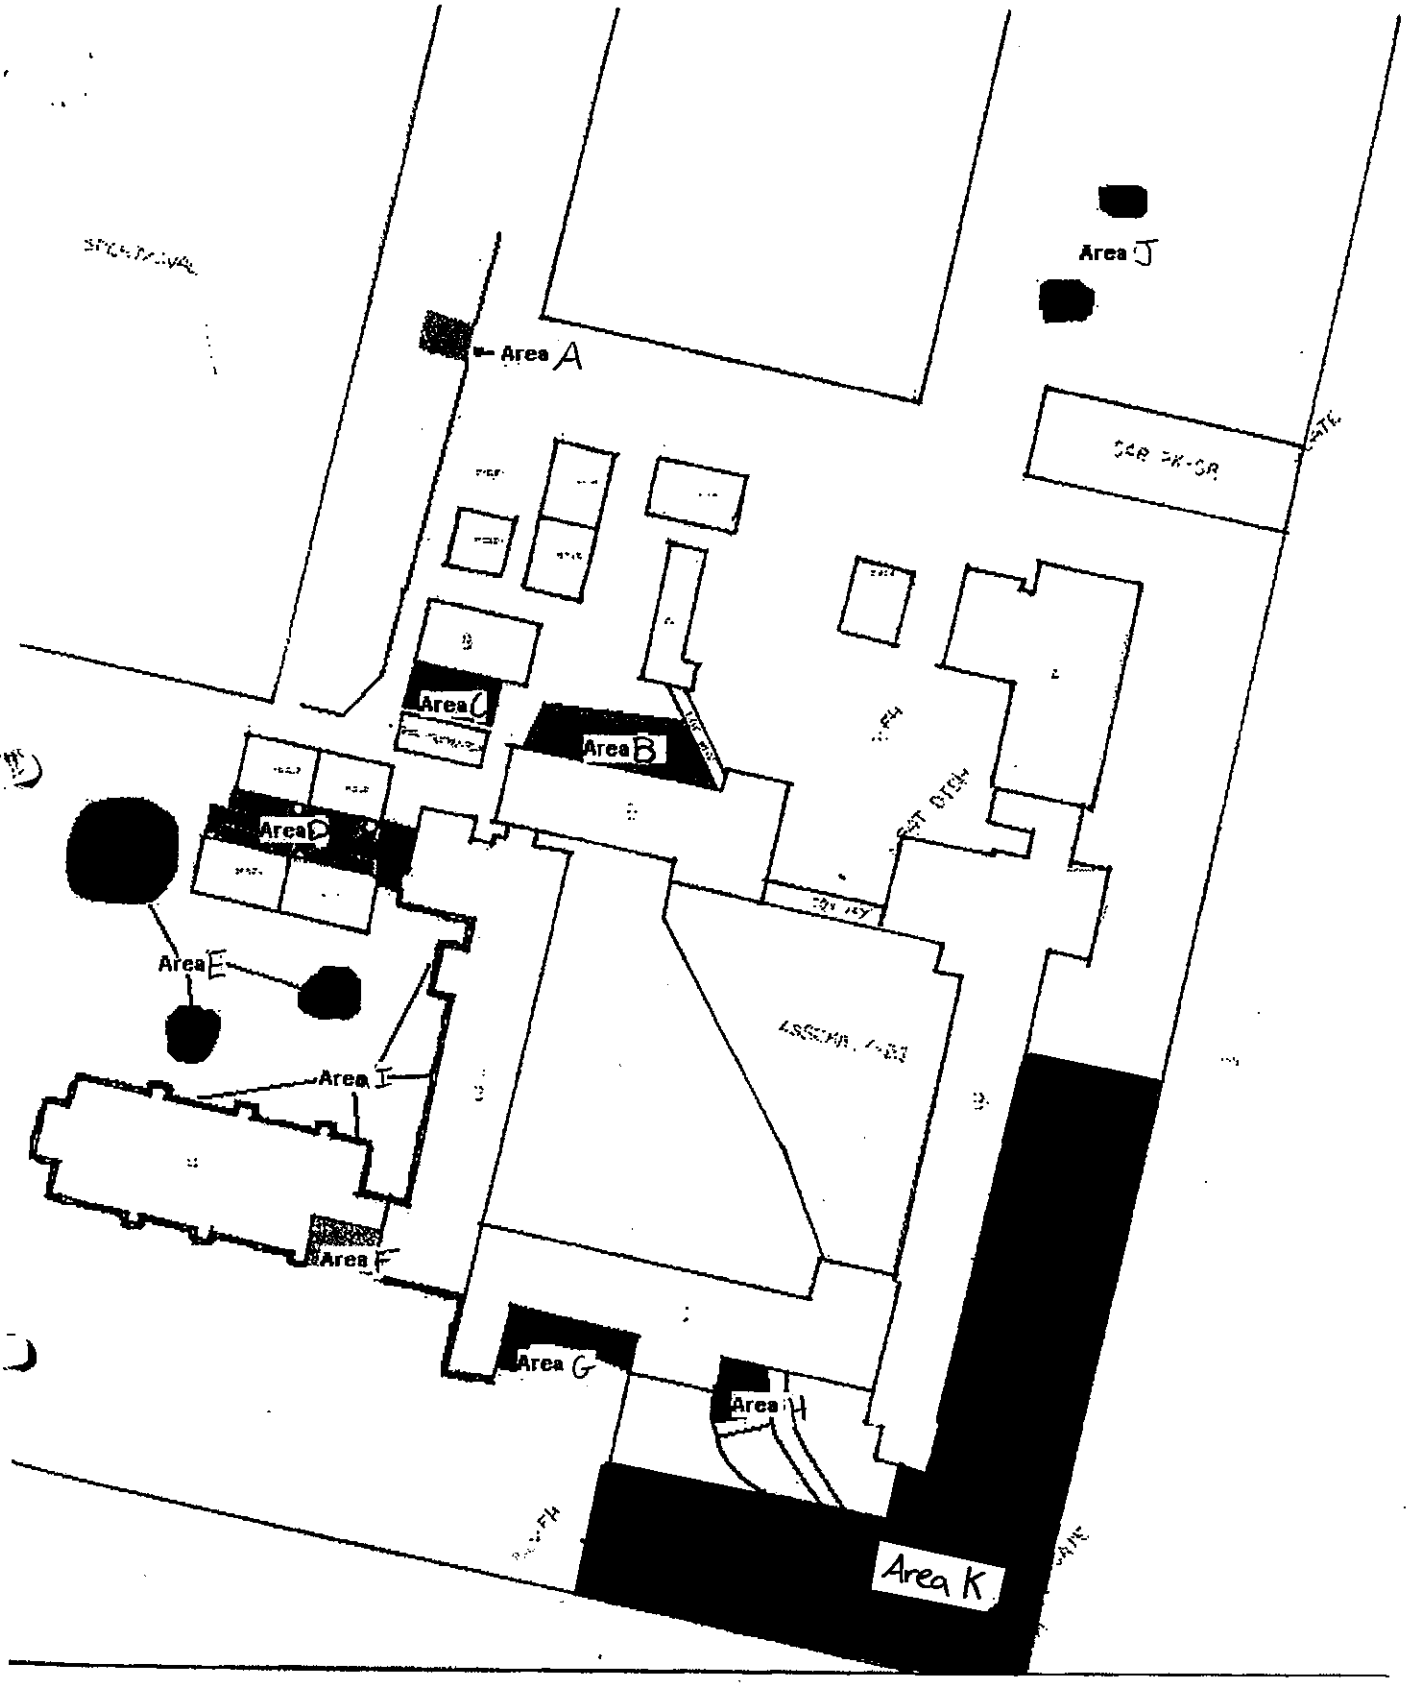
Site layout plans

The remediated areas are shown in Figure 1.

Asbestos cement fragments may be present as a component of buried fill within the asbestos zone areas. Refer to Figure 1 site plan. A hygienist should be engaged to determine whether the asbestos within the Asbestos Zones is considered *non friable* or *friable* in accordance with the NSW WorkCover Authority 'Working with Asbestos, 2008'. This contains safety guidelines and requirements for work involving asbestos.

\* Refer to Figure 1 for detail of area locations
