Asbestos in Grounds, Asbestos Management Plan, Girraween High School, Girraween, NSW

March 2014

NSW Public Works

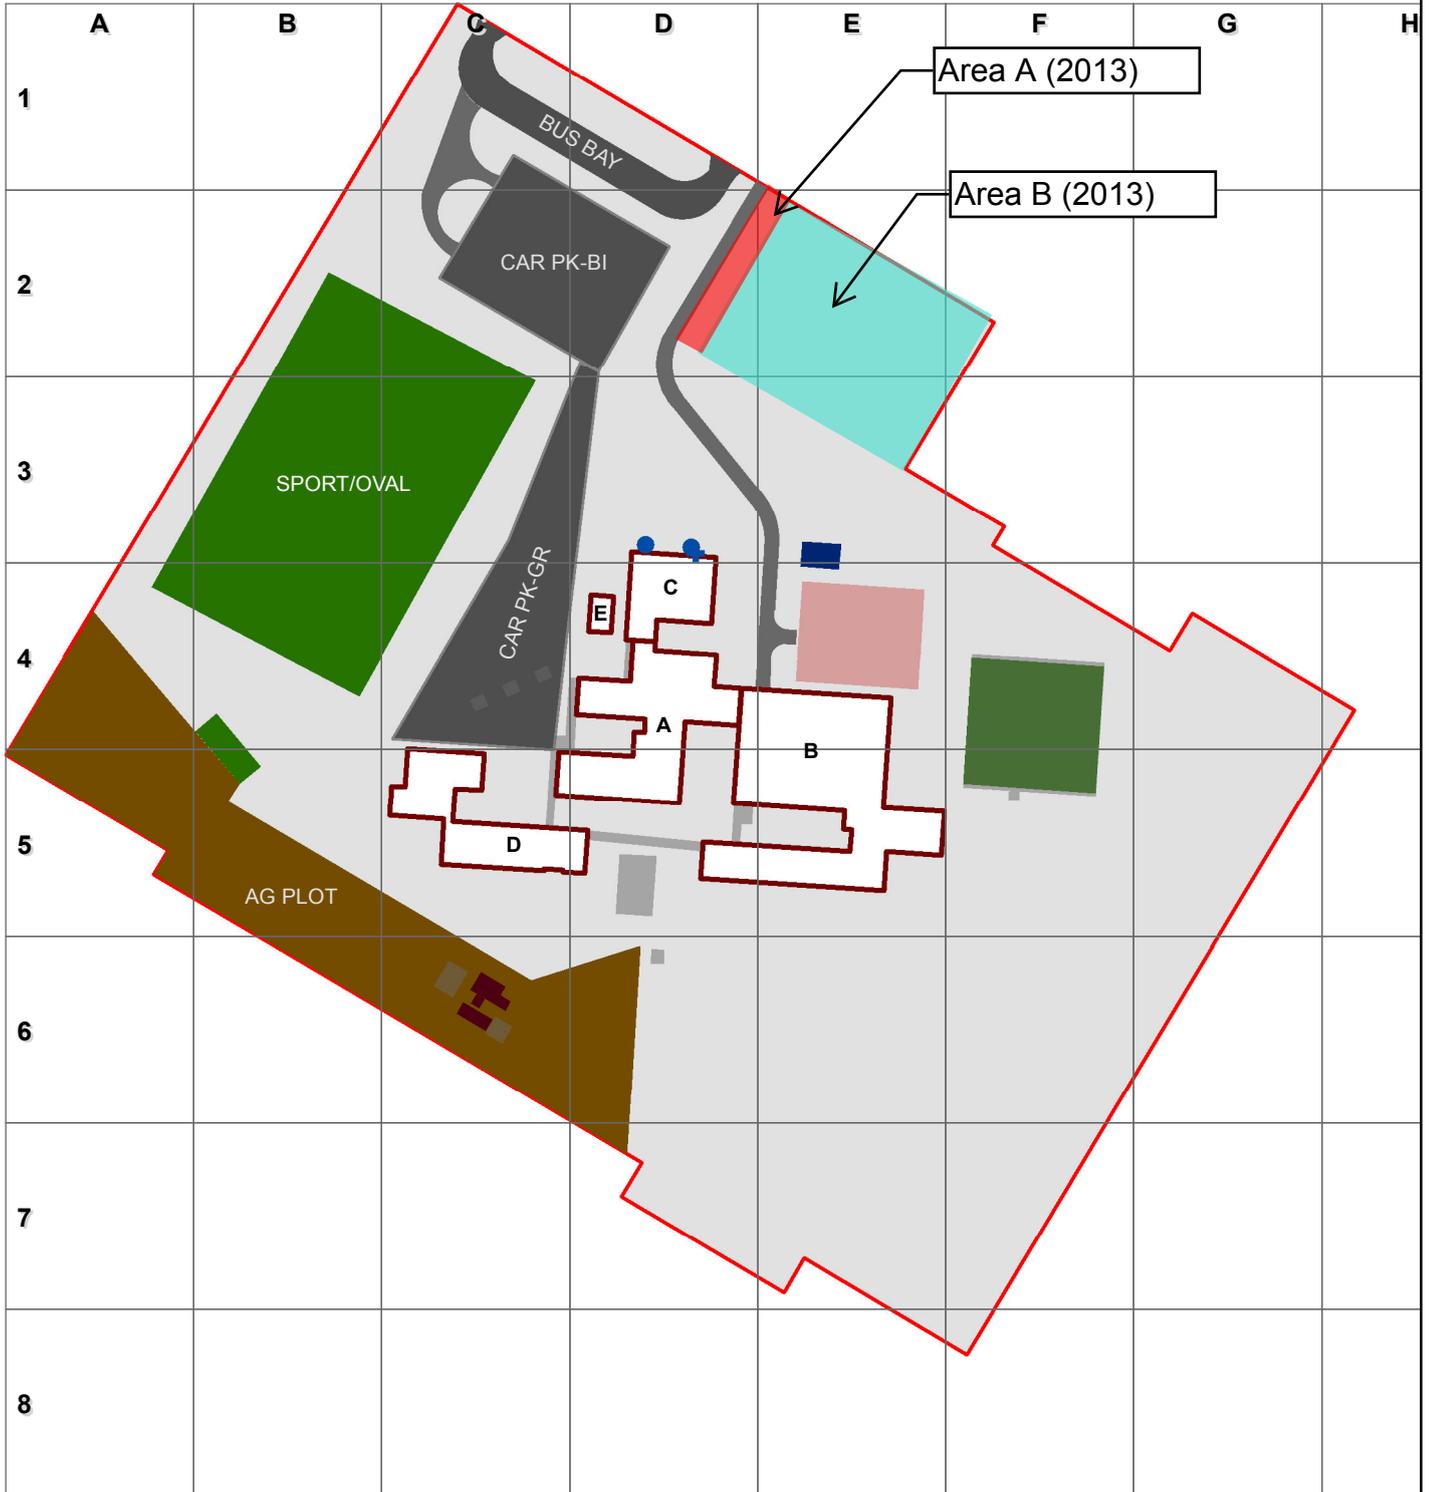
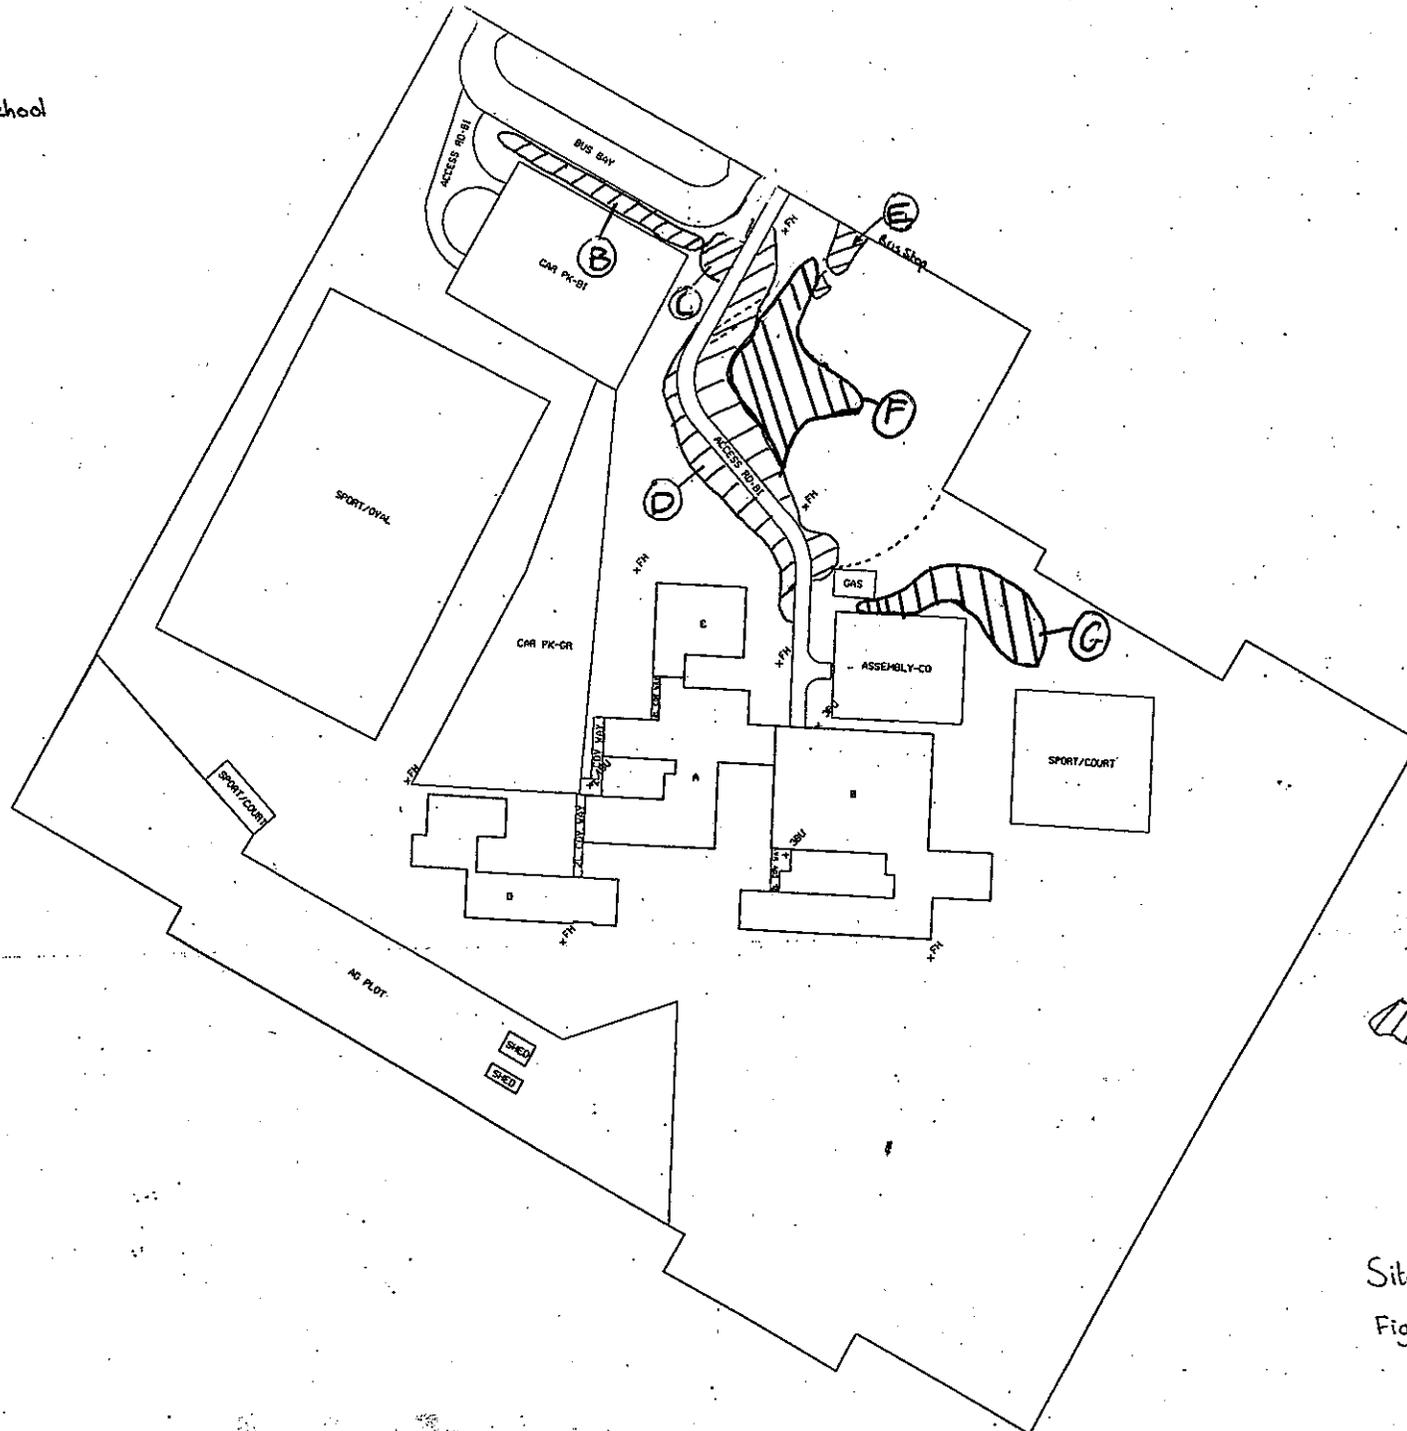
Site Layout
Figure 1

The remediated areas are shown in Figures 1 & 2.

Asbestos cement fragments may be present as a component of buried fill within the asbestos zone areas. Refer to Figure 1 site plan.
