Asbestos in Grounds, Asbestos Management Plan, Lake Heights Public School, Lake Heights, NSW

March 2013

NSW Public Works

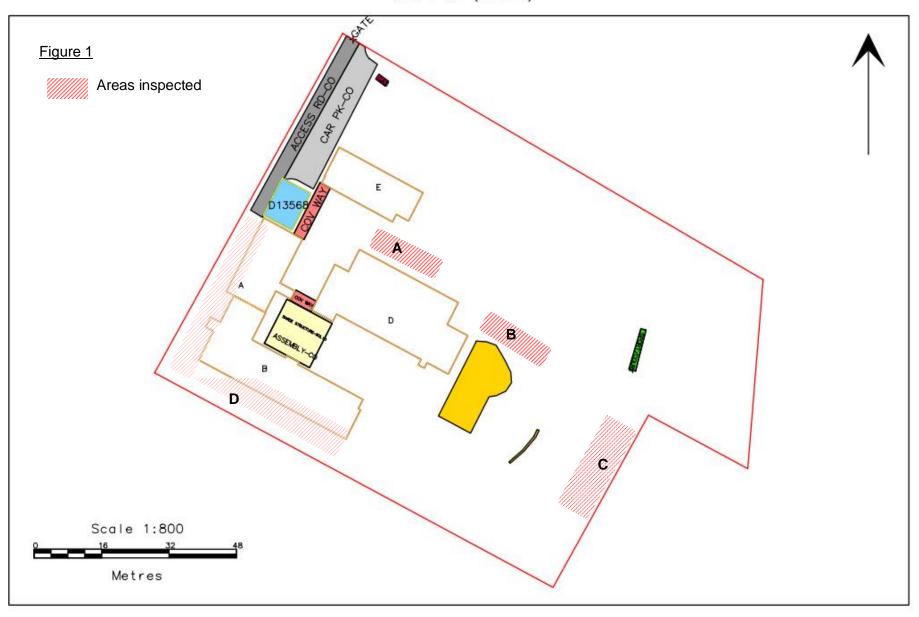
4011 — Lake Heights Public School Site Plan (12744)

In May 2010, fibrous cement fragments were identified on the ground surfaces of the northern and southern playing fields, at Lake Heights Public School, located on Northcliffe Drive, Lake Heights NSW 2502.

In order to manage the risk of exposure to asbestos, any fibrous cement fragments are to be removed from the ground surfaces (Refer to Section 1.3). The areas where fibrous cement fragments have been identified within the fill material (and further in-situ asbestos fragments may be present) have been designated as "asbestos zones".

- Area A Bike rack area to the north of Block D
- Area B Playground seating area situated to the north of the playground equipment.
- Area C Playground area running along the eastern perimeter of the school
- Area D Out of bounds area to the south of Block B and to the west of Block A.
