Asbestos in Grounds, Asbestos Management Plan, Lethbridge Park Public School, Lethbridge Park, NSW

January 2013

NSW Public Works

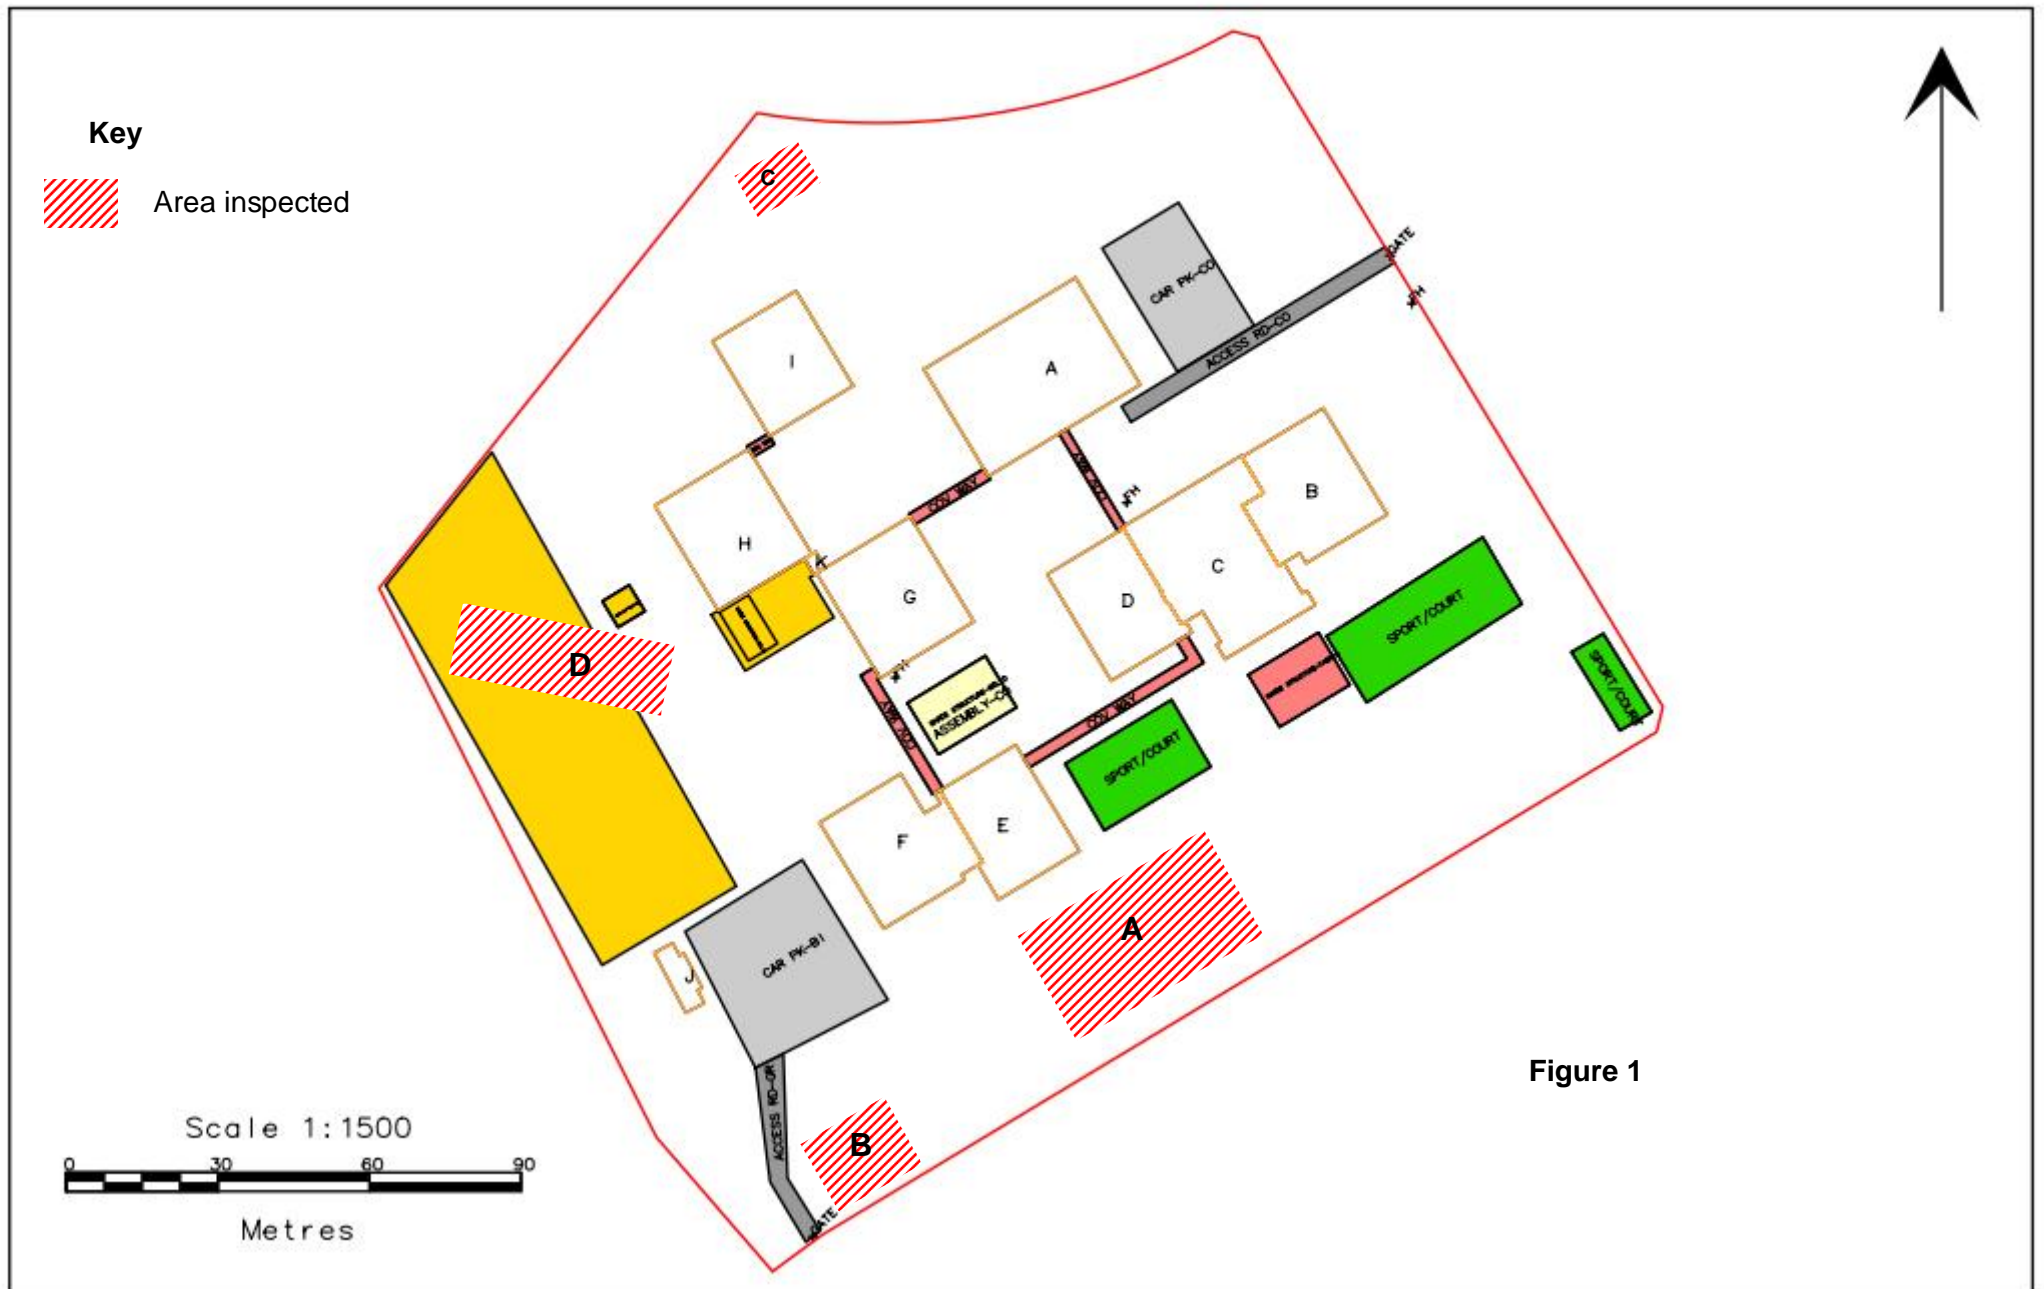
4408 – Lethbridge Park Public School Site Plan (10464)

The remediated areas are shown in Figure 1.

Asbestos cement fragments may be present as a component of buried fill within the asbestos zone areas. Refer to Figure 1 site plan. A hygienist should be engaged to determine whether the asbestos within the Asbestos Zones is considered *bonded* or *friable* in accordance with the NSW WorkCover Authority 'Working with Asbestos, 2008'. This contains safety guidelines and requirements for work involving asbestos.

Event	Location	Description of Material	Extent	Condition	Risk Status	Control Priority	Control Recommendation/Comments
School Grounds*							
A	South playground area	Possible buried asbestos cement fragments	Throughout – below surface ground	Unknown	Low	Low	Maintain existing surface/ new surface. Do not disturb soil surface Inspect every three months or after adverse weather conditions for signs of surface wear and possible fragments at surface
B	Grassed area, adjacent to the car park access road	Possible buried asbestos cement fragments	Throughout – below surface ground	Unknown	Low	Low	Maintain existing surface/ new surface. Do not disturb soil surface Inspect every three months or after adverse weather conditions for signs of surface wear and possible fragments at surface
C	Northern grassed area	Possible buried asbestos cement fragments	Throughout – below surface ground	Unknown	Low	Low	Maintain existing surface/ new surface. Do not disturb soil surface Inspect every three months or after adverse weather conditions for signs of surface wear and possible fragments at surface

D	Western playground area	Possible buried asbestos cement fragments	Throughout – below surface ground	Unknown	Low	Low	Maintain existing surface/ new surface. Do not disturb soil surface Inspect every three months or after adverse weather conditions for signs of surface wear and possible fragments at surface
E	South of Block J	Possible asbestos insulation	Localise the immediate area	Unknown	Low	Low	No further asbestos debris has been identified since the clearance was undertaken. No further action is considered necessary.
