# Asbestos in Grounds, Asbestos Management Plan, Palmers Island Public School, Palmers Island, NSW

January 2013

NSW Public Works

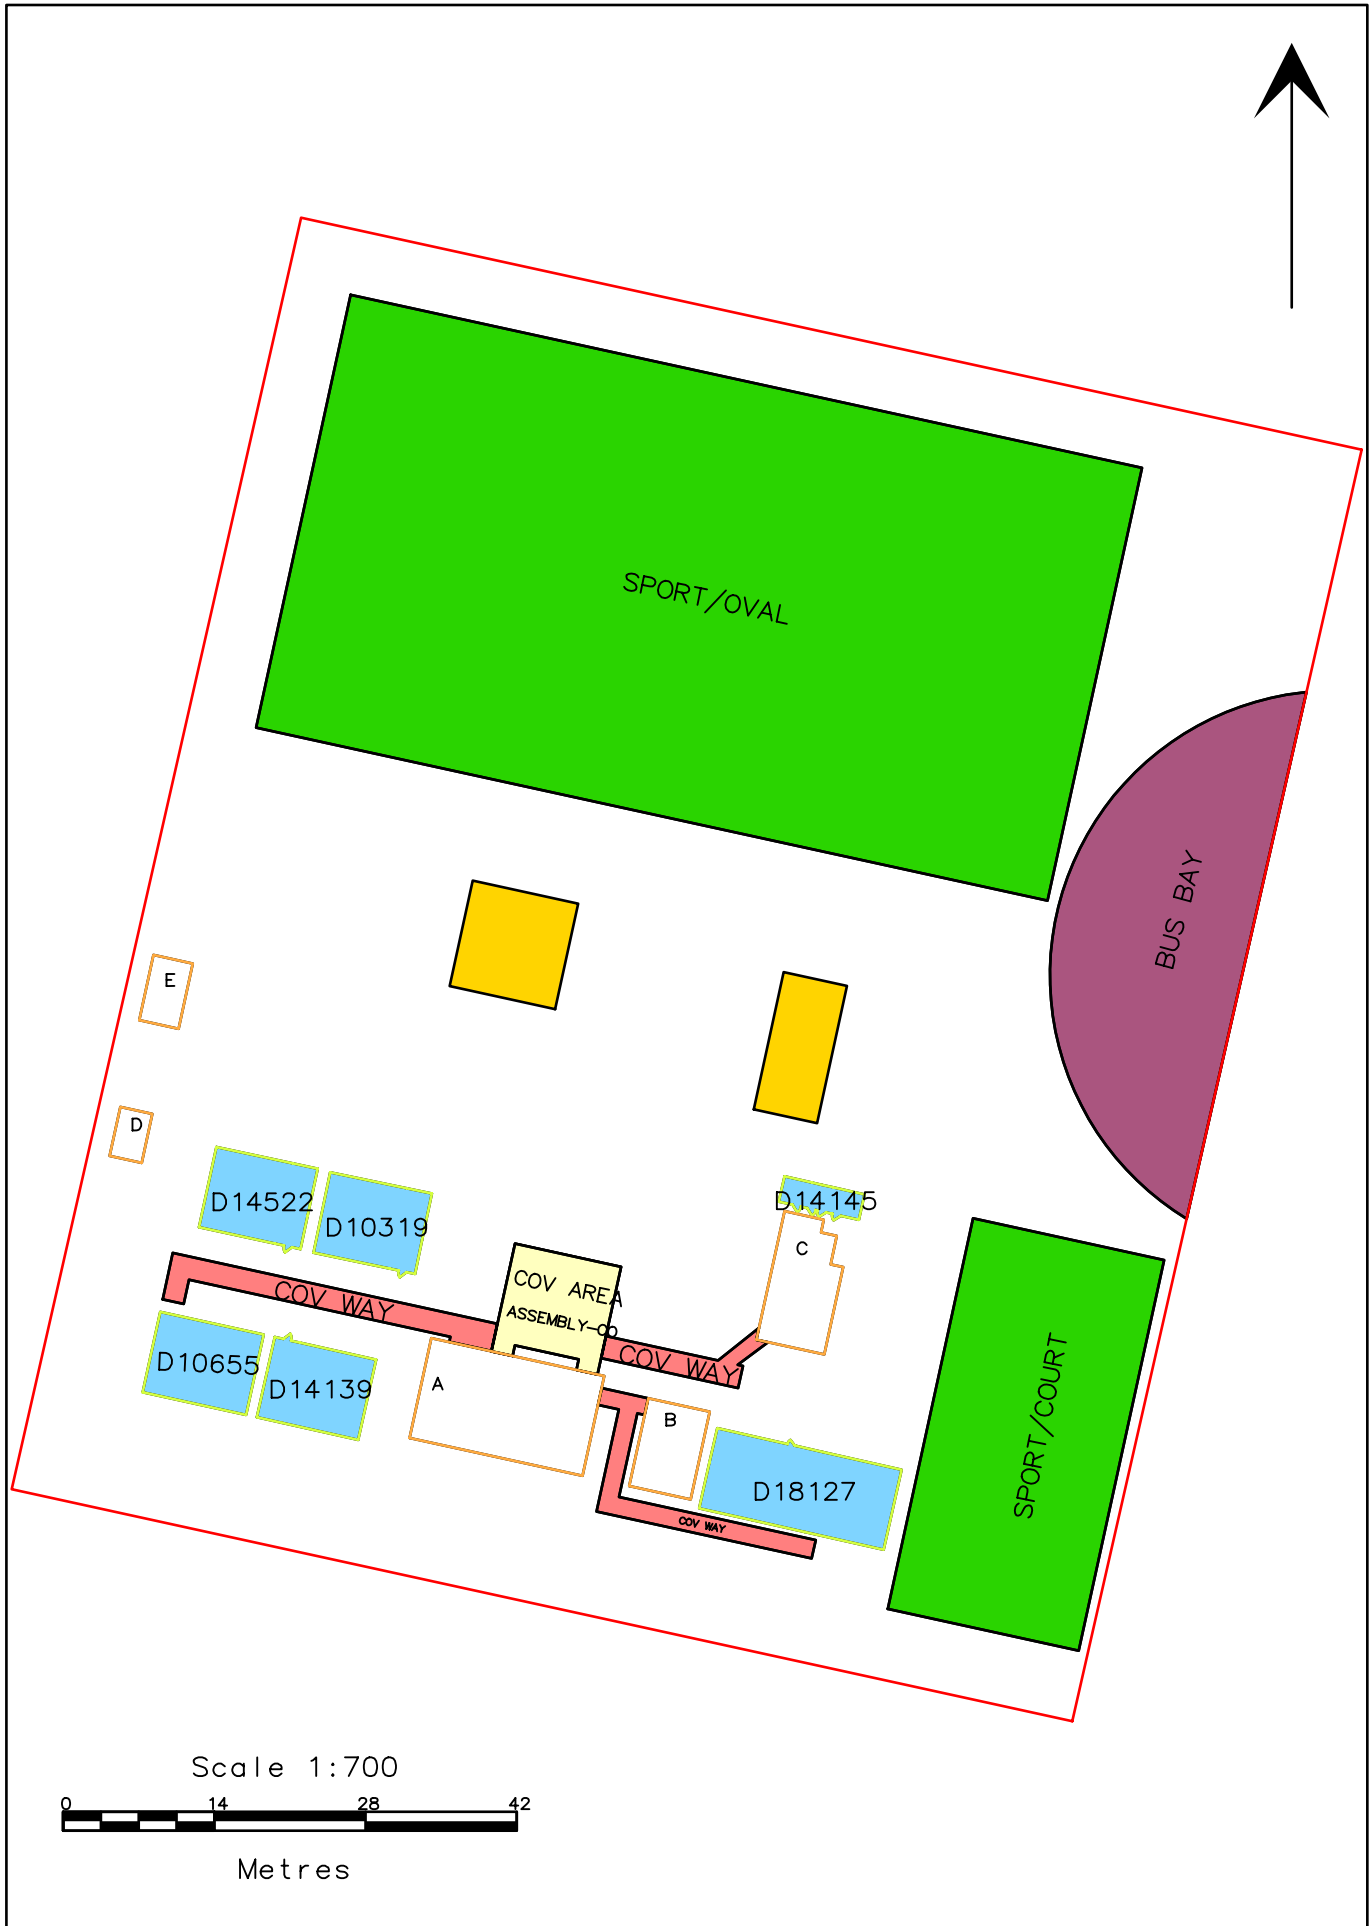
# 2829 – Palmers Island Public School Site Plan (10674)

The school site plan is shown in Figure 1. However the exact location of the asbestos impacted area is not known by PB at this time.

Asbestos cement fragments may be present as a component of buried fill within the asbestos zone areas. Refer to Figure 1 site plan. A hygienist should be engaged to determine whether the asbestos within the Asbestos Zones is considered *bonded* or *friable* in accordance with the NSW WorkCover Authority 'Working with Asbestos, 2008'. This contains safety guidelines and requirements for work involving asbestos.

Event	Location	Description of Material	Extent	Condition	Risk Status	Control Priority	Control Recommendation/Comments
<i>School Grounds*</i>							
A	Area adjacent to the septic tank	Possible buried asbestos cement fragments	Throughout – below ground surface	Unknown	Low	Low	No further fibrous cement fragments have been identified since the clearance was undertaken. The area should be inspected on an annual basis for fibrous cement fragments
