# Asbestos in Grounds, Asbestos Management Plan, Peakhurst Public School, Peakhurst, NSW

March 2014

NSW Public Works

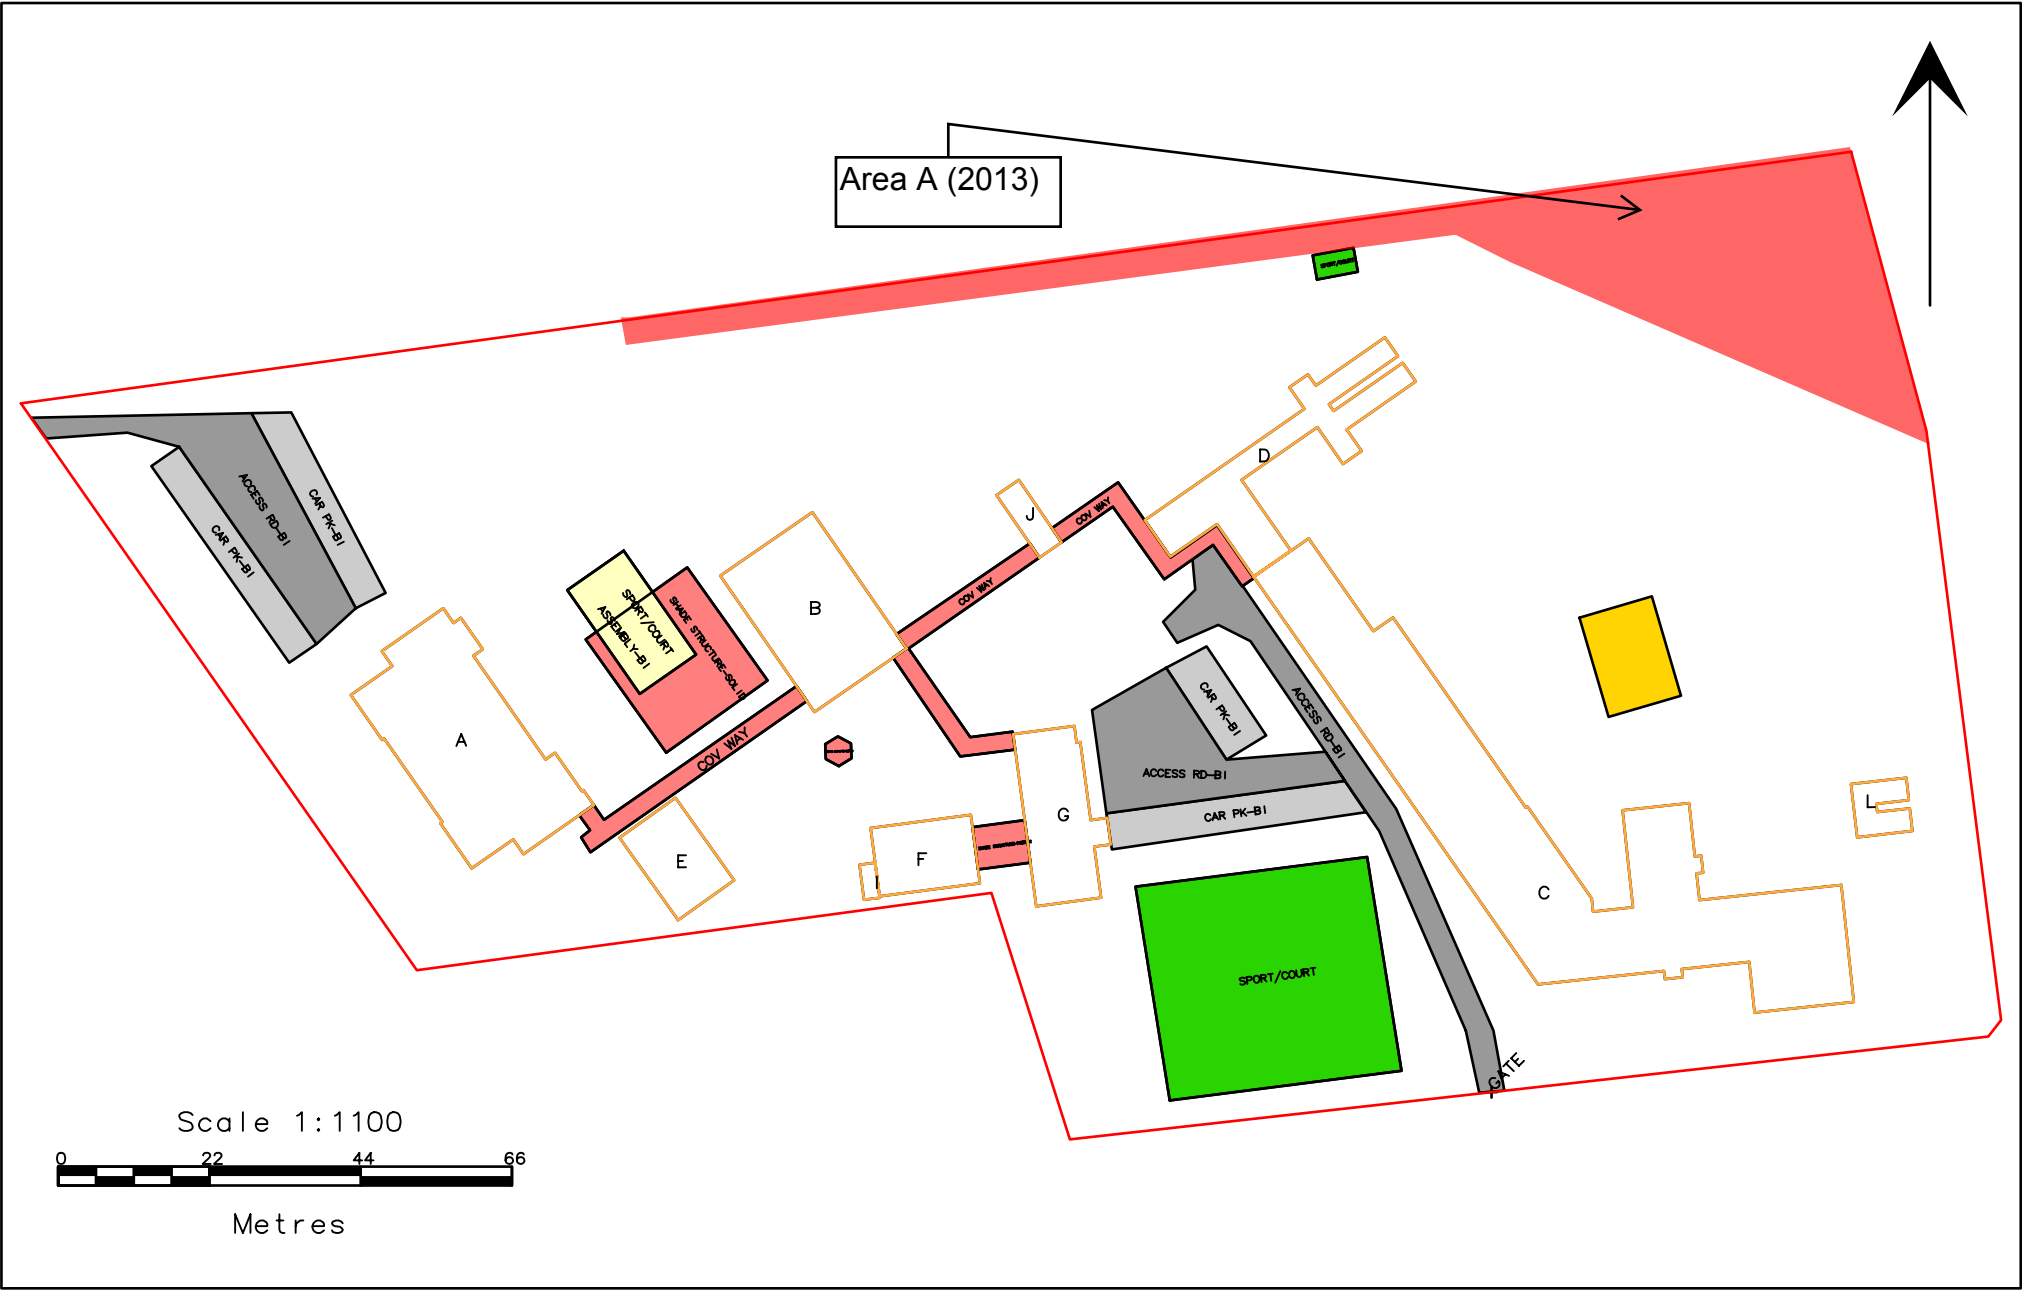
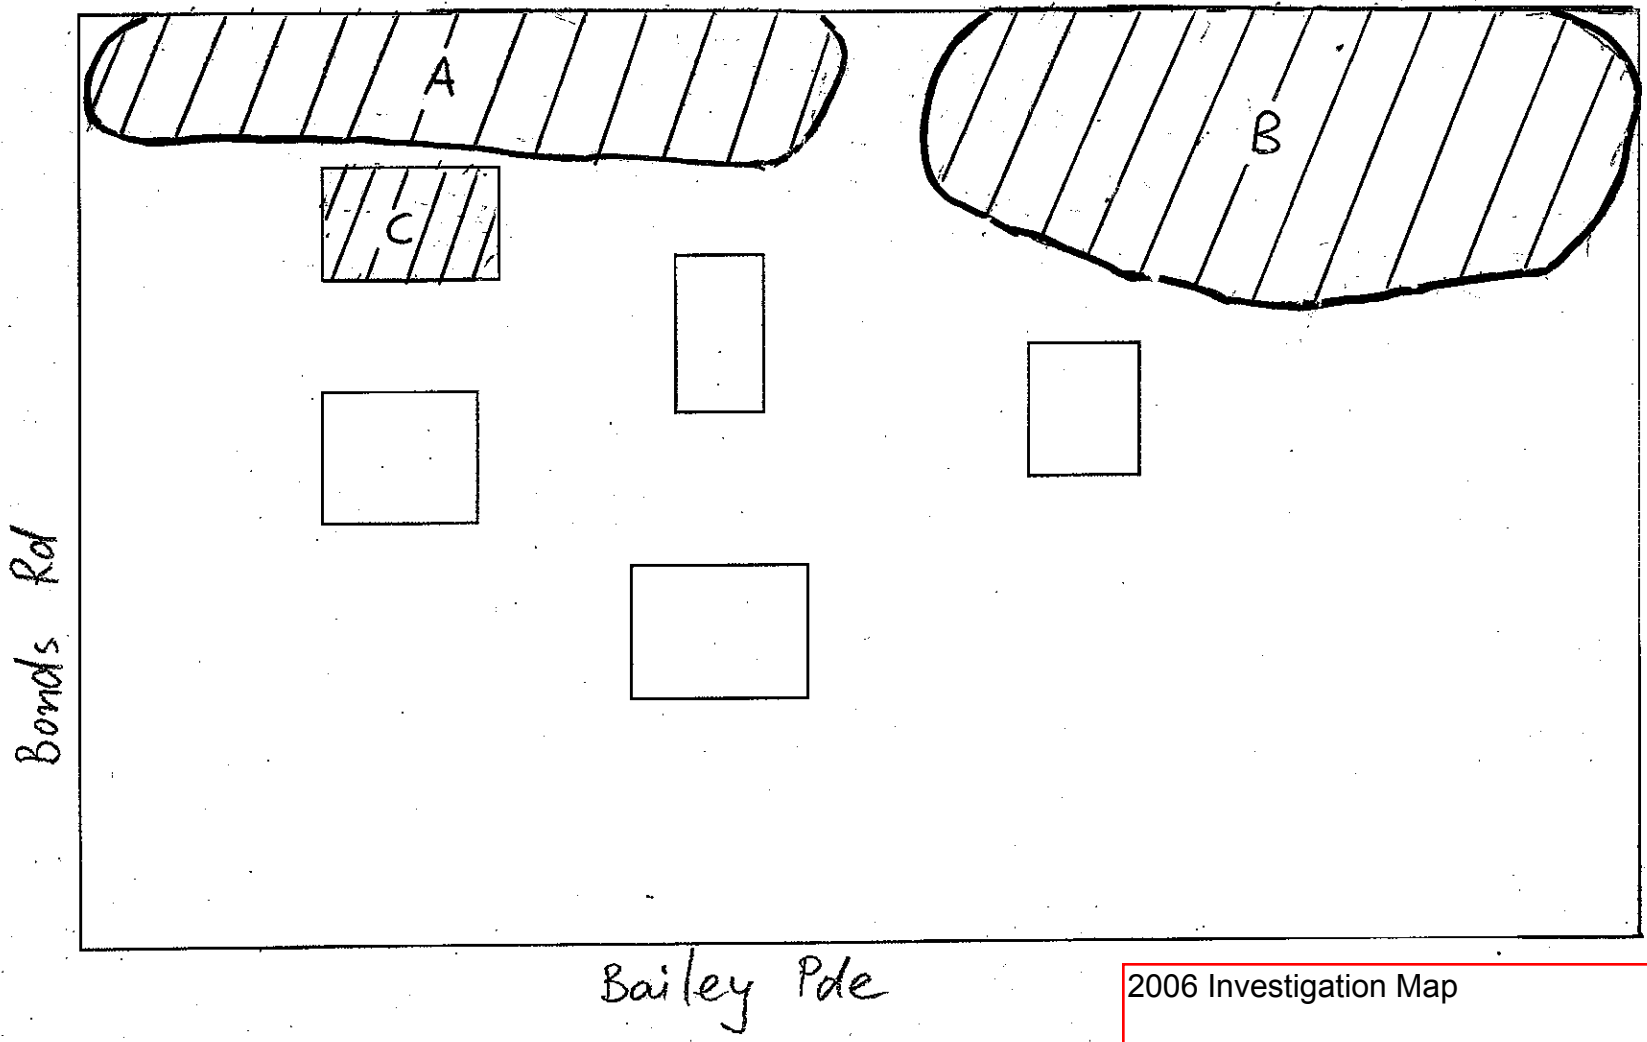
**Figure**

- the removal, clean-up and disposal of the visible fragments of fibrous cement on the ground surface. Removal was limited to the accessible surface areas only. The remediated areas are shown in Figures 1 & 2.

Asbestos cement fragments may be present as a component of buried fill within the asbestos zone areas. Refer to Figure 1 site plan.

\* Refer to Figure 1 for detail of area locations

Area A (2013)

Asbestos Zones

2006 Investigation Map
