# Asbestos in Grounds, Asbestos Management Plan, Farmborough Road Public School, Unanderra, NSW

June 2008

NSW Department of Commerce

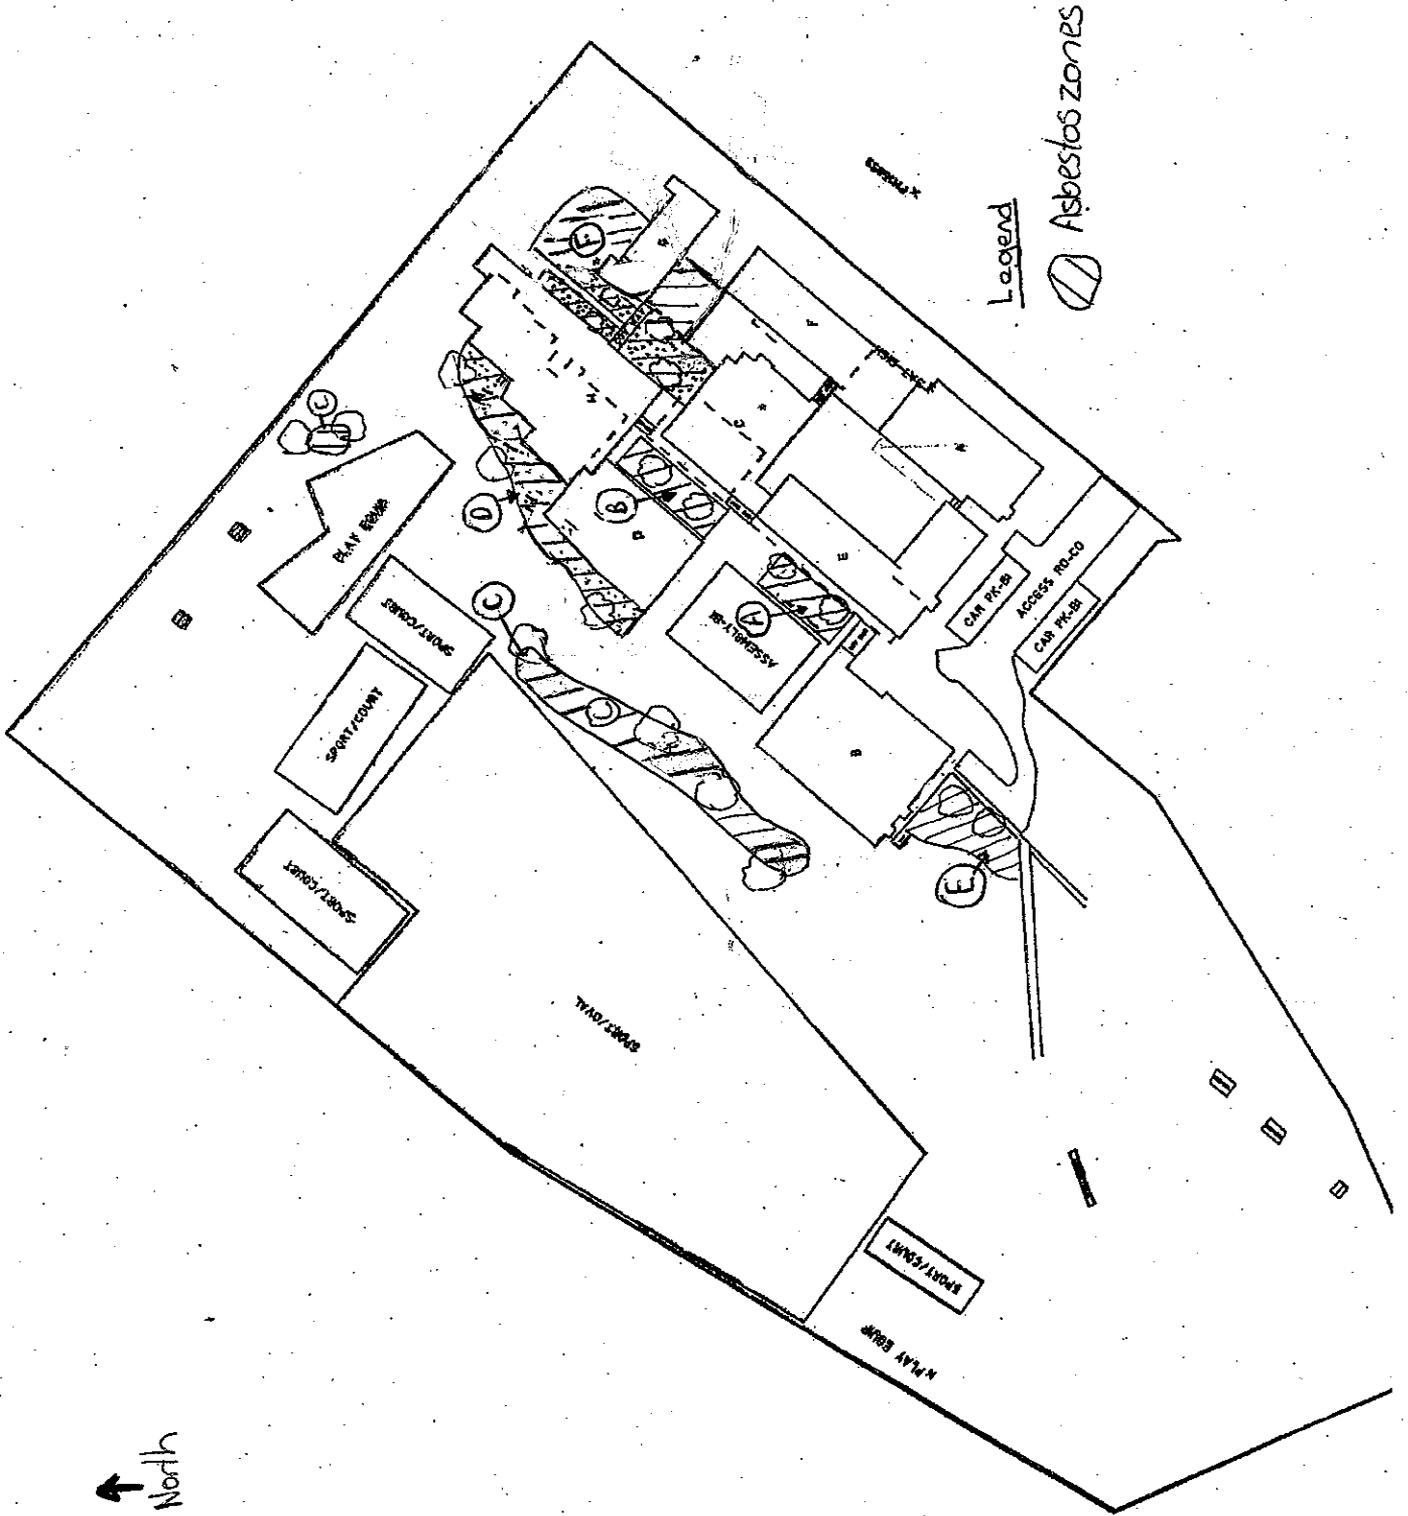
- Area A - bank between concrete playground and Block E
- Area B - garden between Blocks C and D
- Area C - shaded areas around school oval
- Area D - boundary between Blocks D and H and school oval
- Area E - grasses area South-West of Block B
- Area F - grassed surface surrounding Block G

The remediated areas are shown in Figure 1.

Asbestos cement fragments may be present as a component of buried fill within the asbestos zone areas. Refer to Figure 1 site plan. All presumed asbestos within the Asbestos Zones should be considered as *friable* in accordance with the interpretation of the NSW WorkCover Authority published in 'Your Guide to Working with Asbestos. Safety guidelines and requirements for work involving asbestos, March 2003'.
