Asbestos in Grounds, Asbestos Management Plan, Woodport Public School, Erina, NSW

July 2013

NSW Public Works

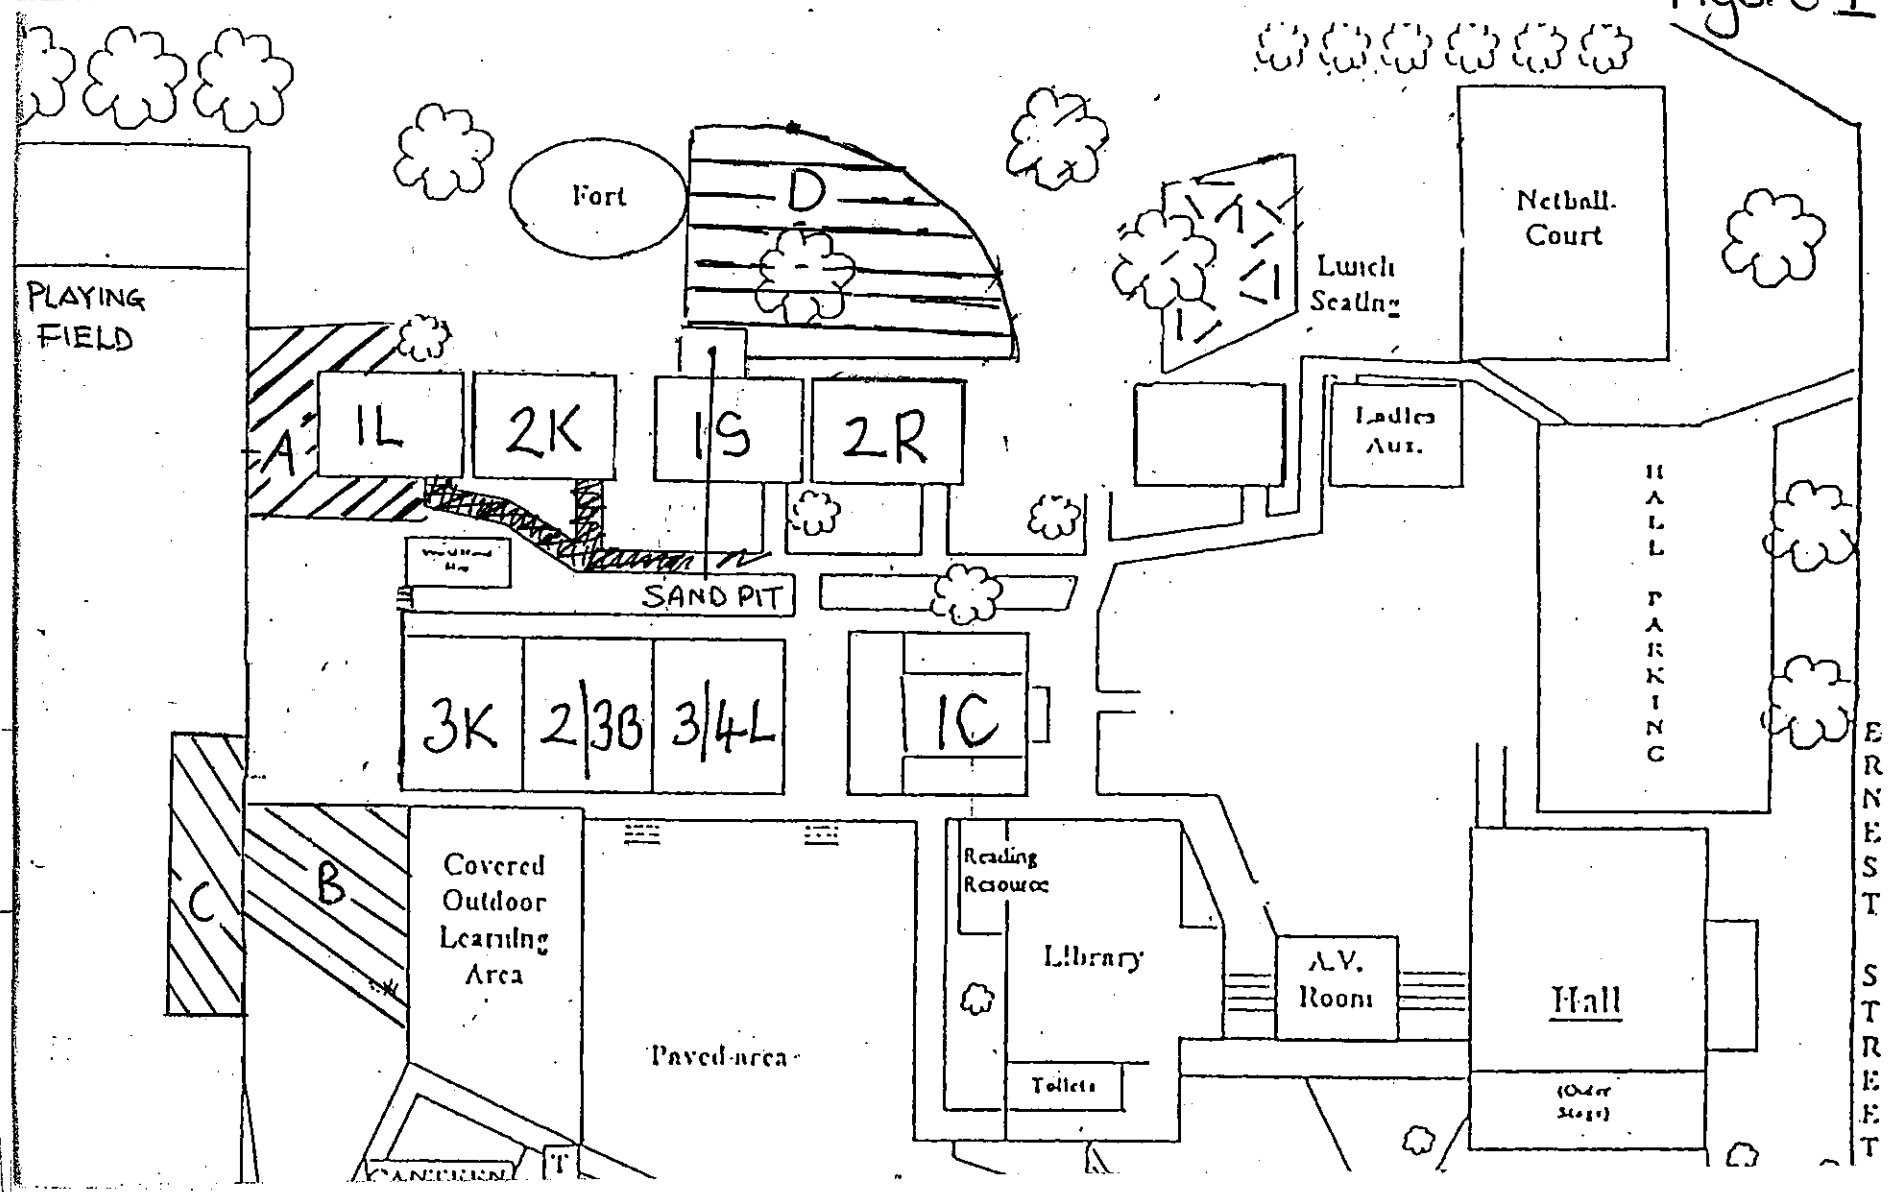
Figure 1

The remediated areas are shown in Figure 1.

Asbestos Zones
