CLEARANCE CERTIFICATE – ASBESTOS REMOVAL

CLIENT DETAILS	
Name of client:	School Infrastructure NSW
Project number:	PS118293
Client contact details	Warren Ellery
ASBESTOS REMOVAL WORK DETAILS	
Site address where asbestos removal work is being carried out:	Newcastle East Public School (School #2736) 48 Brown Street, The Hill NSW 2300
Date(s) asbestos removal work carried out:	02/02/20
Scope of work (as advised by client/contractor):	Remediation of asbestos containing dust (ACD) identified to contents stored within the Sports Shed.
Details of the specific asbestos removal work area(s):	Comprehensive sampling throughout the school indicated the presence of asbestos on contents stored within the Sports Shed. Remediation of the identified asbestos included disposal of all stored contents, followed by precautionary decontamination of the shed. Decontamination was achieved through HEPA vacuuming and wet-wiping of all accessible surfaces. Refer to Appendix A Site Photographs, Appendix B Certificates of Analysis and Appendix C Site Plan.

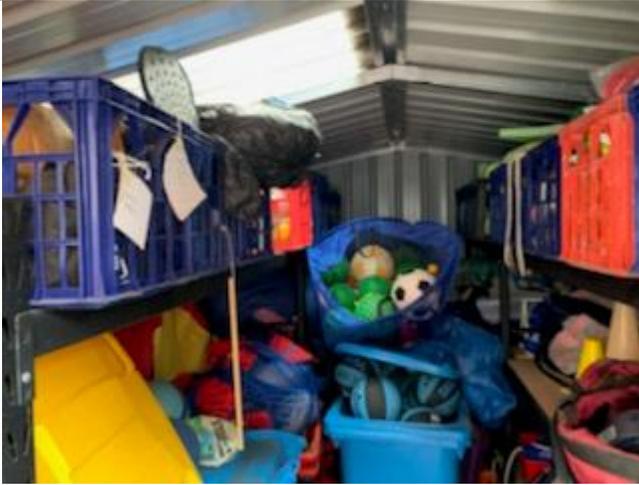
Photo 1: View of positive asbestos sample locations (WSP-57160, 57163)

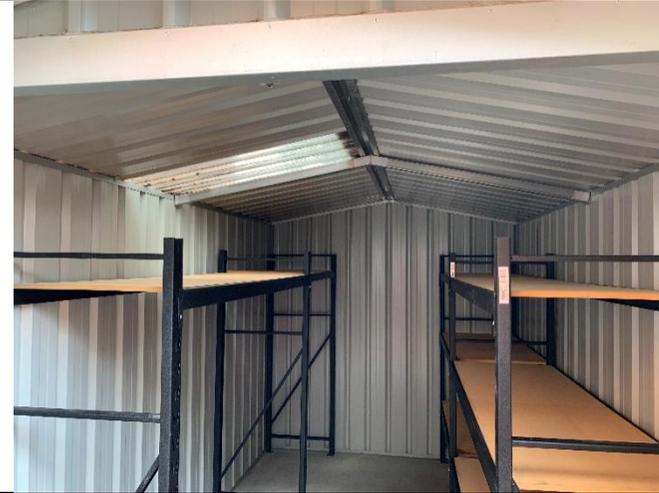
Photo 2: View of the Sports Shed following removal of contents and decontamination

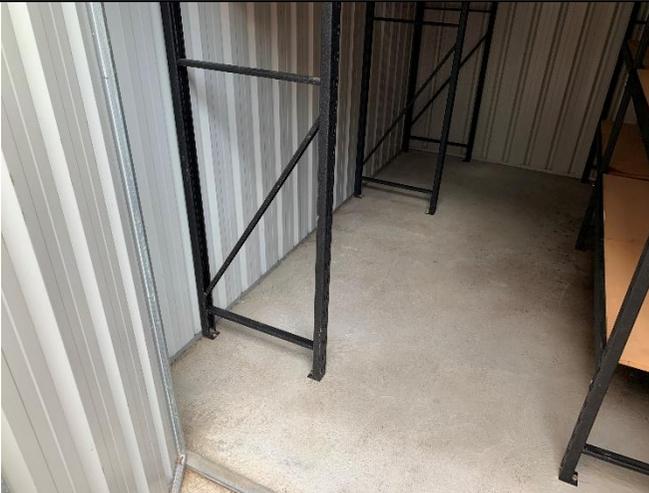
Photo 3: View of the Sports Shed following removal of contents and decontamination

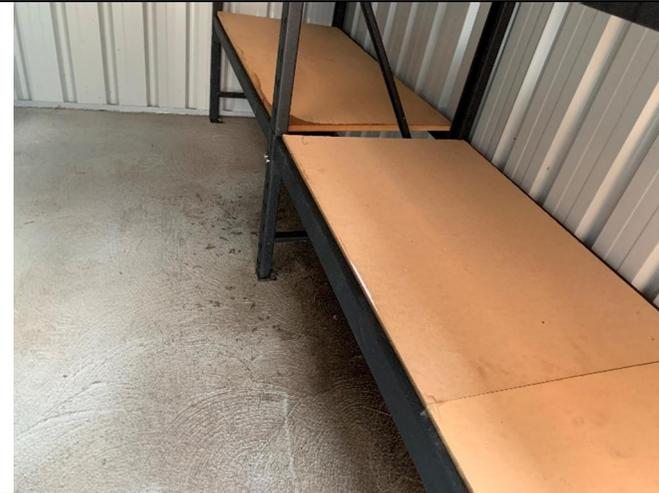
Photo 4: View of the Sports Shed following removal of contents and decontamination
