AIR MONITORING RISK ASSESSMENT
CRINGILA PUBLIC SCHOOL - NW HOTSPOT
35 SHEFFIELD STREET
CRINGILA NSW 2502

Summary Report 11/03/19 - 22/03/19

C107826: J153825: RC/TO

Cringila Public School NW Hotspot – 35 Sheffield Street, Cringila NSW 2502

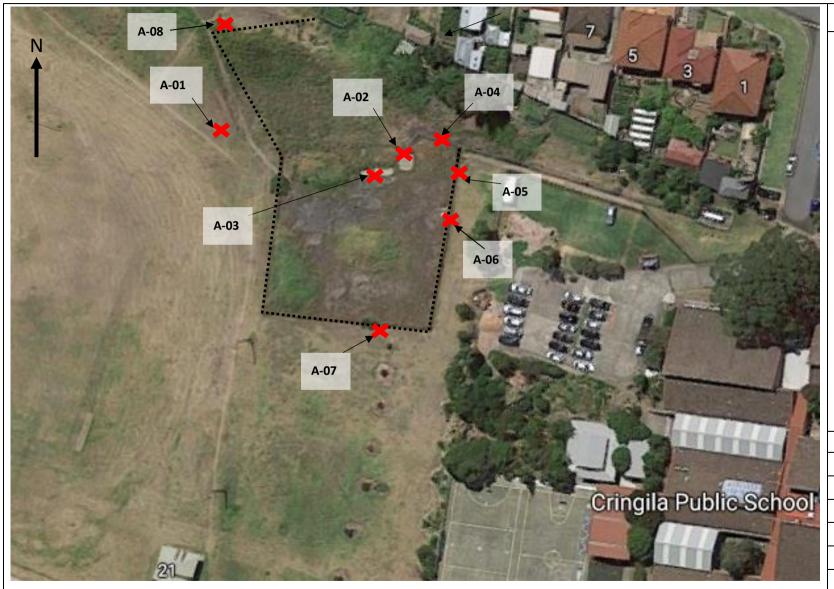
**Appendix A: Site Map and Sampling Locations**

- A-01 General Background
- A-02 NW Hotspot Concrete Cap Surface
- A-03 NW Hotspot Small Mound
- A-04 NW Hotspot NE fence line
- A-05 Exclusion Area Fence Line East of Hotspot (Approx. 10m)
- A-06 Exclusion Area Fence Line Southeast of Hotspot (Approx. 15m)
- A-07 Exclusion Area Fence Line South of Hotspot (Approx. 30m)
- A-08 Exclusion Area Fence Line Northwest of Hotspot, adjacent 17 Lackawanna Street (Approx. 50m)

Site	Cringila Public School
Area	Northwest Hotspot
Consultant	Tom Oyston
Date	Monday, 25 March 2019
lob Number	J153825-02
Report	AMR-05
Version	1.0
