## NEAR SURFACE TEMPERATURE MONITORING CRINGILA PUBLIC SCHOOL - NW HOTSPOT

Summary Report  
28/01/2019 - 08/02/2019

NSW Department  
of Education  
Cringila Public School

February 2019  
C107826: J153825: RC/TO

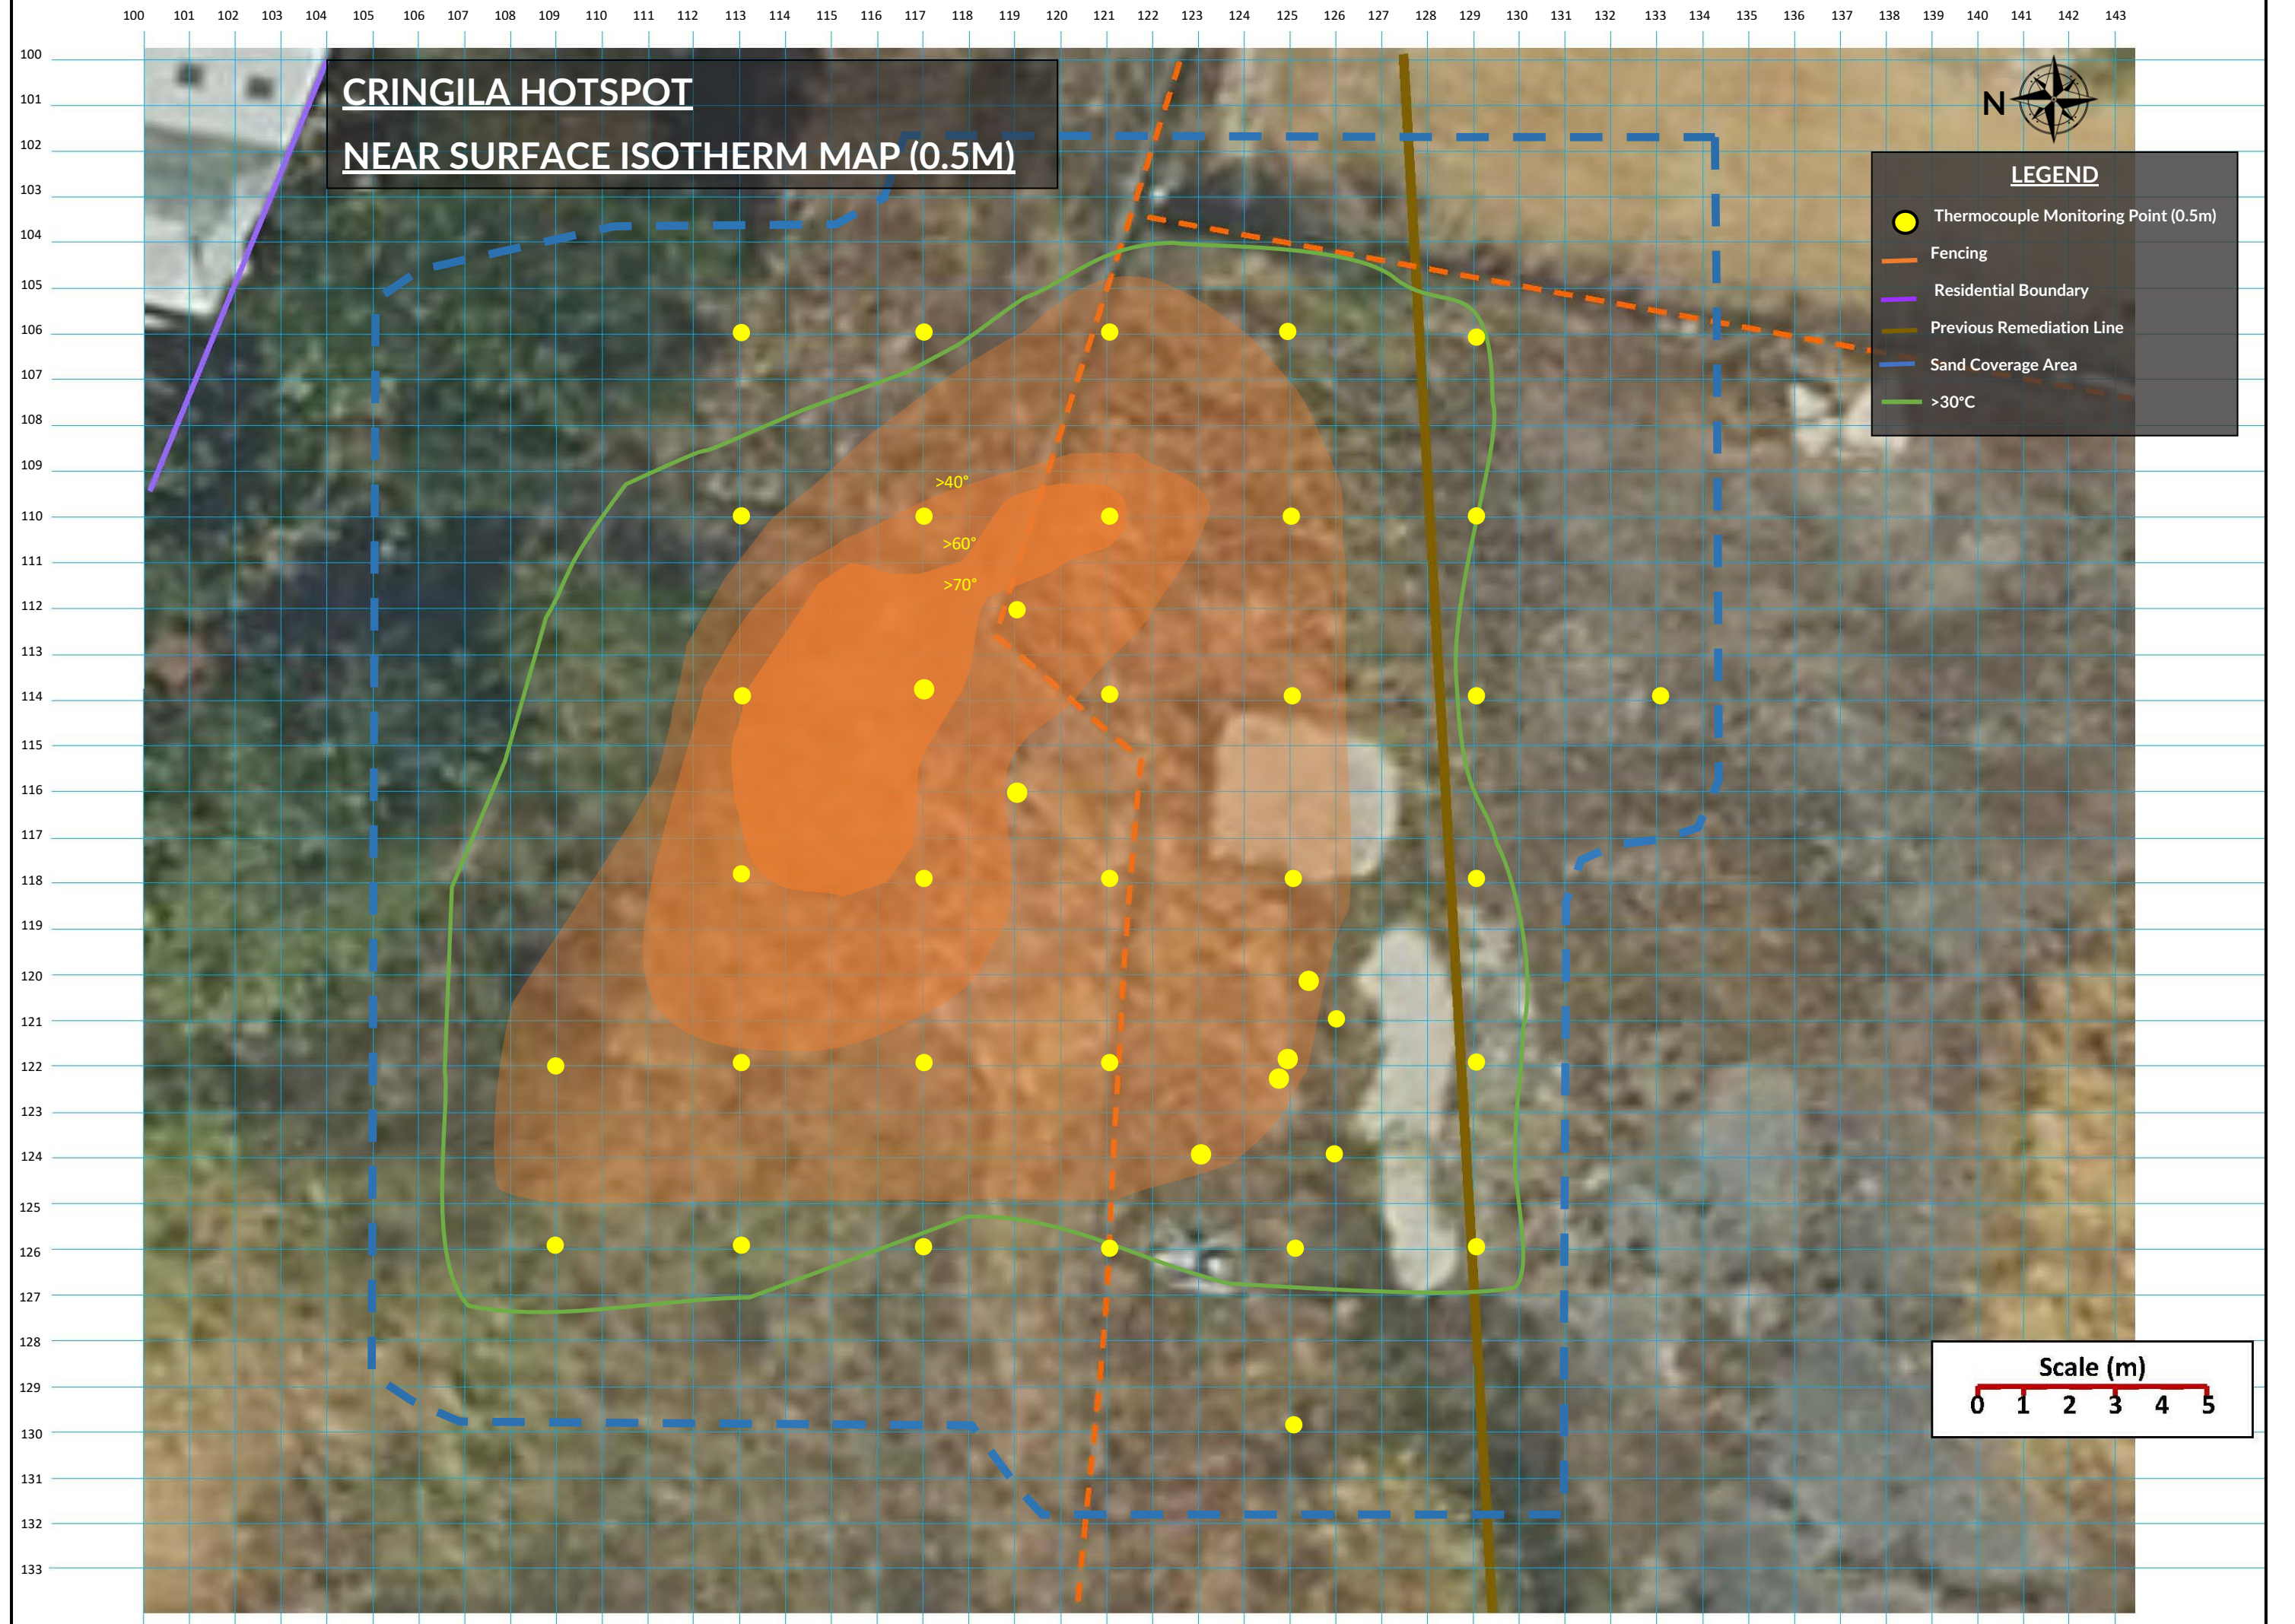
### Appendix B: Near Surface Temperature Isotherm Map (0.5m)

The isotherm map shows the general zone of influence for temperatures between 30°C and 95°C at 0.5m, coloured orange. The isotherm map suggests that the hotspot may extend deeper than 0.5m and that the increased temperature in these areas is a result of heat venting to the surface.

It is noted that temperature at the near-surface may be variable across the hotspot due to inconsistencies in the consolidation and compaction of subsurface materials.

# CRINGILA HOTSPOT NEAR SURFACE ISOTHERM MAP (0.5M)
