## NEAR SURFACE TEMPERATURE MONITORING CRINGILA PUBLIC SCHOOL - NW HOTSPOT

Summary Report  
11/02/2019 - 22/02/2019

NSW Department  
of Education  
Cringila Public School

February 2019  
C107826: J153825: RC/TO

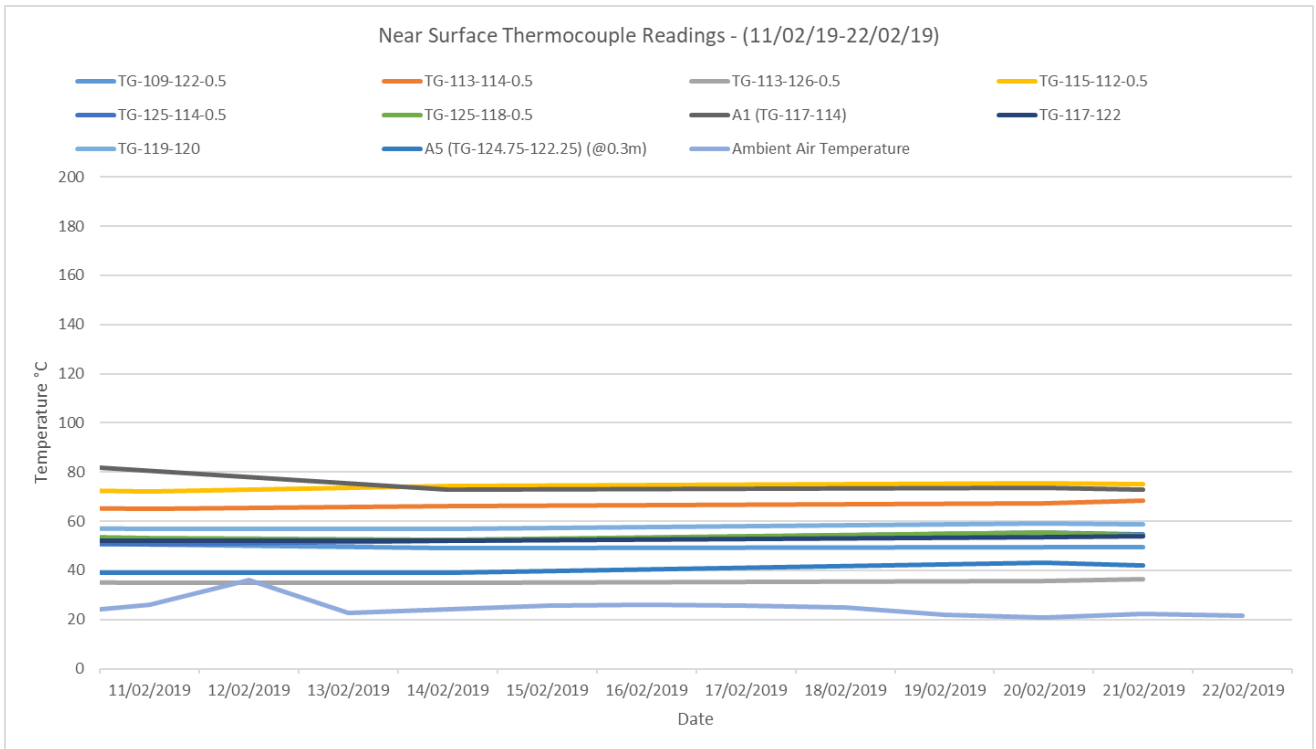
### 3.2. Near Surface Temperature Graph – Selected Points (Weekly)

Near surface temperature measurements for key thermocouple locations, over monitoring period - 11/02/2019 to 22/02/2019.

The near surface temperature at selected points across the northwest hotspot over the period of monitoring appear to remain consistent.

There were no significant near surface temperature variations identified during the period of monitoring.

There were significant rainfall events during the period of monitoring; 18.6mm recorded on 22<sup>nd</sup> February 2019.

It is recommended that weekly site inspections and recording are continued to monitor the near surface temperatures surrounding the subsurface hotspot identified at the site.

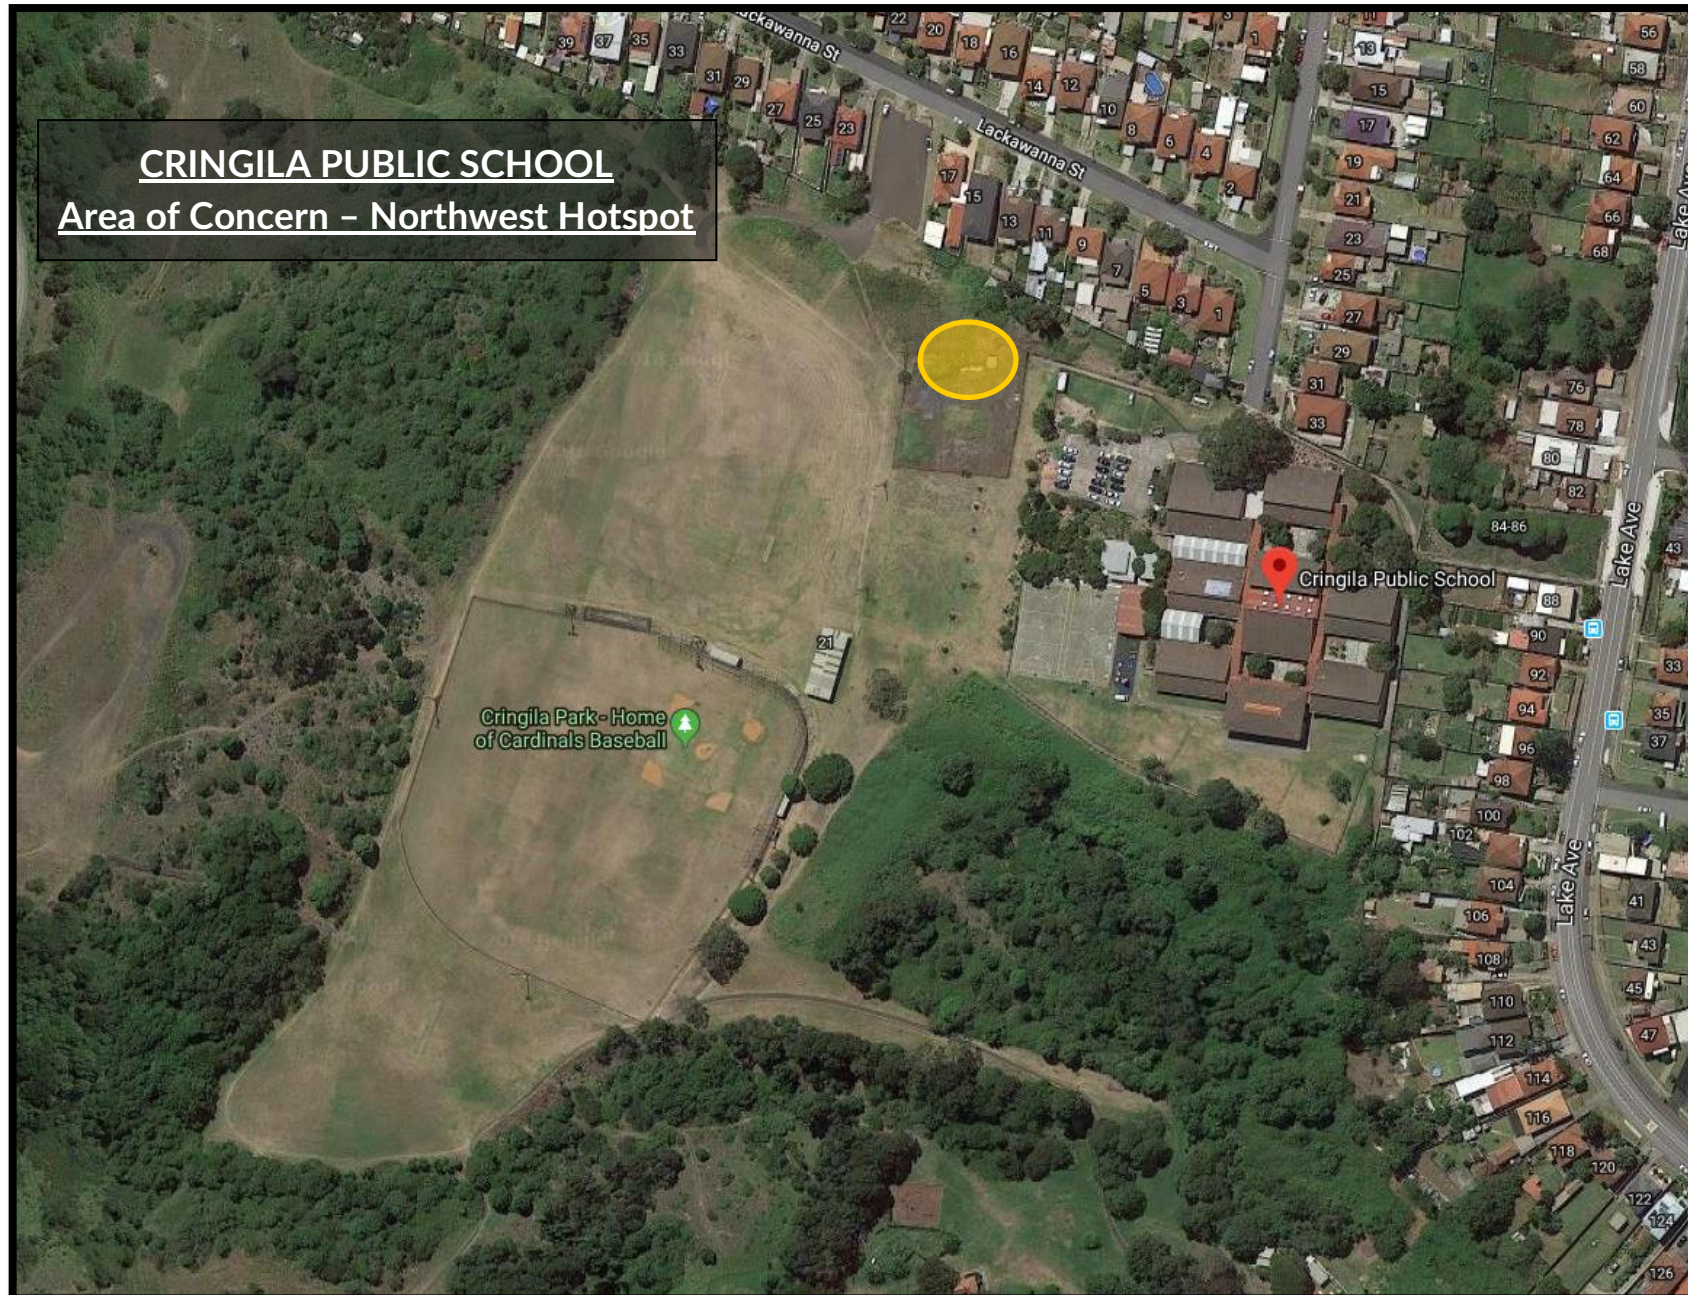
### Appendix A: Area of Concern – Northwest Hotspot Map

**CRINGILA PUBLIC SCHOOL**  
**Area of Concern - Northwest Hotspot**

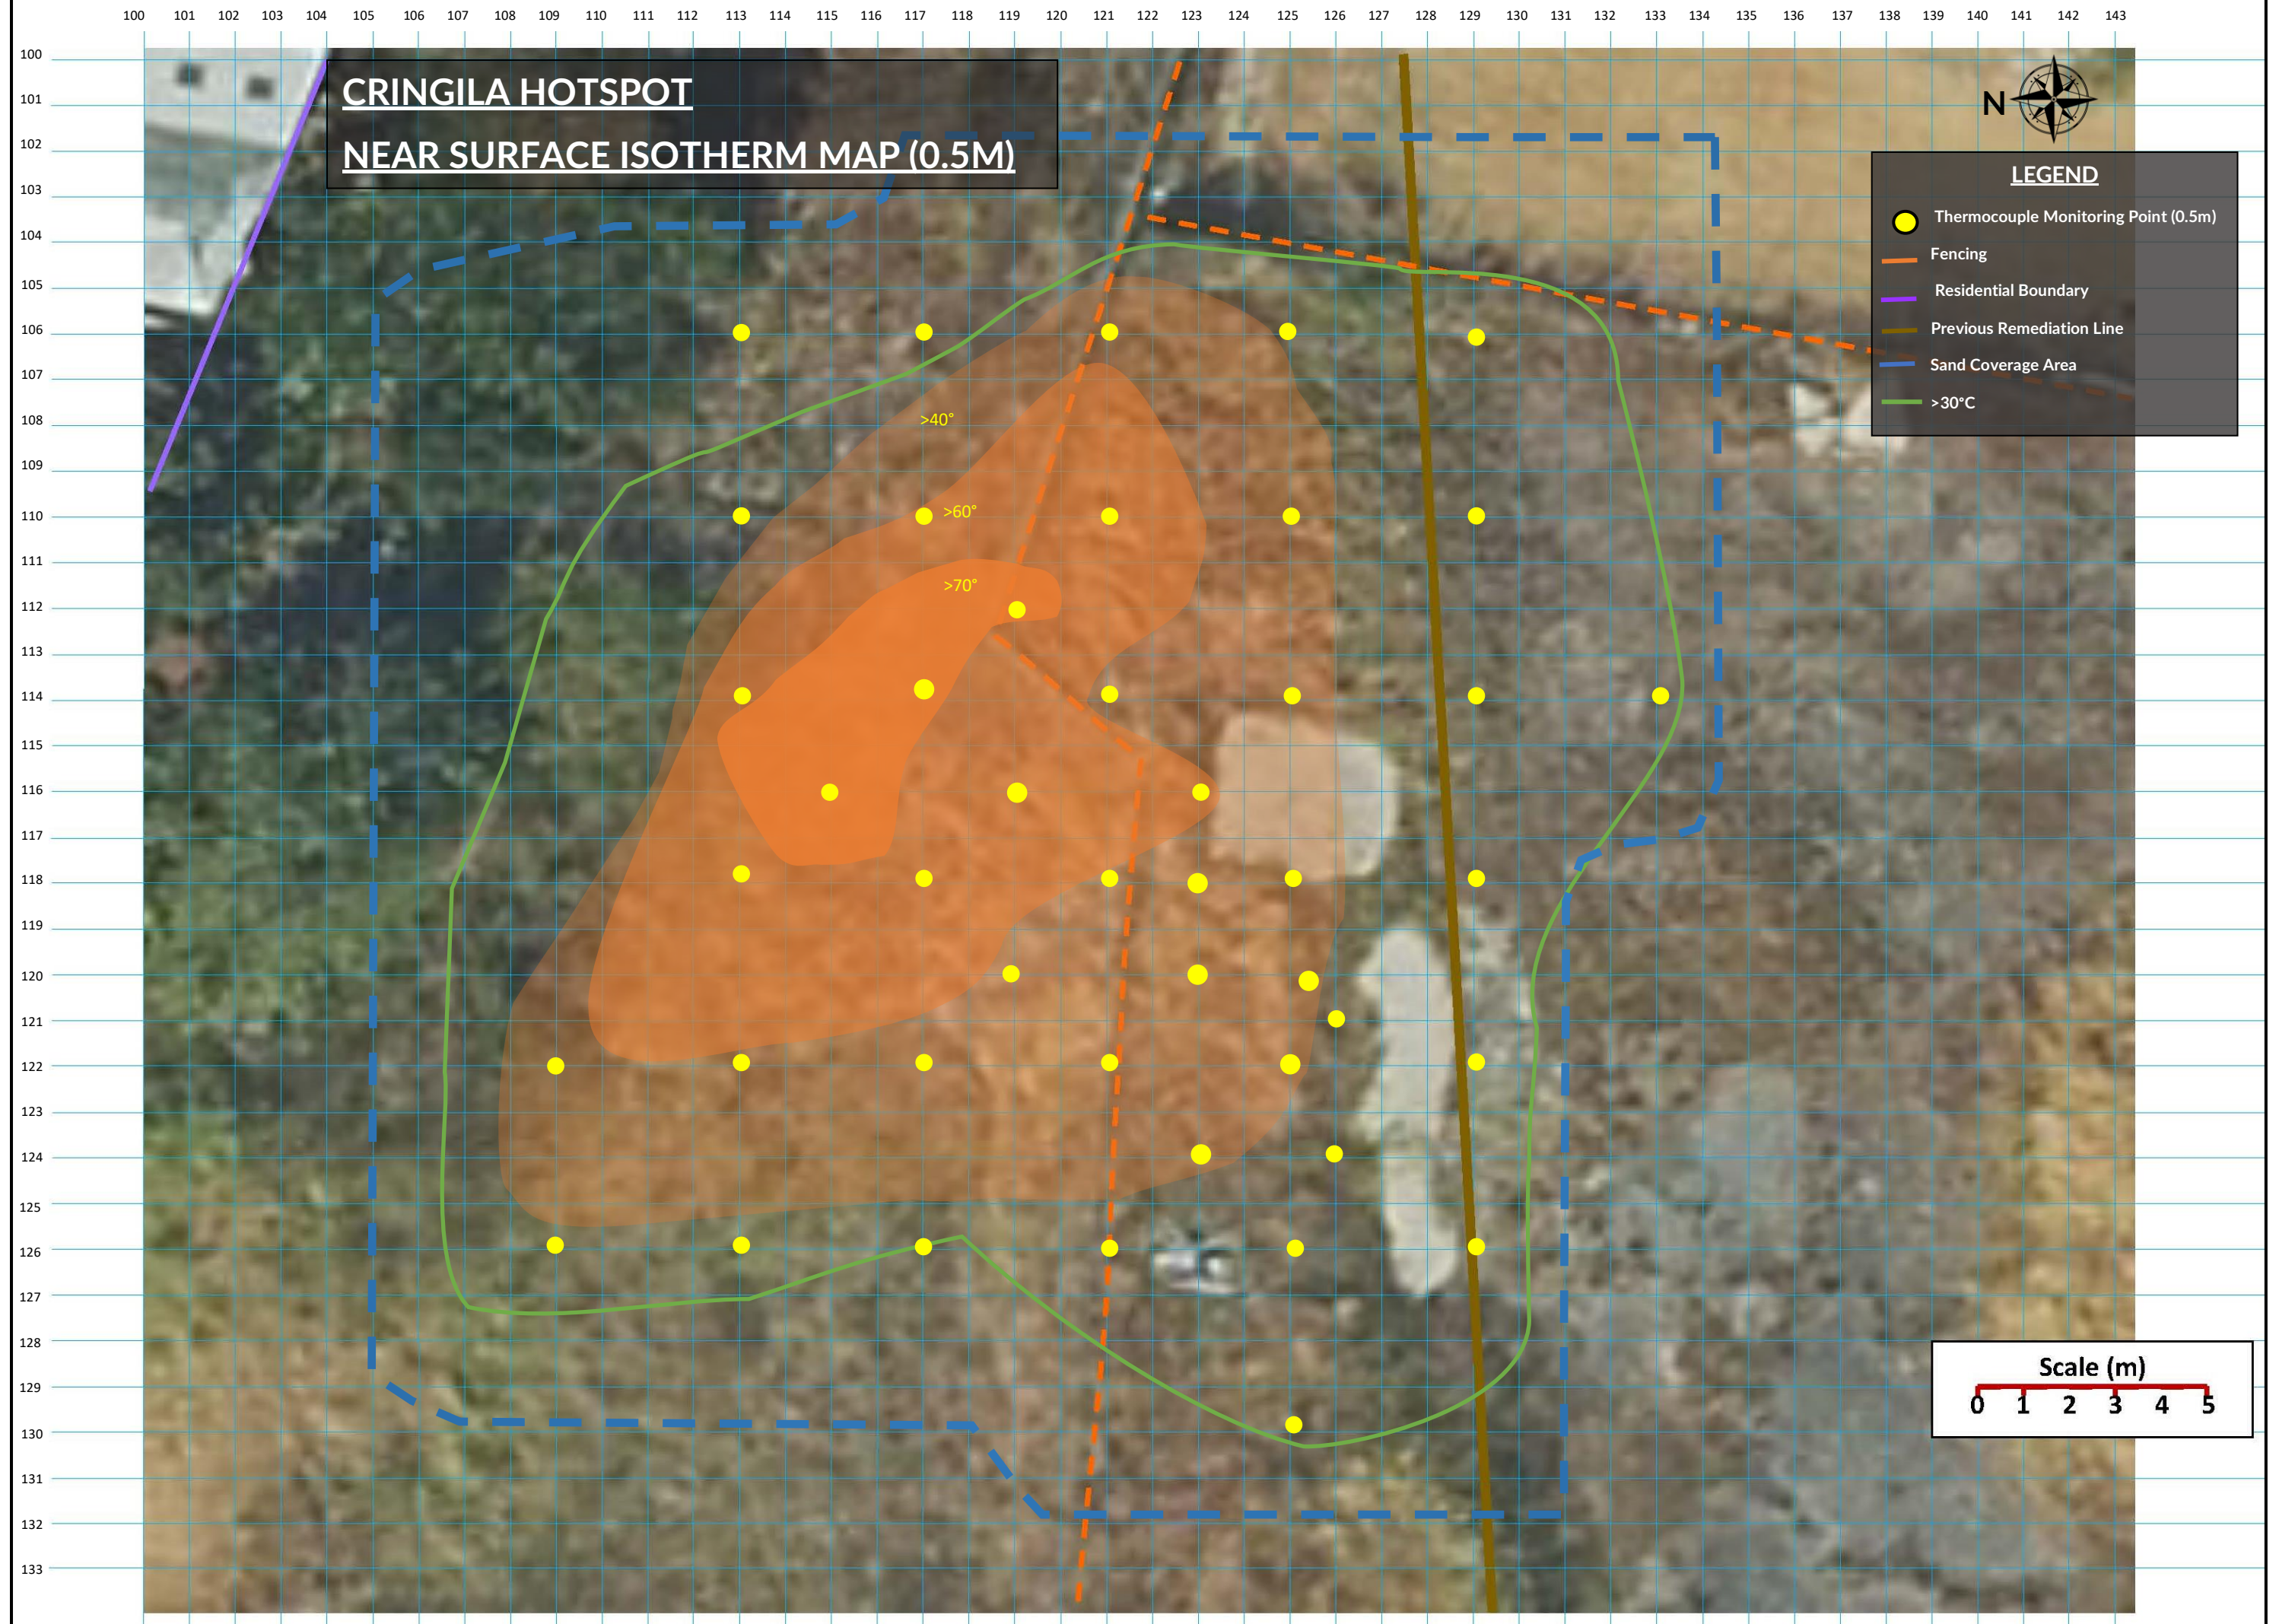
### Appendix B: Near Surface Temperature Isotherm Map (0.5m)

The isotherm map shows the general zone of influence for temperatures between 30°C and 73°C at 0.5m, coloured orange. The isotherm map suggests that the hotspot may extend deeper than 0.5m and that the increased temperature in these areas is a result of heat venting to the surface.

It is noted that temperature at the near-surface may be variable across the hotspot due to inconsistencies in the consolidation and compaction of subsurface materials.

# CRINGILA HOTSPOT NEAR SURFACE ISOTHERM MAP (0.5M)

The near surface temperature monitoring conducted between 11<sup>th</sup> February 2019 and 22<sup>nd</sup> February 2019 indicates that the spatial extent of the northwest hotspot appears to remain localised.
