NEAR SURFACE TEMPERATURE MONITORING CRINGILA PUBLIC SCHOOL - NW HOTSPOT

Summary Report
11/03/2019 - 22/03/2019

NSW Department
of Education
Cringila Public School

35 Sheffield Street
Cringila NSW 2502

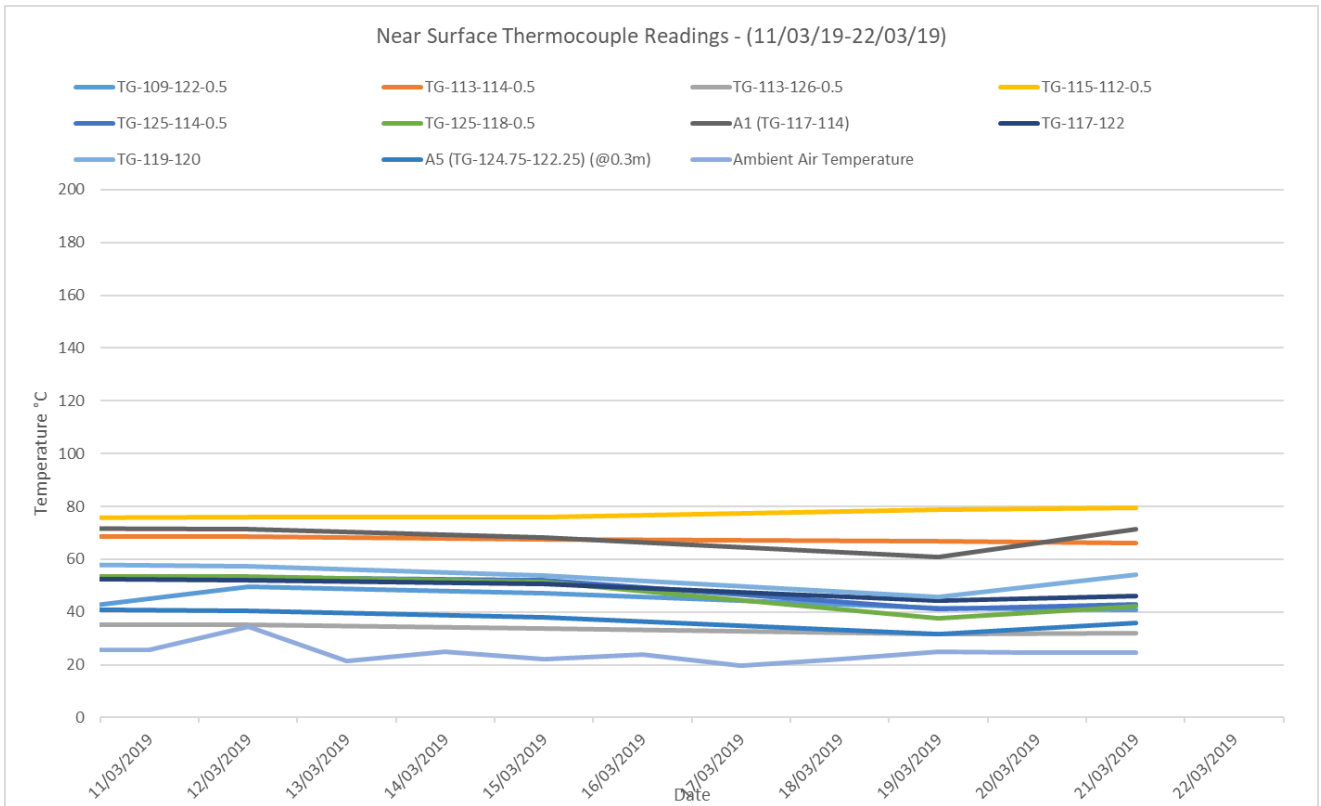
3.2. Near Surface Temperature Graph – Selected Points (Weekly)

Near surface temperature measurements for key thermocouple locations, over the monitoring period – 11th March 2019 to 22nd March 2019.

The near surface temperature at selected points across the northwest hotspot over the period of monitoring appear to remain consistent.

The near surface temperature monitoring conducted between 11th March 2019 and 22nd March 2019 indicates that the spatial extent of the northwest hotspot appears to remain localised.

There were no significant near surface temperature variations identified during the period of monitoring.

It is recommended that weekly site inspections and recording are continued to monitor the near surface temperatures surrounding the subsurface hotspot identified at the site.

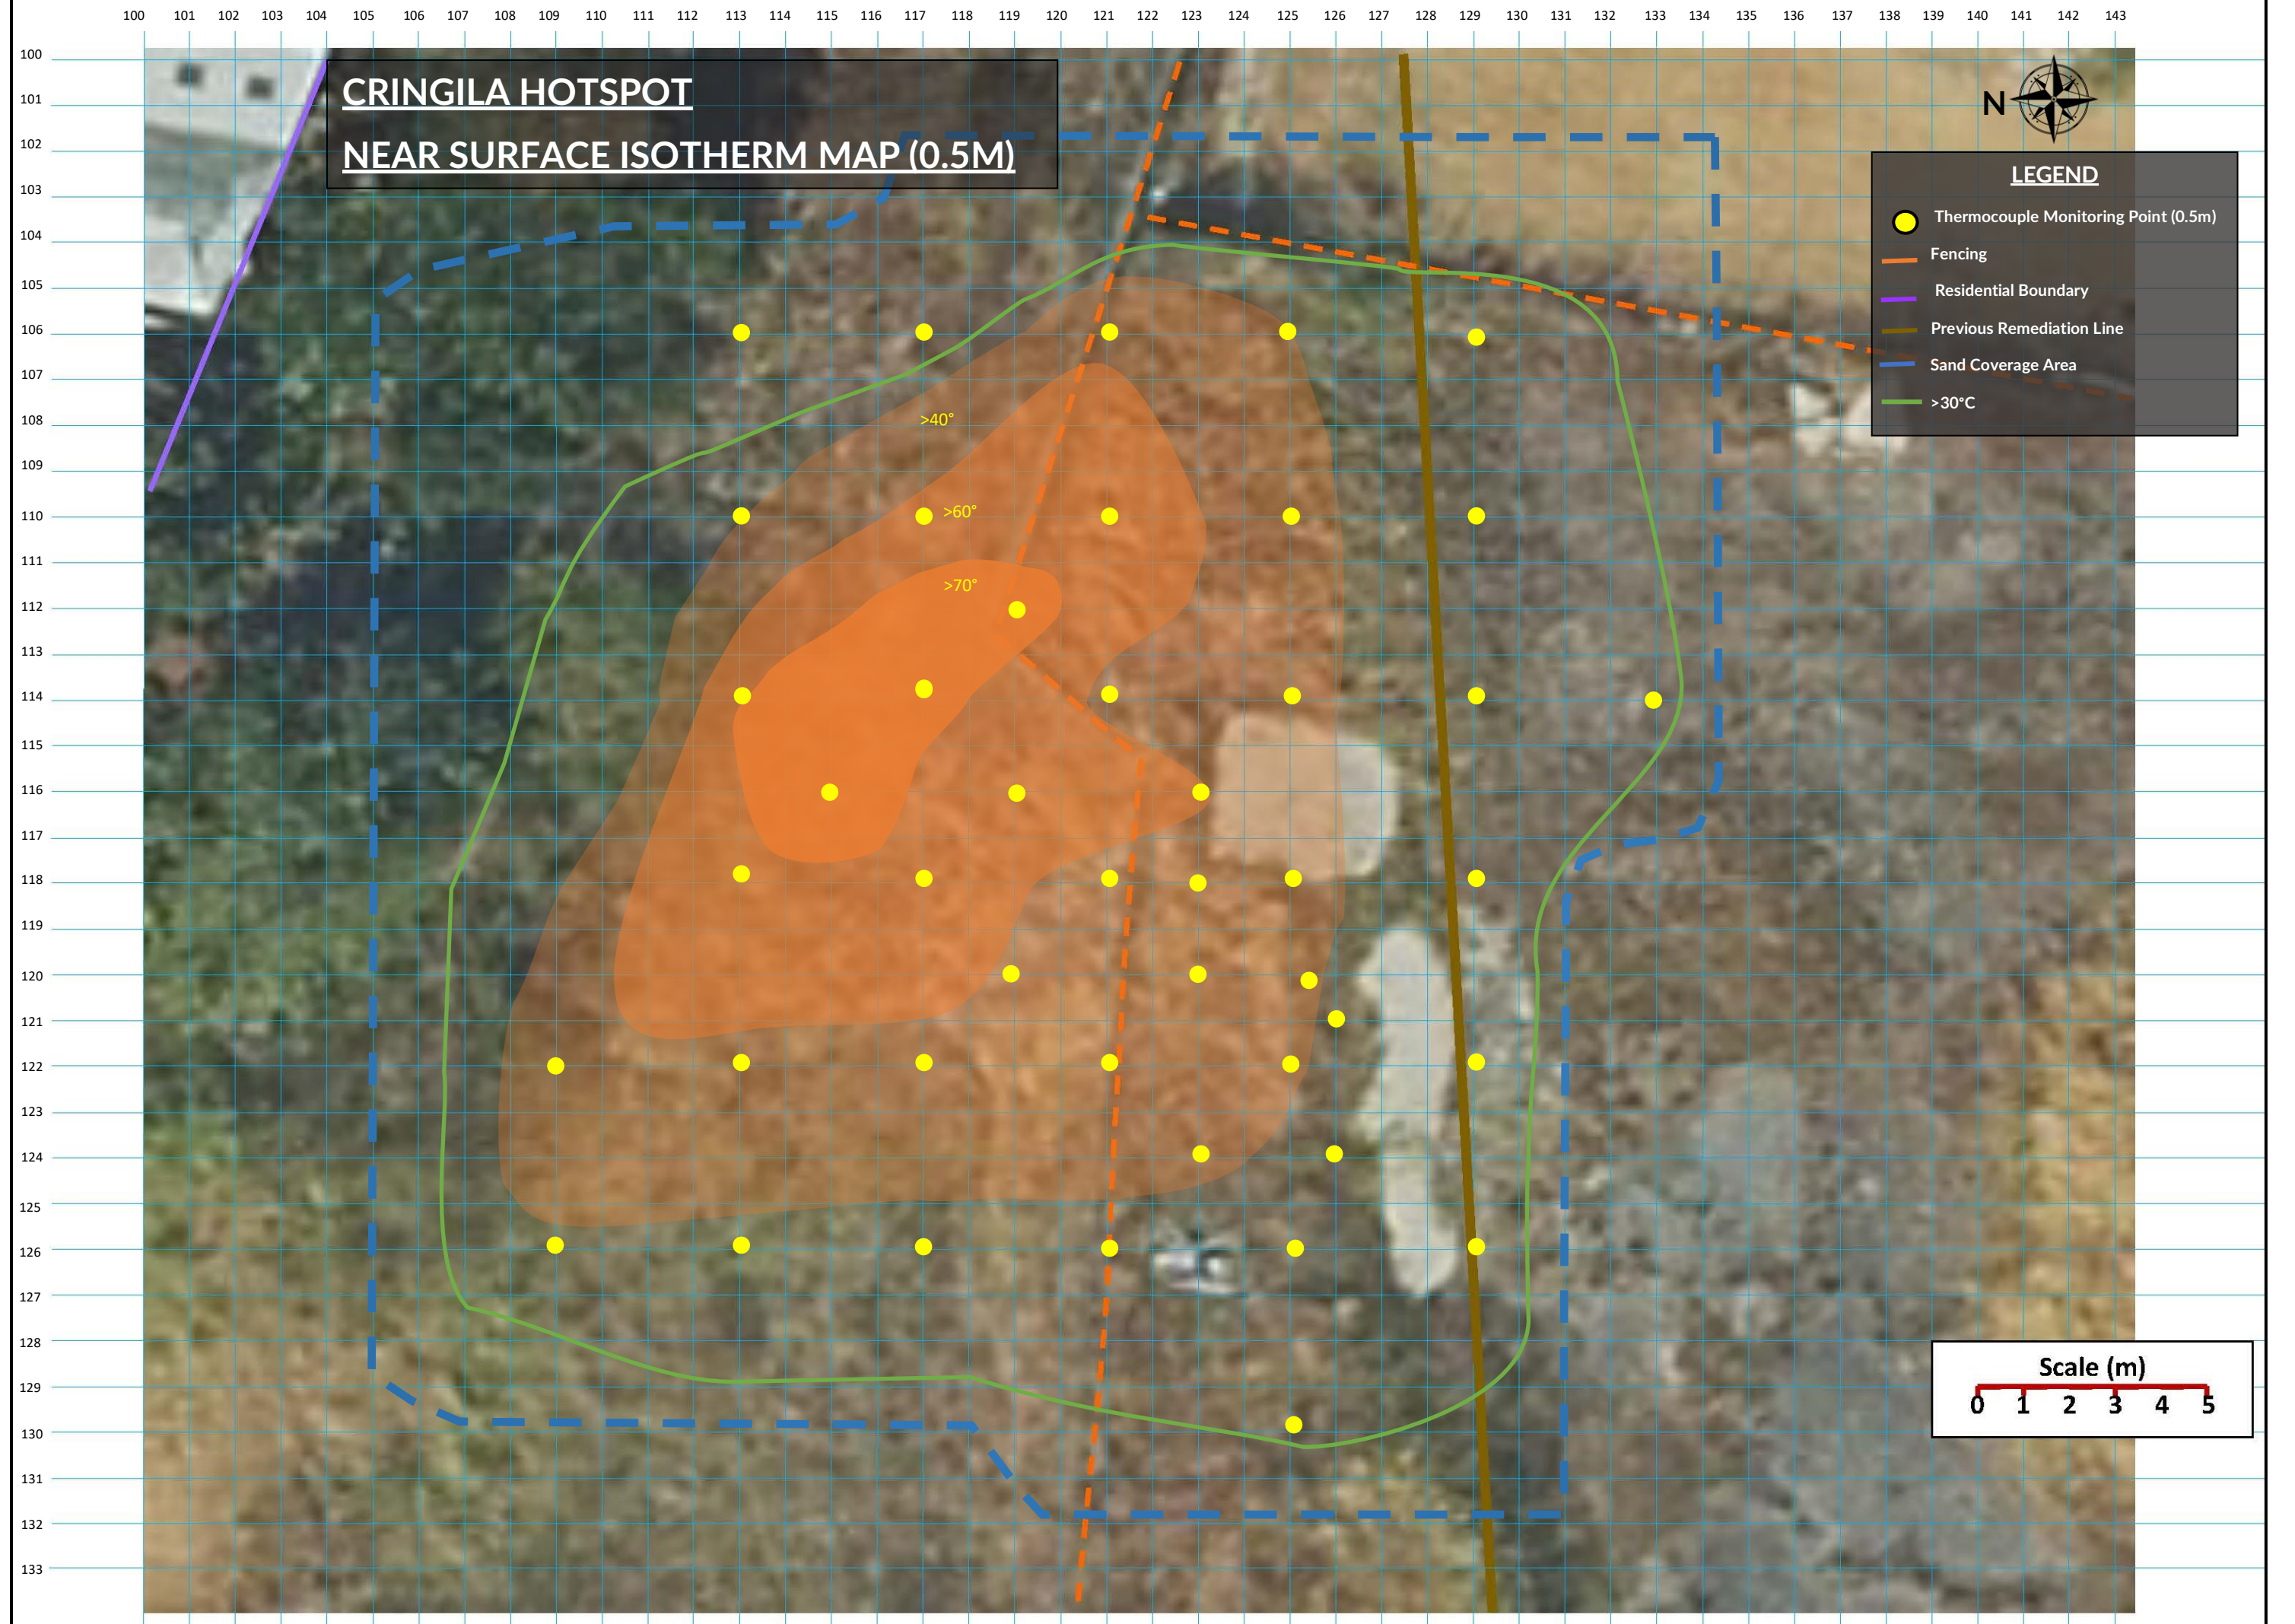
CRINGILA HOTSPOT NEAR SURFACE ISOTHERM MAP (0.5M)

The isotherm map shows the general zone of influence for temperatures between 30°C and 80°C at 0.5m, coloured orange. The isotherm map suggests that the hotspot may extend deeper than 0.5m and that the increased temperature in these areas is a result of heat venting to the surface.

It is noted that temperature at the near-surface may be variable across the hotspot due to inconsistencies in the consolidation and compaction of subsurface materials.
