NEAR SURFACE TEMPERATURE MONITORING CRINGILA PUBLIC SCHOOL - NW HOTSPOT

Summary Report
25/03/2019 - 05/04/2019

NSW Department
of Education
Cringila Public School

35 Sheffield Street
Cringila NSW 2502

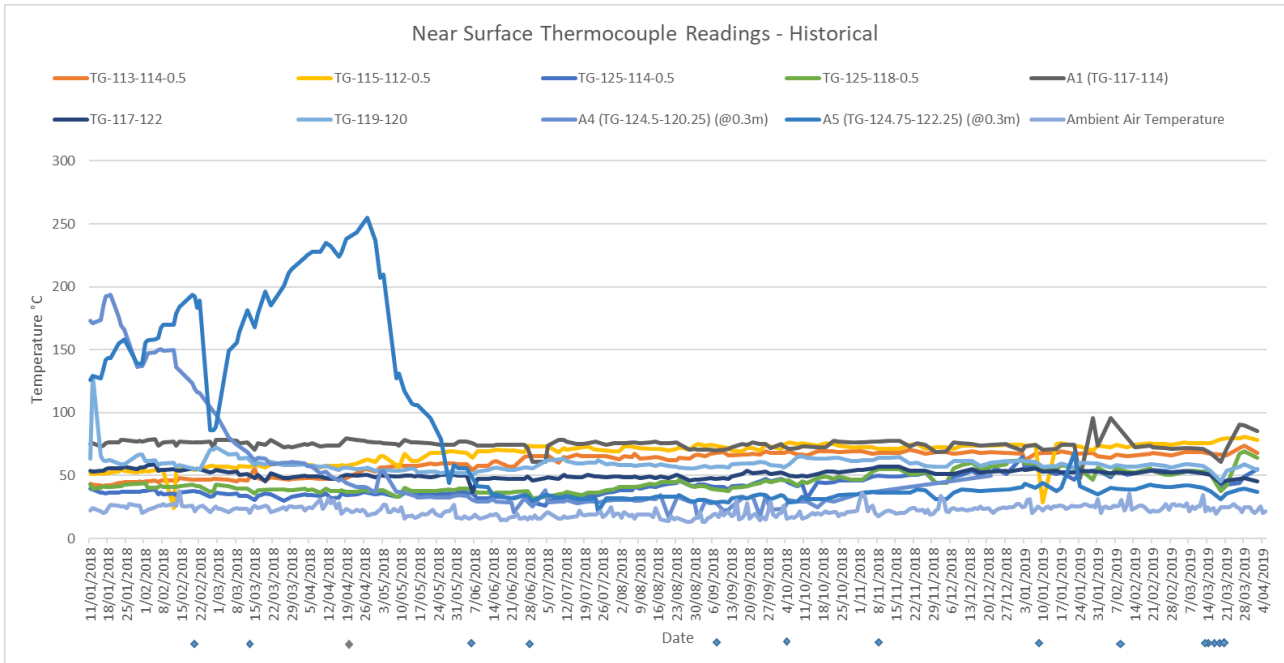
3.1. Near Surface Temperature Graph – Selected Points (Historical)

Near surface temperature measurements for key thermocouple locations, progressive from Thursday 11th January 2018 to present.

◆ = Rain event (>20mm) ◆ = Sand placement

The near surface temperature appears to be trending downwards following the placement of sand (approximately 100mm) across the surface of the northwest hotspot grid monitoring area.

Fluctuations in near surface temperature are evident following significant rain events (i.e. over 20mm rain).

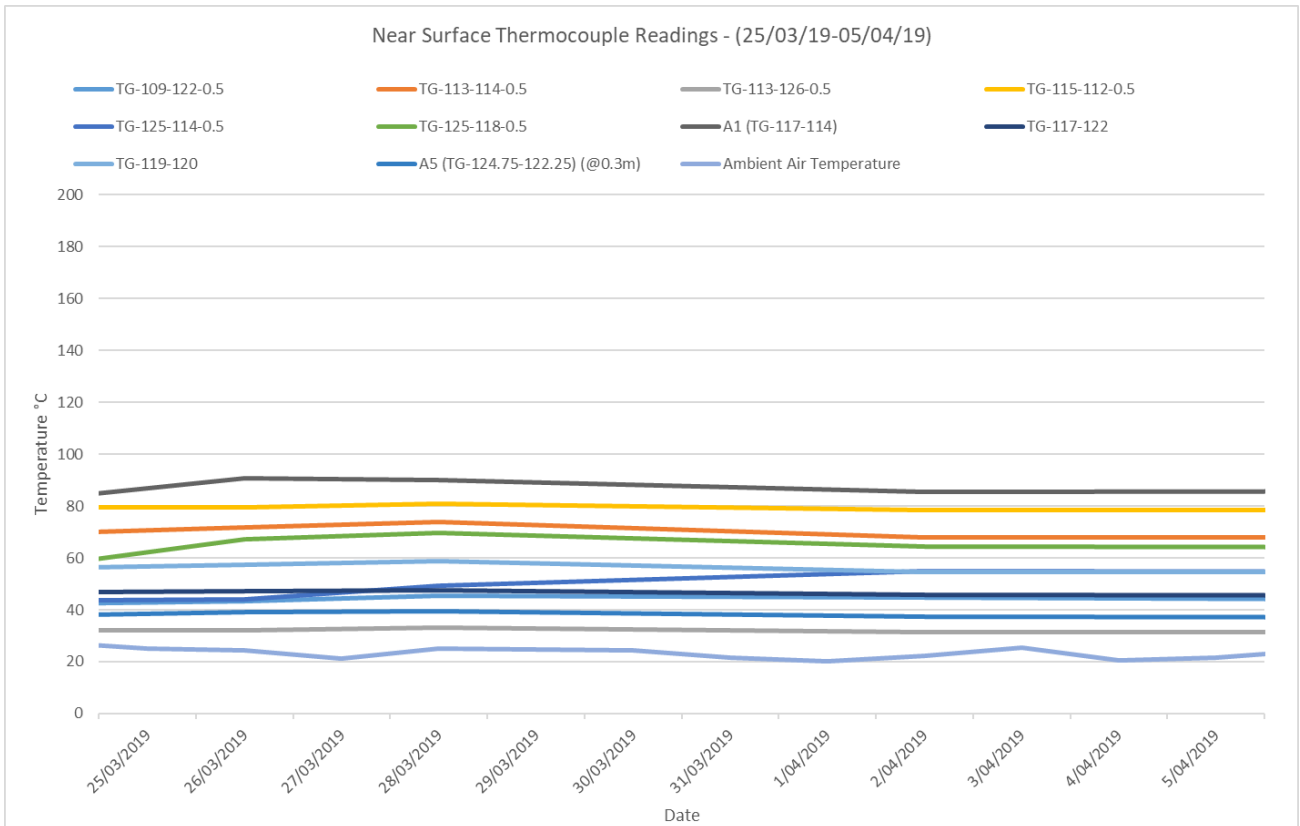
3.2. Near Surface Temperature Graph – Selected Points (Weekly)

Near surface temperature measurements for key thermocouple locations, over the monitoring period – 25th March 2019 to 5th April 2019.

The near surface temperature at selected points across the northwest hotspot over the period of monitoring appear to remain consistent.

The near surface temperature monitoring conducted between 25th March 2019 and 5th April 2019 indicates that the spatial extent of the northwest hotspot appears to remain localised.

There were no significant near surface temperature variations identified during the period of monitoring.

It is recommended that weekly site inspections and recording are continued to monitor the near surface temperatures surrounding the subsurface hotspot identified at the site.

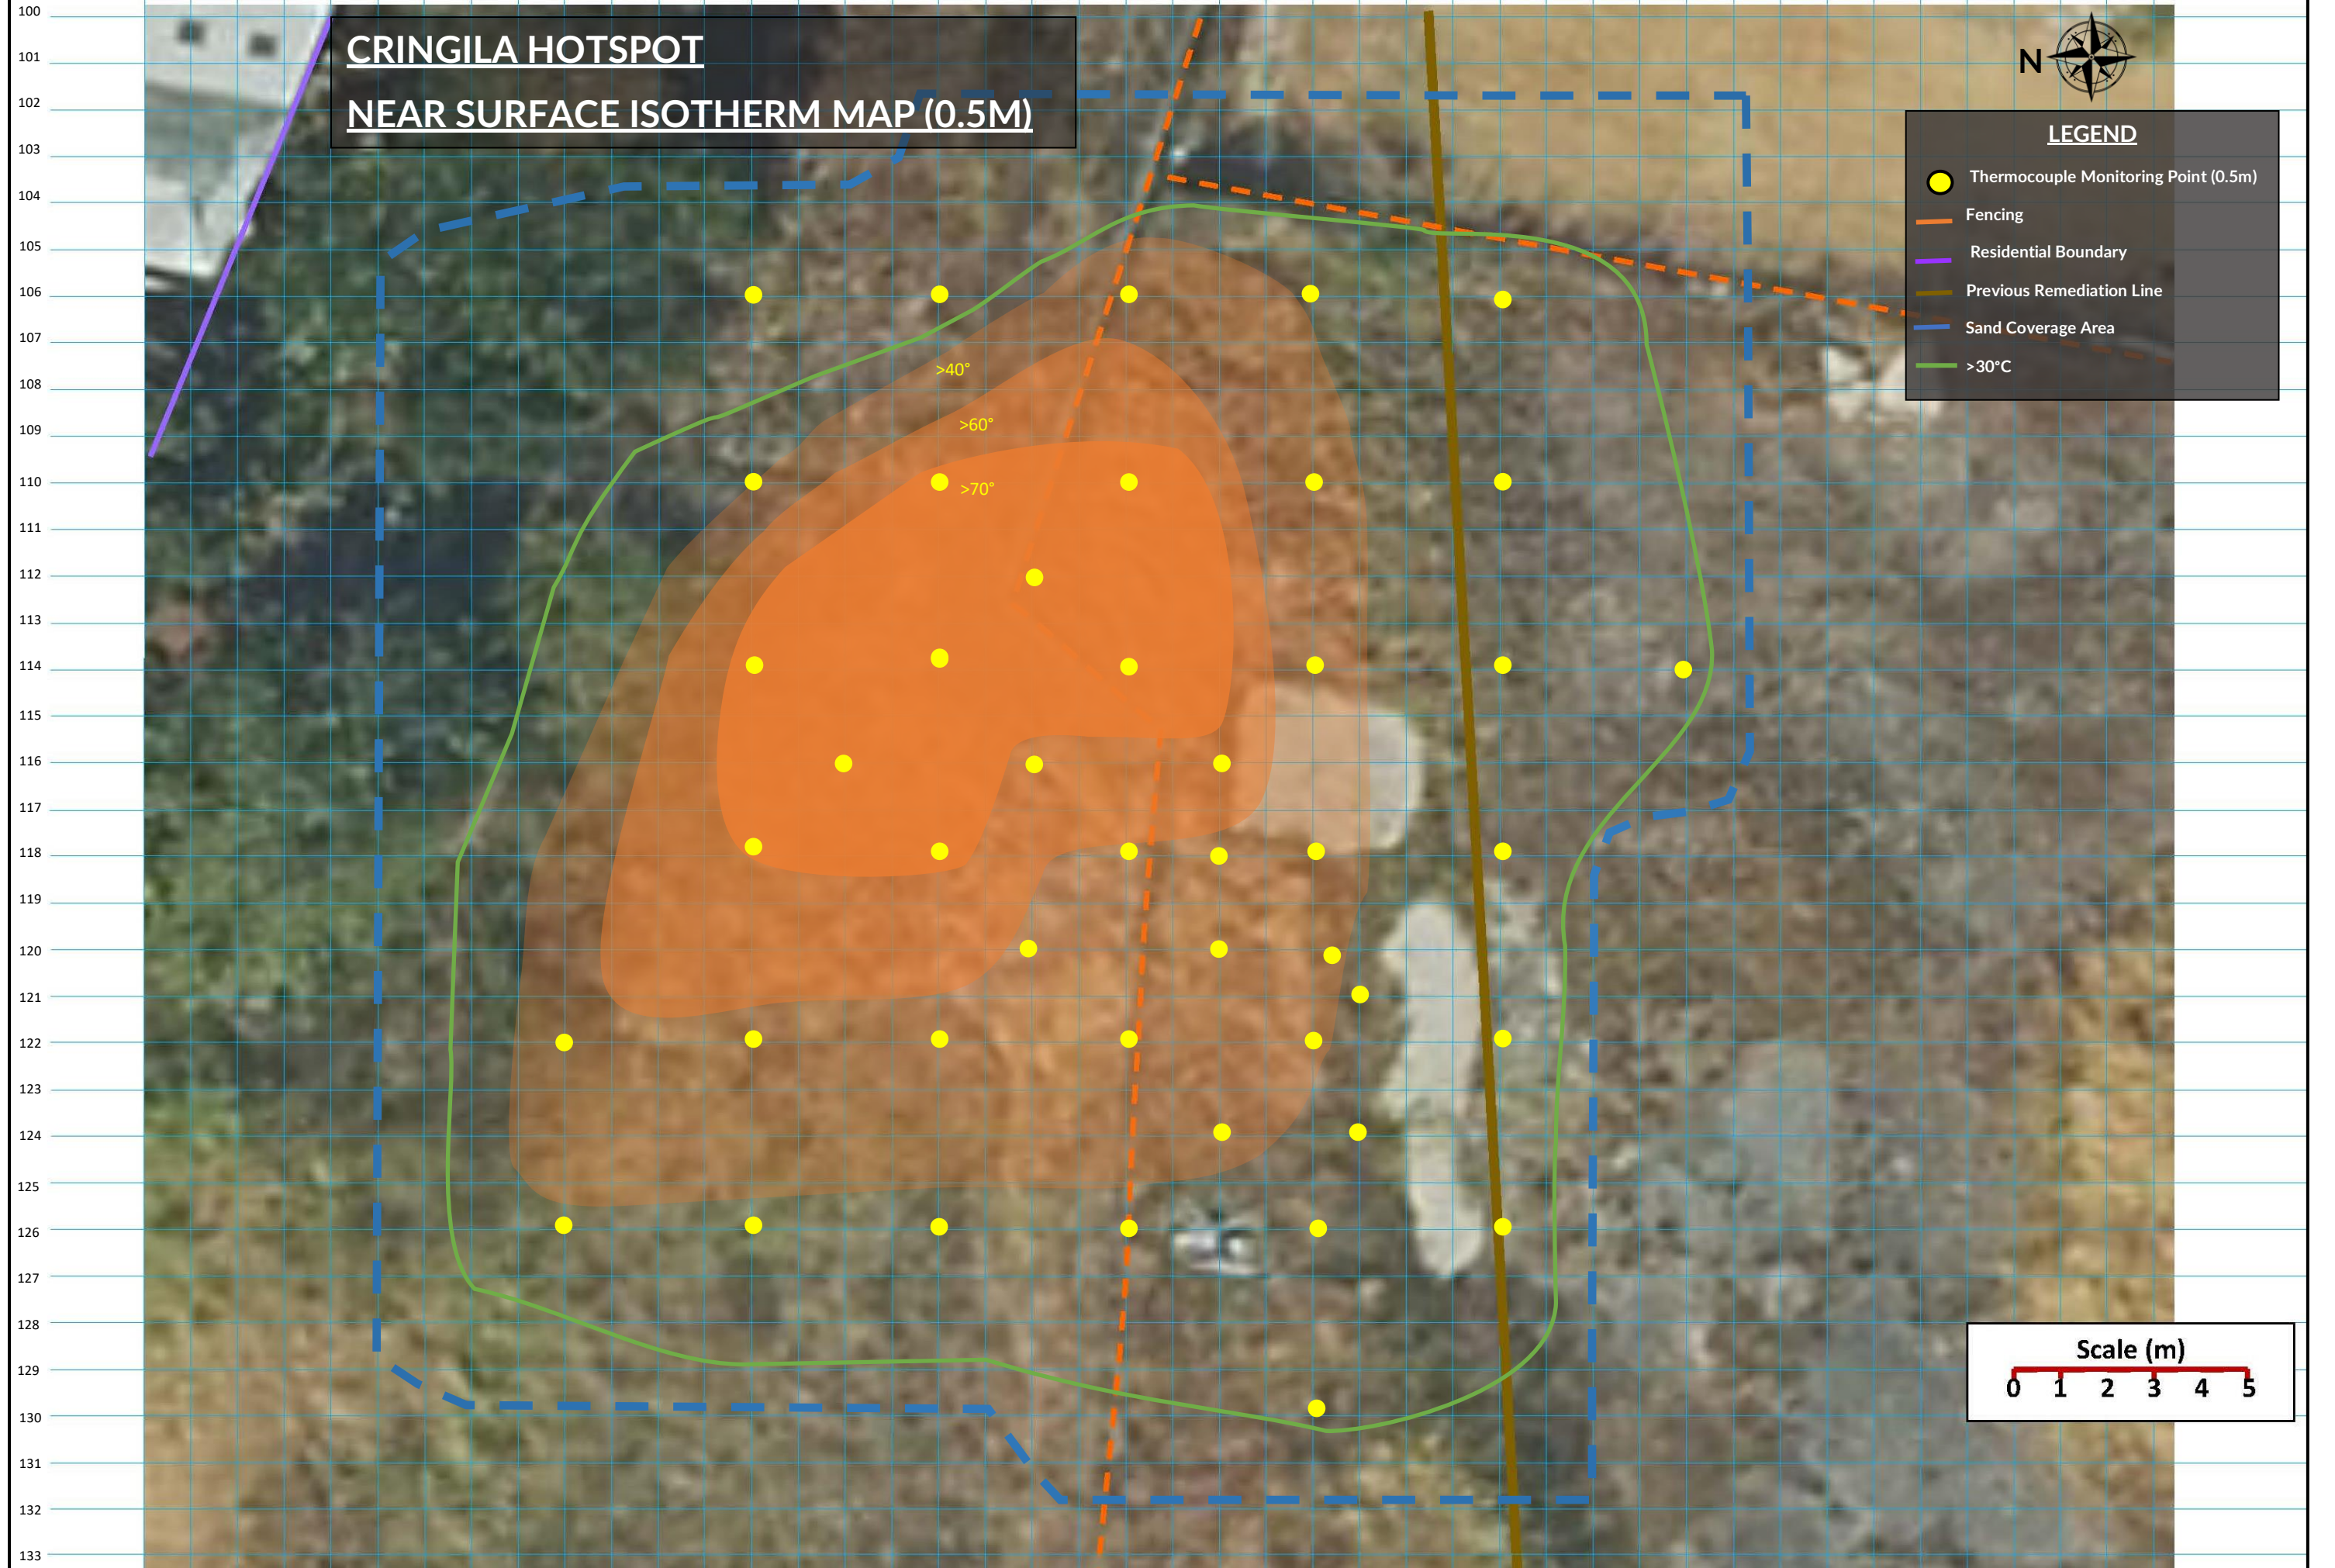
Appendix B: Near Surface Temperature Isotherm Map (0.5m)

The isotherm map shows the general zone of influence for temperatures between 30°C and 93°C at 0.5m, coloured orange. The isotherm map suggests that the hotspot may extend deeper than 0.5m and that the increased temperature in these areas is a result of heat venting to the surface.

It is noted that temperature at the near-surface may be variable across the hotspot due to inconsistencies in the consolidation and compaction of subsurface materials.

CRINGILA HOTSPOT NEAR SURFACE ISOTHERM MAP (0.5M)
