NEAR SURFACE TEMPERATURE MONITORING CRINGILA PUBLIC SCHOOL - NW HOTSPOT

Summary Report
08/04/2019 - 19/04/2019

NSW Department
of Education
Cringila Public School

35 Sheffield Street
Cringila NSW 2502

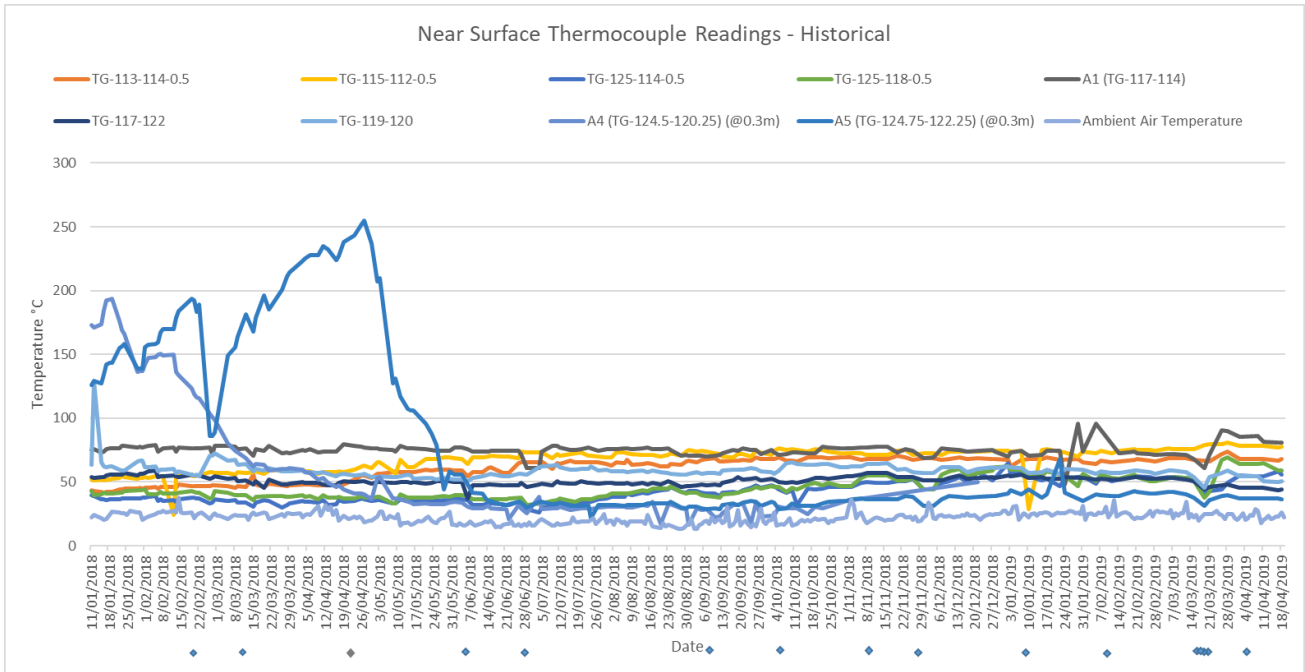
3.1. Near Surface Temperature Graph – Selected Points (Historical)

Near surface temperature measurements for key thermocouple locations, progressive from Thursday 11th January 2018 to present.

◆ = Rain event (>20mm) ◆ = Sand placement

The near surface temperature appears to be trending downwards following the placement of sand (approximately 100mm) across the surface of the northwest hotspot grid monitoring area.

Fluctuations in near surface temperature are evident following significant rain events (i.e. over 20mm rain).
