NEAR SURFACE TEMPERATURE MONITORING INVESTIGATION CRINGILA PUBLIC SCHOOL - NW HOTSPOT

Summary Report
22/04/2019 – 03/05/2019

NSW Department
of Education
Cringila Public School

35 Sheffield Street
Cringila NSW 2502

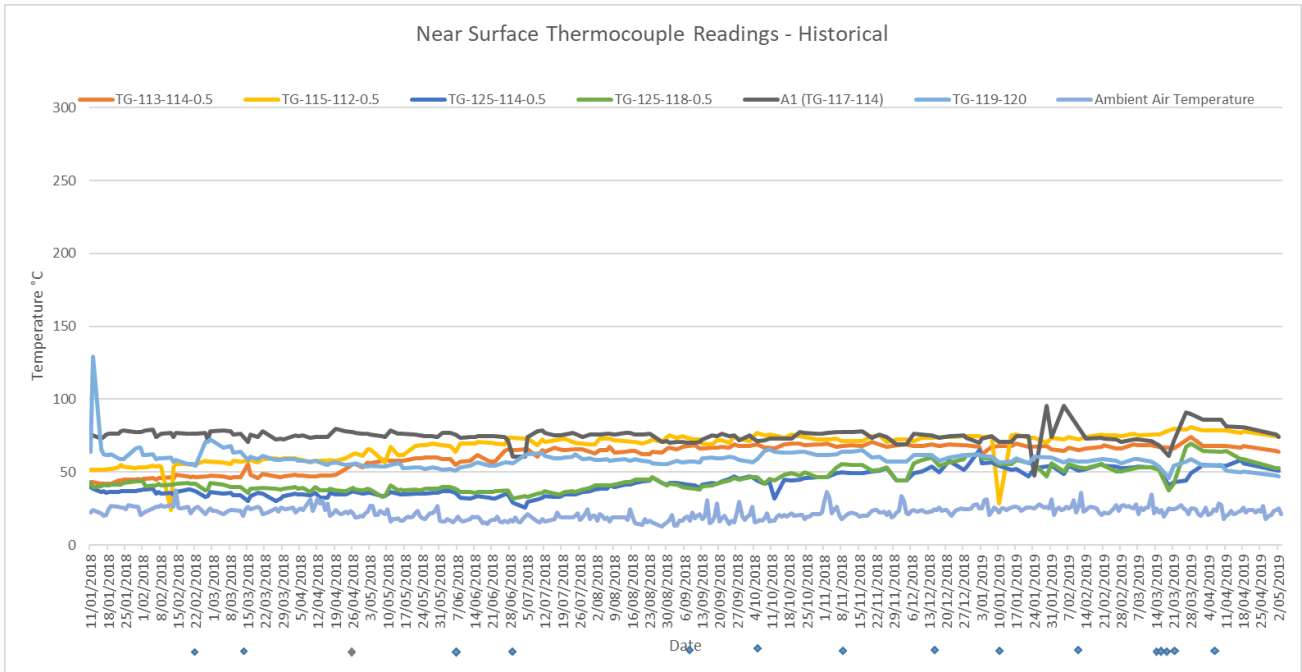
3.1. Near Surface Temperature Graph – Selected Points (Historical)

Near surface temperature measurements for key thermocouple locations, progressive from Thursday 11th January 2018 to present.

The near surface temperature appears to be trending downwards following the placement of sand (approximately 100mm) across the surface of the northwest hotspot grid monitoring area.

Fluctuations in near surface temperature are evident following significant rain events (i.e. over 20mm rain).

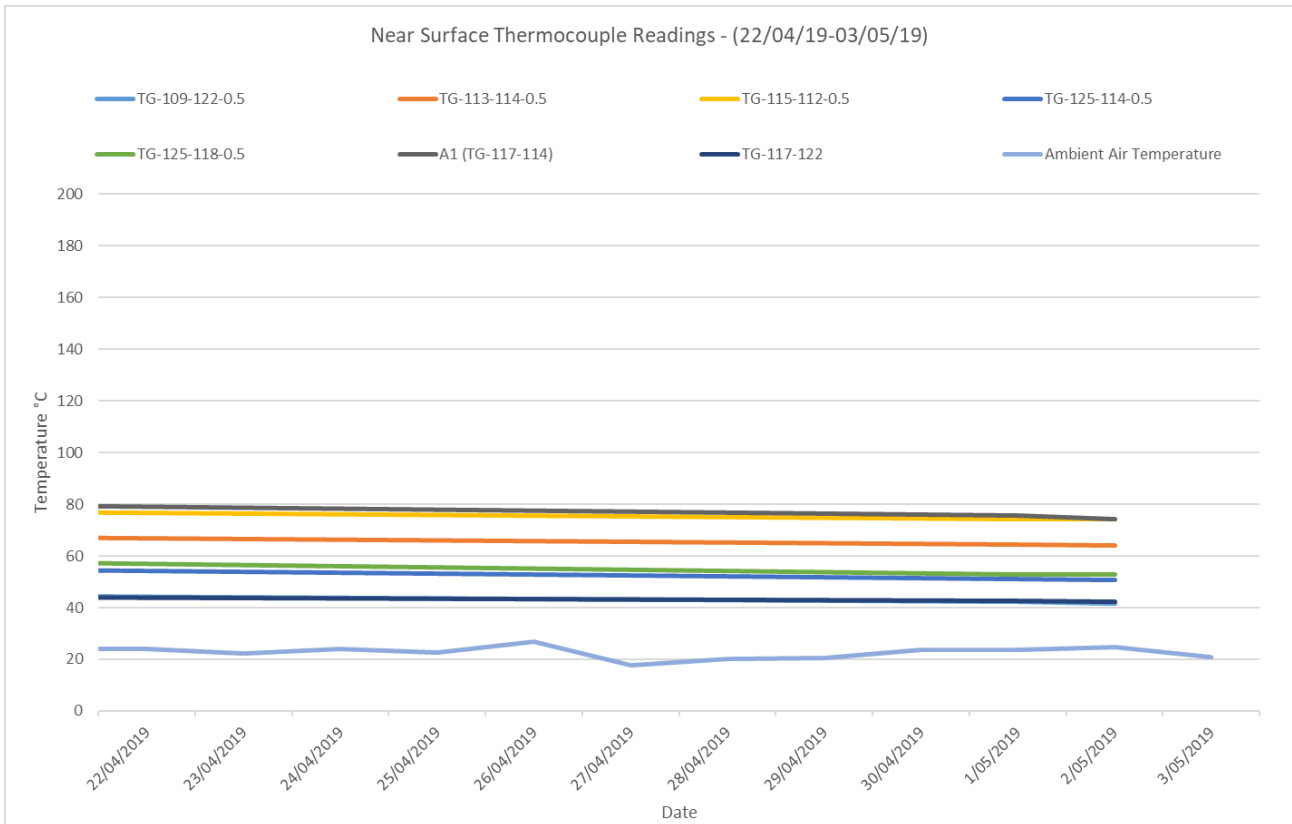
3.2. Near Surface Temperature Graph – Selected Points (Weekly)

Near surface temperature measurements for key thermocouple locations, over the monitoring period – 22nd April 2019 to 3rd May 2019.

The near surface temperature at selected points across the northwest hotspot over the period of monitoring appear to remain consistent.

The near surface temperature monitoring conducted between 22nd April 2019 and 3rd May 2019 indicates that the spatial extent of the northwest hotspot appears to remain localised.

There were no significant near surface temperature variations identified during the period of monitoring.

It is recommended that weekly site inspections and recording are continued to monitor the near surface temperatures surrounding the subsurface hotspot identified at the site.

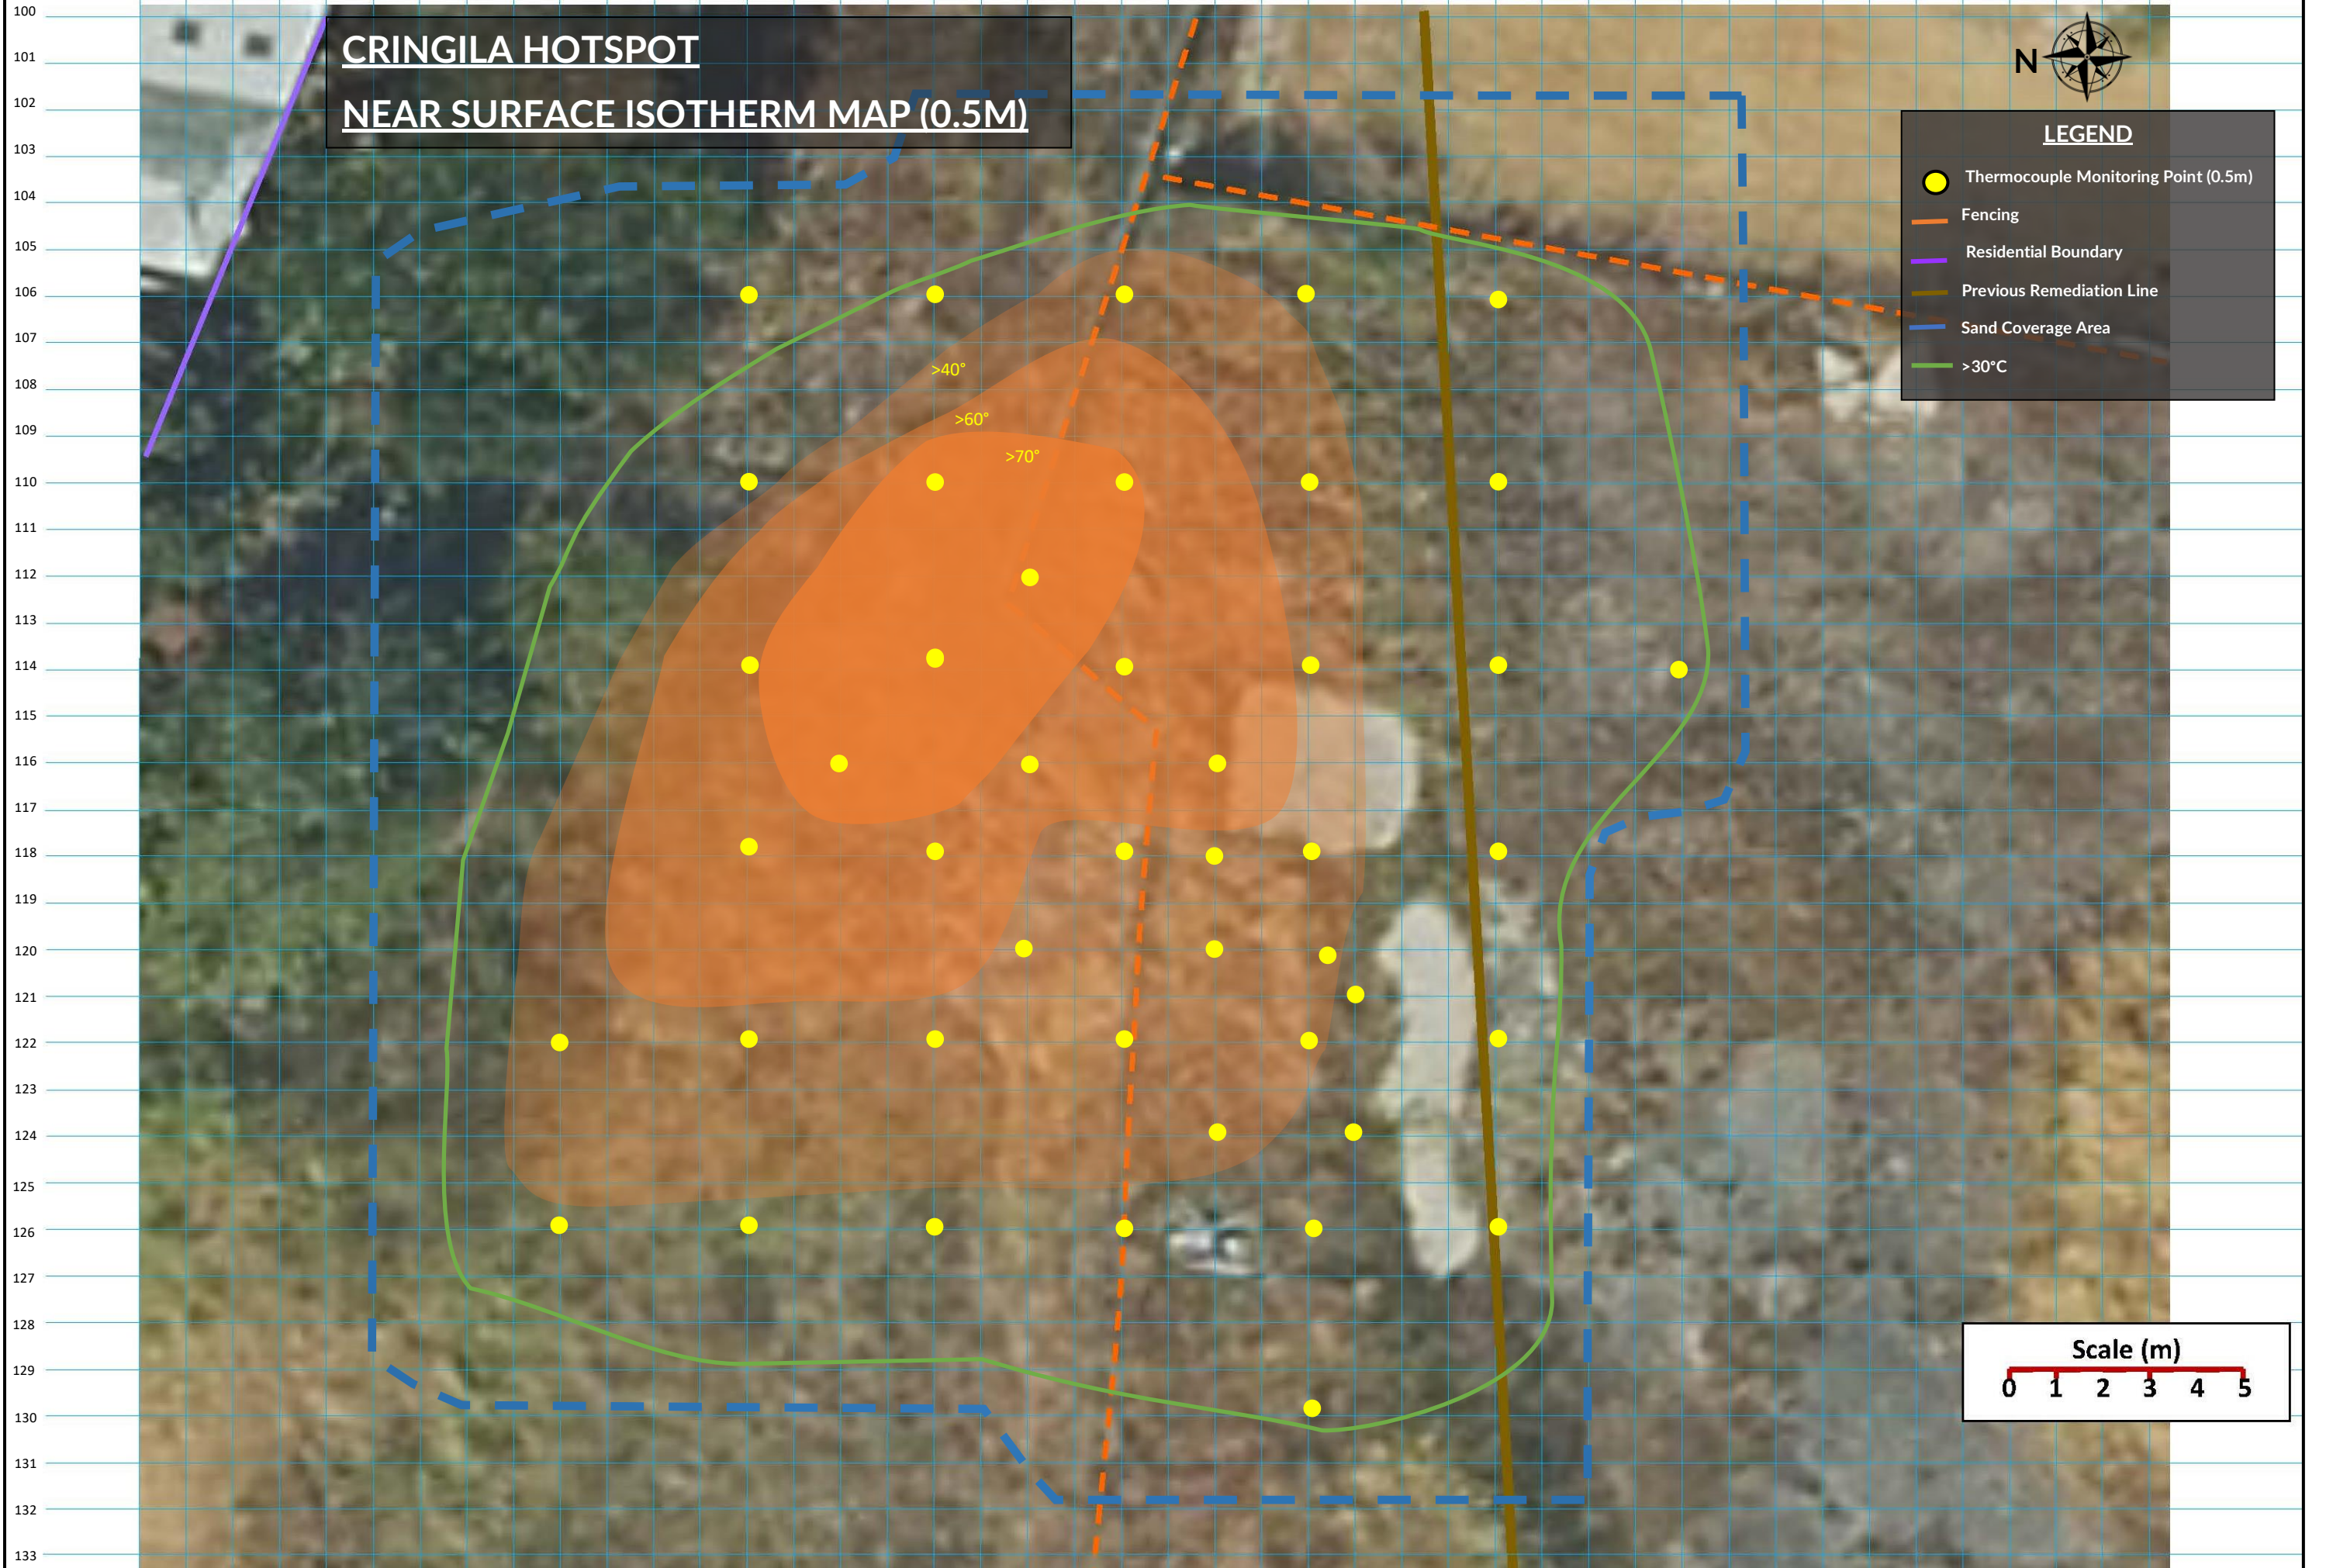
Appendix B: Near Surface Temperature Isotherm Map (0.5m)

The isotherm map shows the general zone of influence for temperatures between 30°C and 80°C at 0.5m, coloured orange. The isotherm map suggests that the hotspot may extend deeper than 0.5m and that the increased temperature in these areas is a result of heat venting to the surface.

It is noted that temperature at the near-surface may be variable across the hotspot due to inconsistencies in the consolidation and compaction of subsurface materials.

CRINGILA HOTSPOT NEAR SURFACE ISOTHERM MAP (0.5M)
