NEAR SURFACE TEMPERATURE MONITORING INVESTIGATION CRINGILA PUBLIC SCHOOL - NW HOTSPOT

Summary Report
20/05/2019 – 31/05/2019

NSW Department
of Education
Cringila Public School

35 Sheffield Street
Cringila NSW 2502

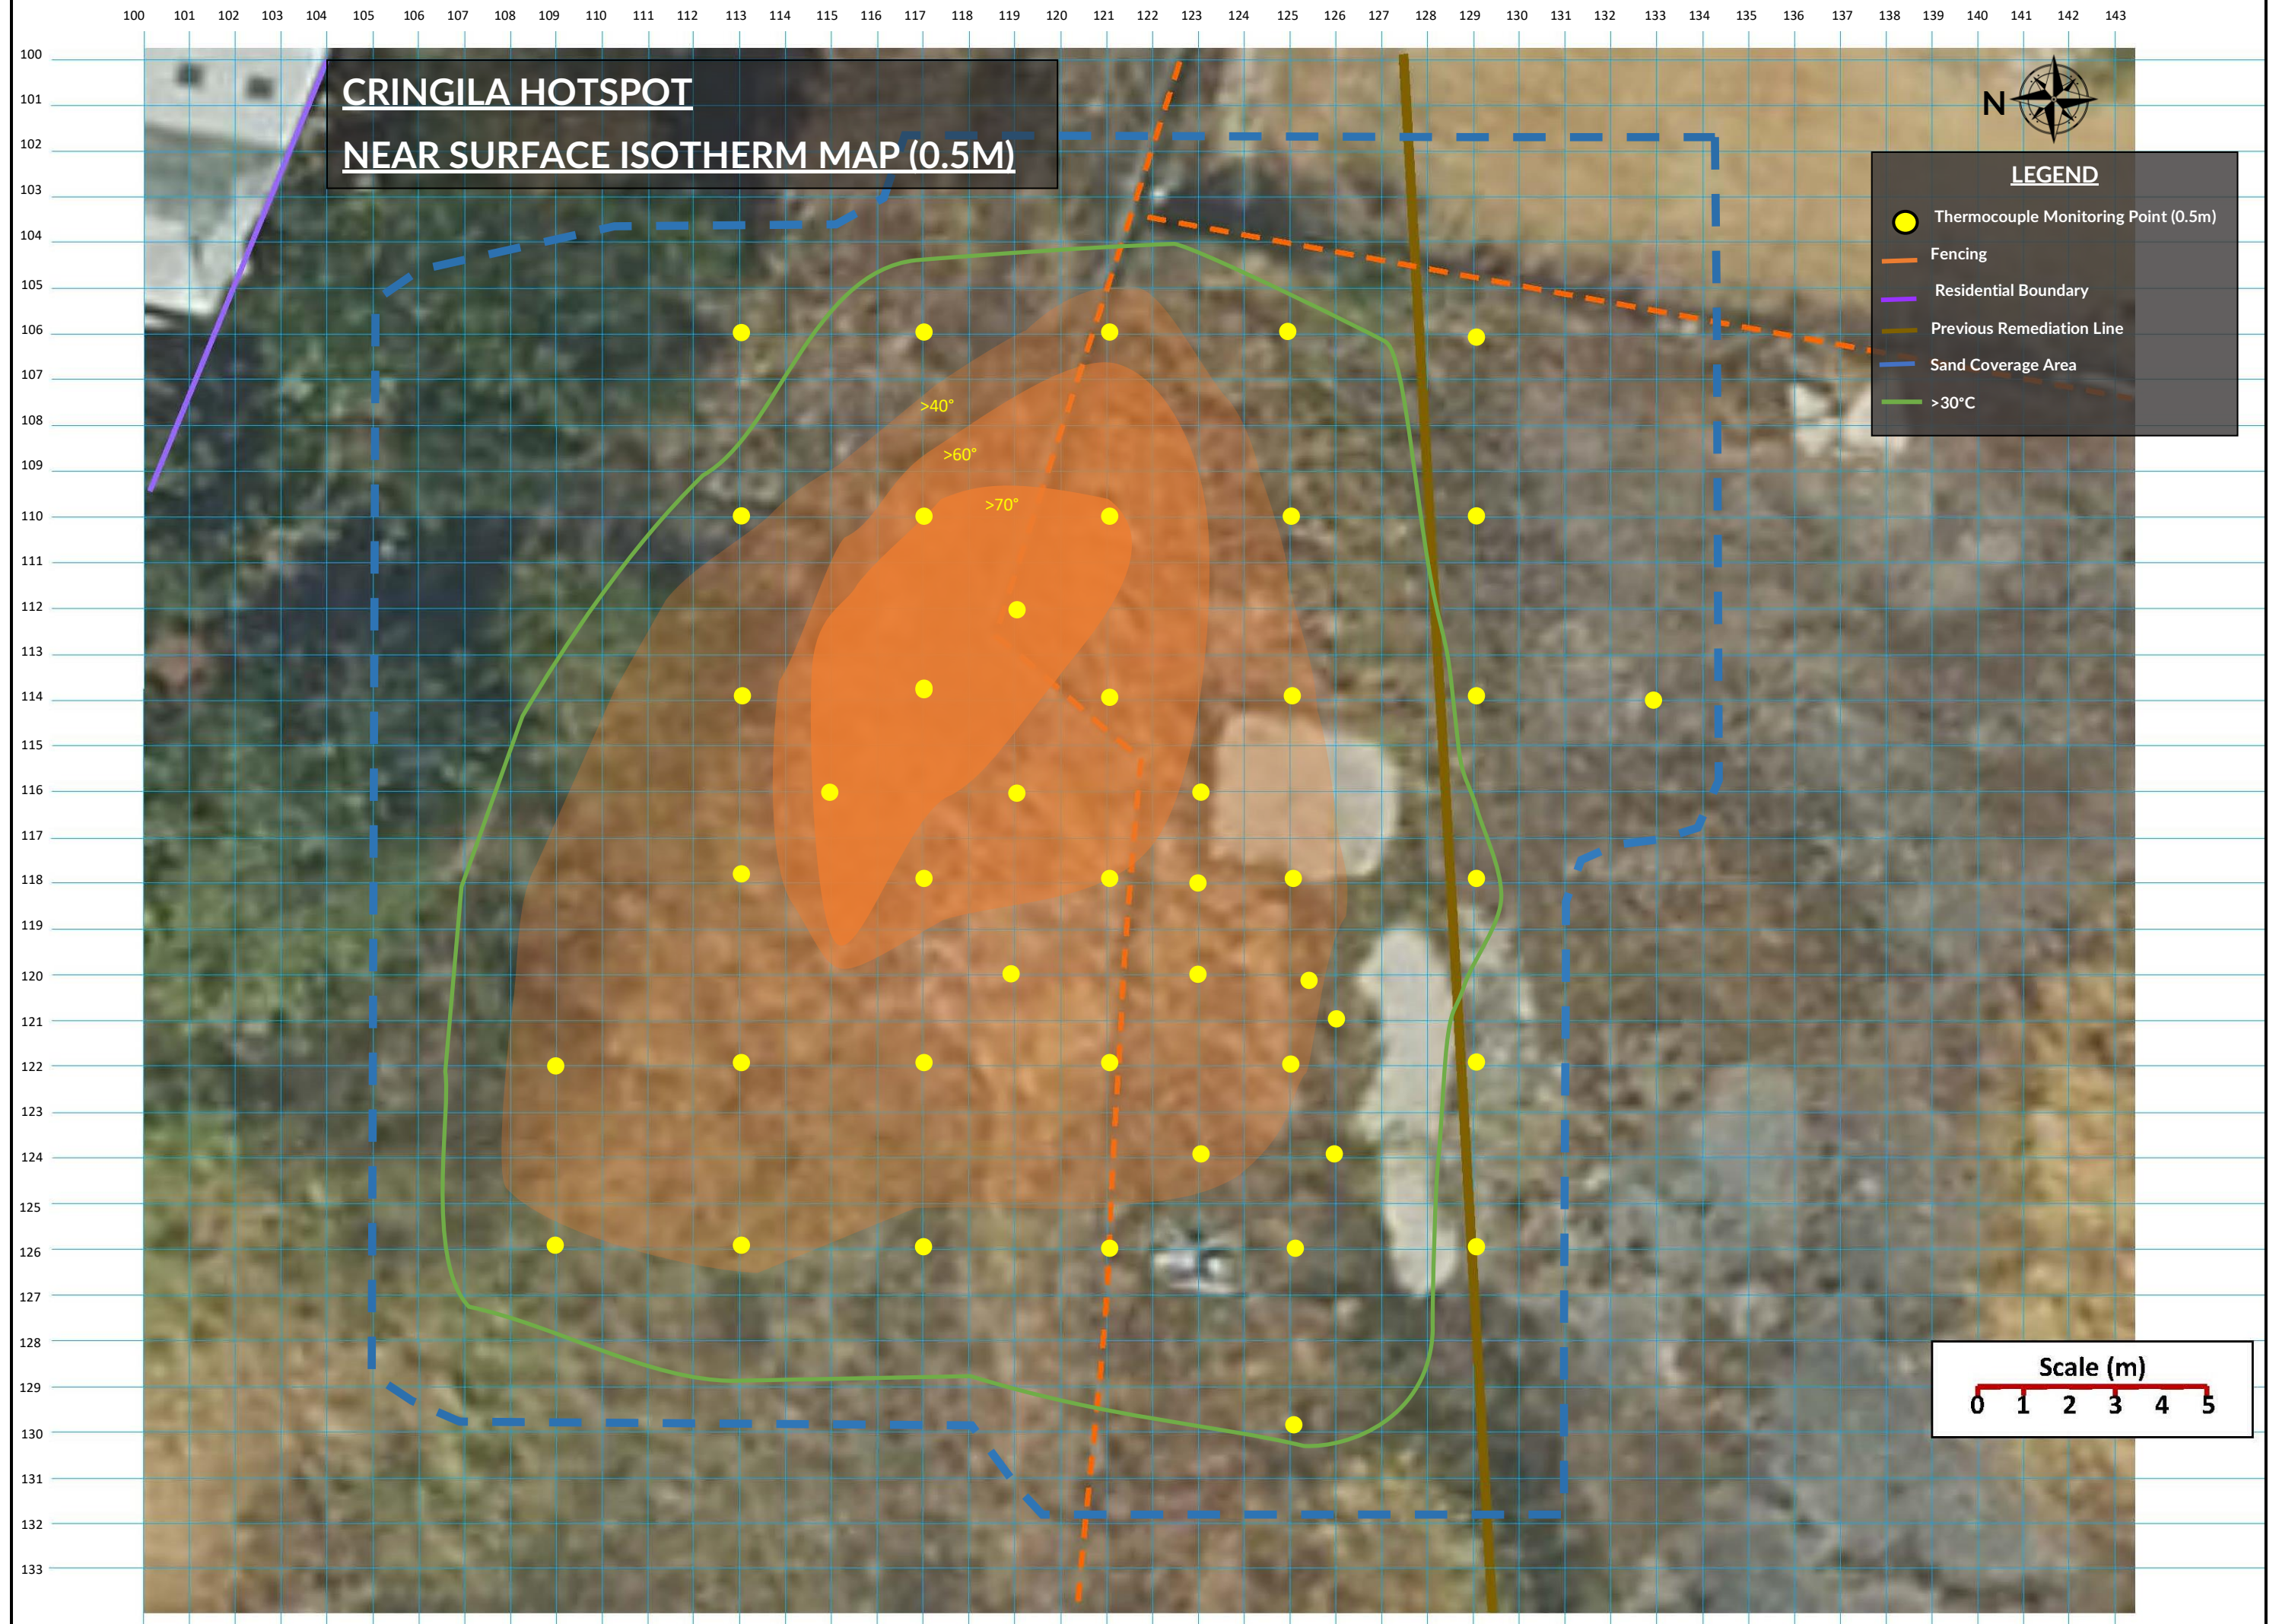
Appendix B: Near Surface Temperature Isotherm Map (0.5m)

The isotherm map shows the general zone of influence for temperatures between 30°C and 72°C at 0.5m, coloured orange. The isotherm map suggests that the hotspot may extend deeper than 0.5m and that the increased temperature in these areas is a result of heat venting to the surface.

It is noted that temperature at the near-surface may be variable across the hotspot due to inconsistencies in the consolidation and compaction of subsurface materials.

CRINGILA HOTSPOT NEAR SURFACE ISOTHERM MAP (0.5M)

It is recommended that weekly site inspections and recording are continued to monitor the near surface temperatures surrounding the subsurface hotspot identified at the site.
