## NEAR-SURFACE TEMPERATURE MONITORING INVESTIGATION CRINGILA PUBLIC SCHOOL - NW HOTSPOT

Summary Report  
01/07/2019 - 12/07/2019

NSW Department  
of Education  
Cringila Public School

July 2019  
C107741: J153825-03: RC

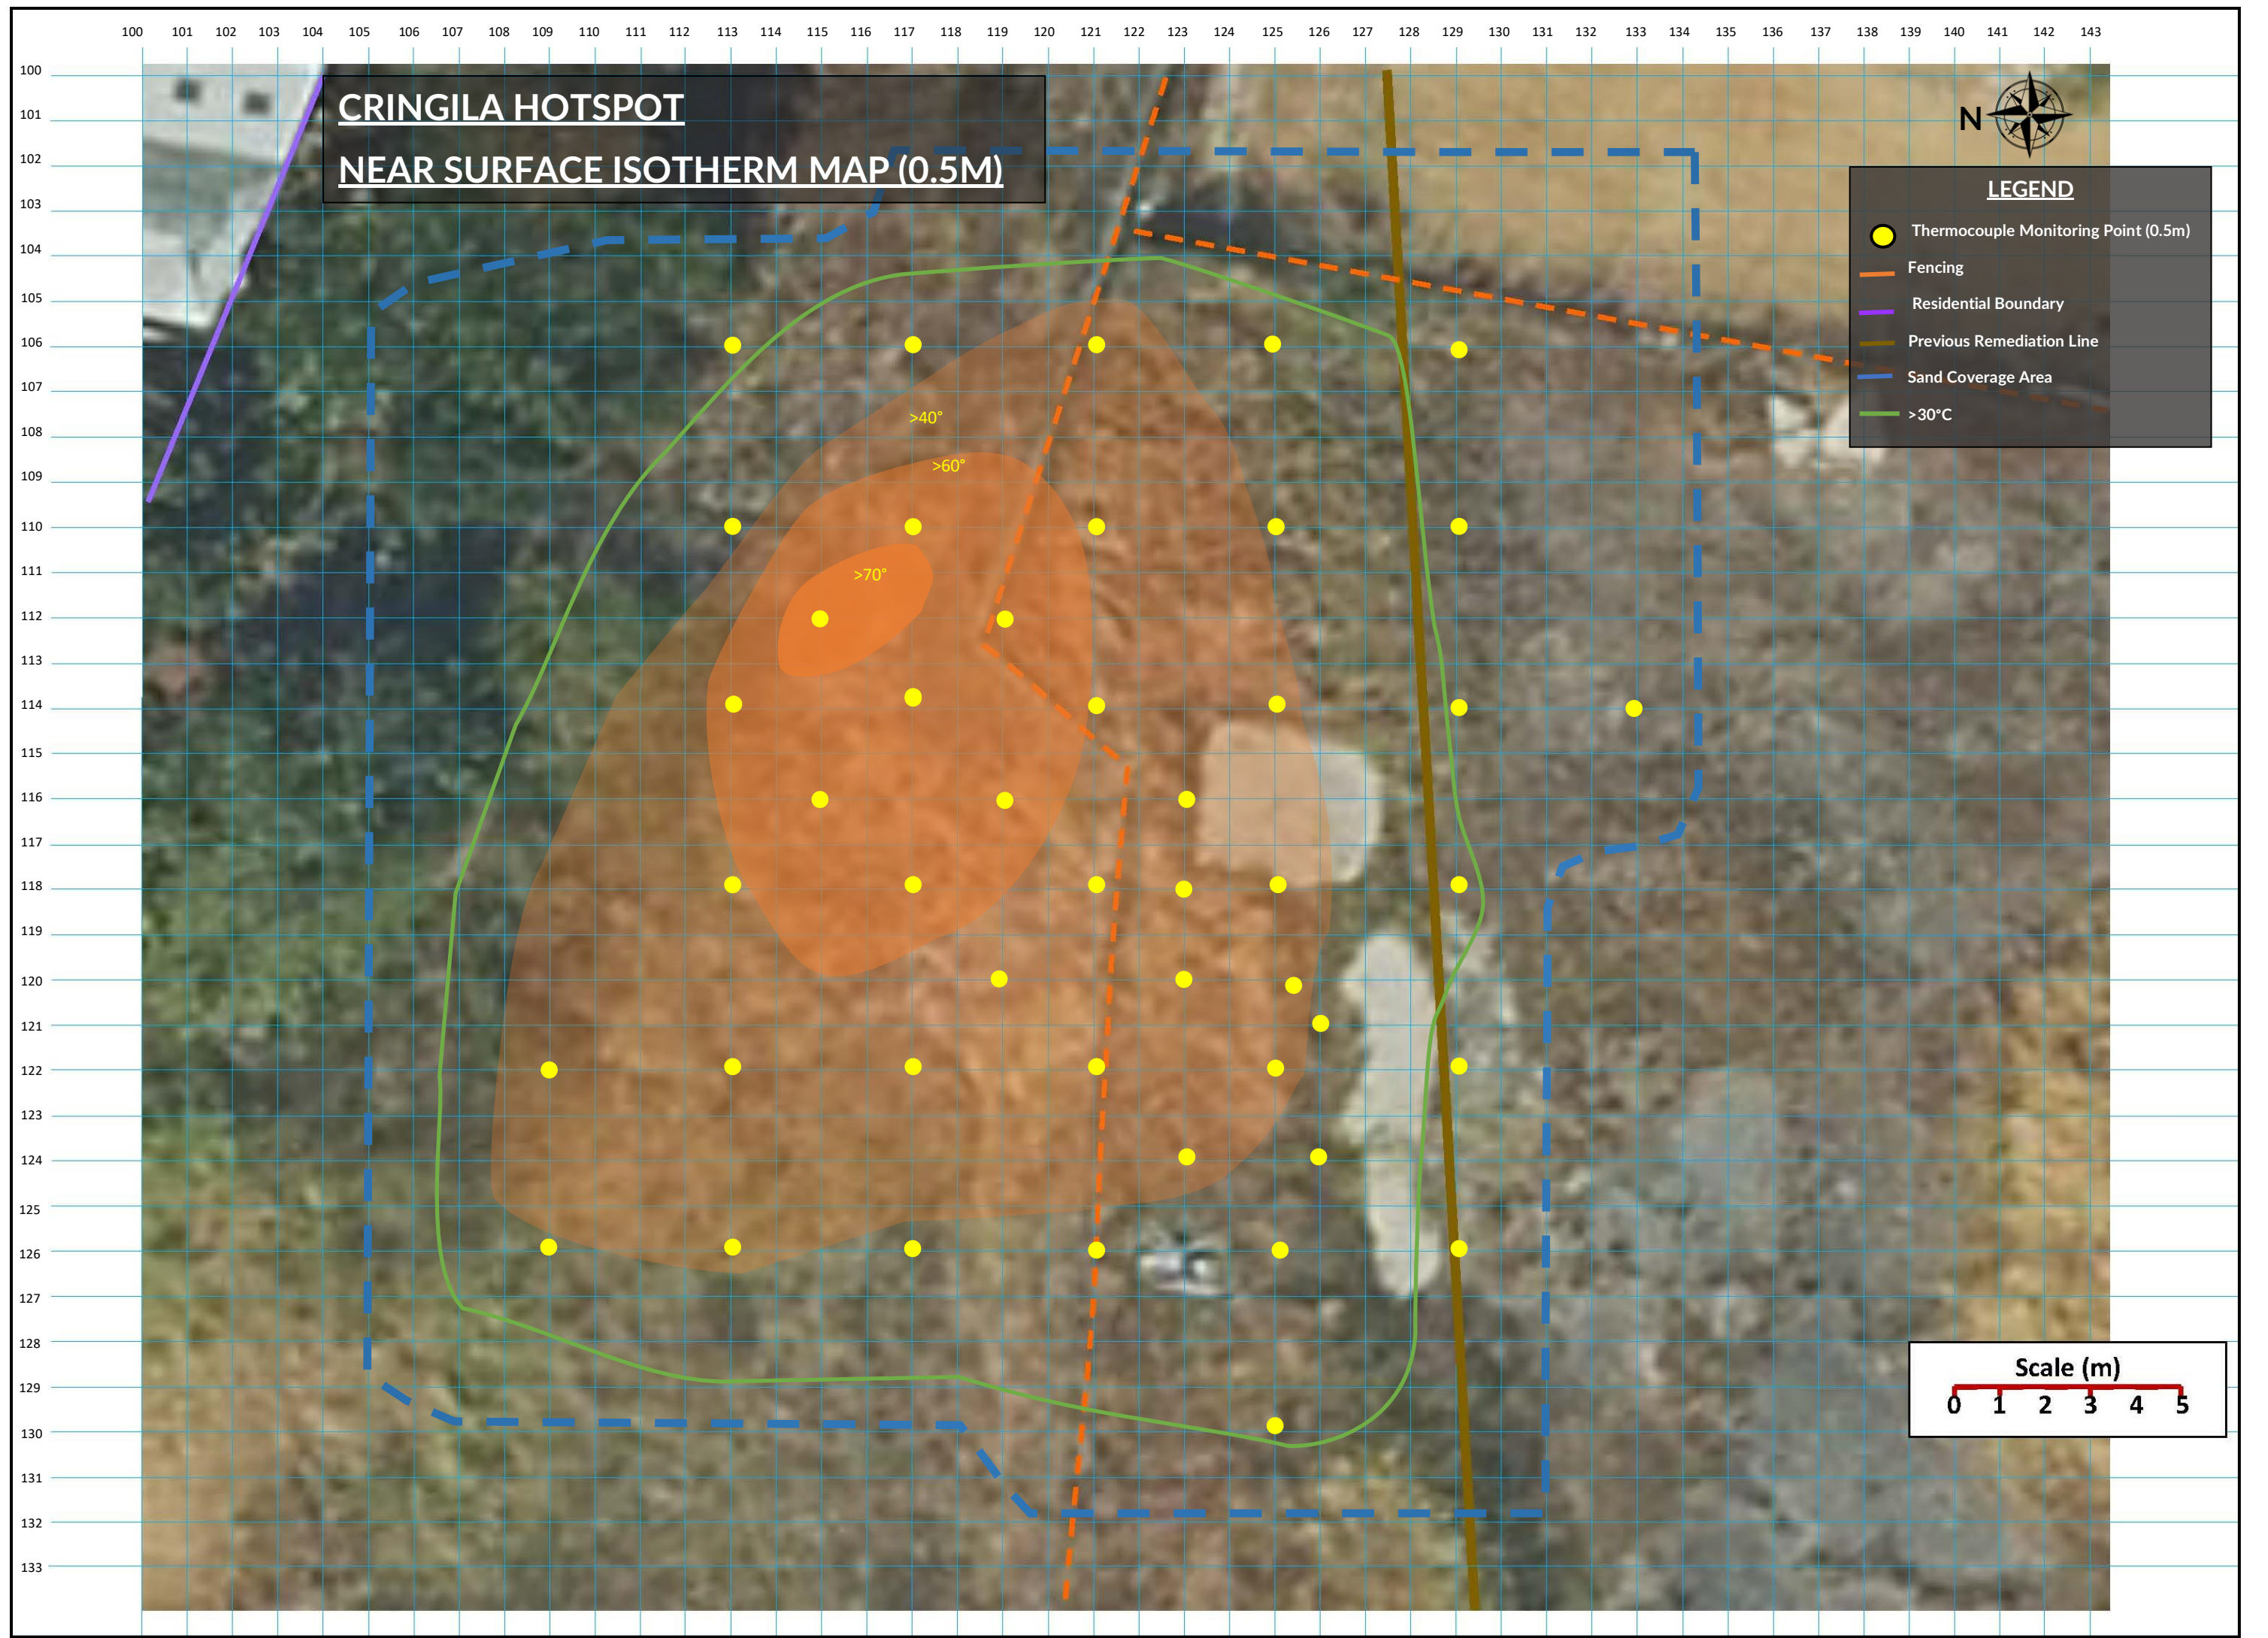
# CRINGILA HOTSPOT NEAR SURFACE ISOTHERM MAP (0.5M)

The isotherm map shows the general zone of influence for temperatures between 30°C and 76°C at 0.5m, coloured orange. The isotherm map suggests that the hotspot may extend deeper than 0.5m and that the increased temperature in these areas is a result of heat venting to the surface.

It is noted that temperature at the near-surface may be variable across the hotspot due to inconsistencies in the consolidation and compaction of subsurface materials.

It is recommended that weekly site inspections and recording are continued to monitor the near-surface temperatures surrounding the subsurface hotspot identified at the site.
