## NEAR-SURFACE TEMPERATURE MONITORING INVESTIGATION CRINGILA PUBLIC SCHOOL - NW HOTSPOT

Summary Report  
15/07/2019 – 26/07/2019

NSW Department  
of Education  
Cringila Public School

35 Sheffield Street  
Cringila NSW 2502

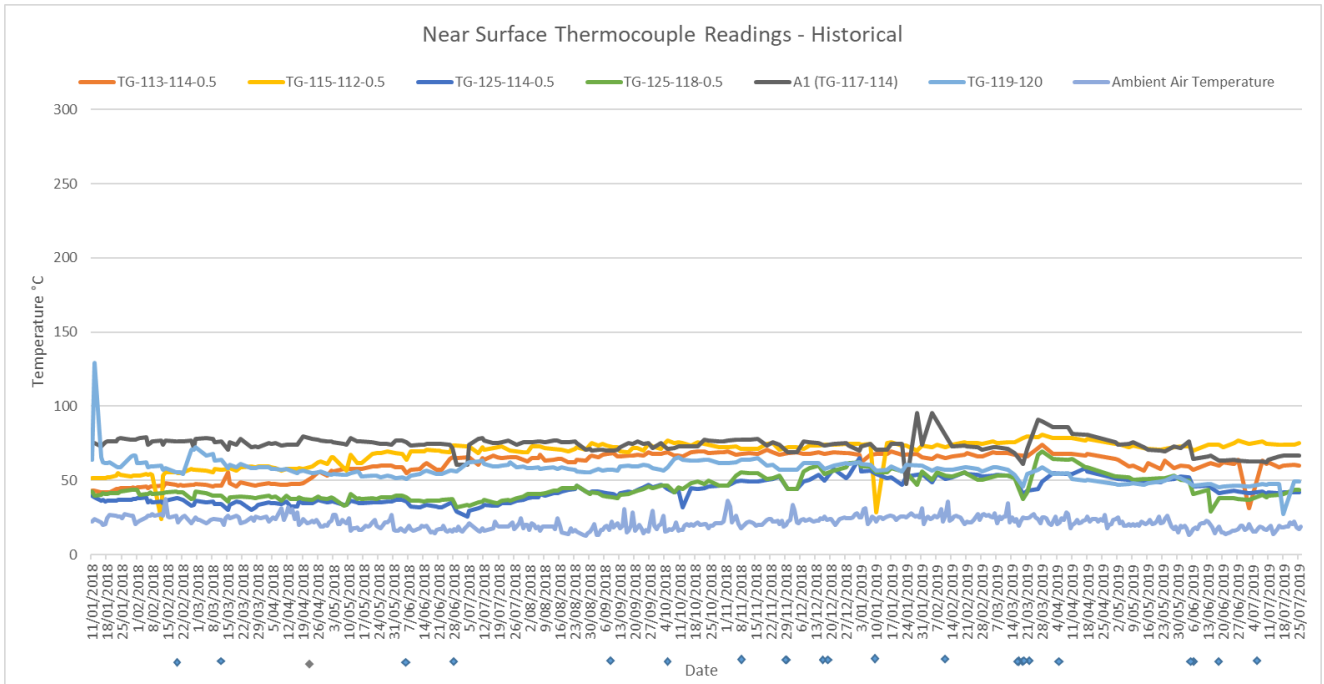
### 3.1. Near-Surface Temperature Graph – Selected Points (Historical)

Near surface temperature measurements for key thermocouple locations, progressive from Thursday 11<sup>th</sup> January 2018 to present.

◆ = Rain Event (>20mm)    ◆ = Sand Placement

The near surface temperature appears to be trending downwards following the placement of sand (approximately 100mm) across the surface of the northwest hotspot grid monitoring area.

Fluctuations in near-surface temperature are evident following significant rain events (i.e. over 20mm rain).

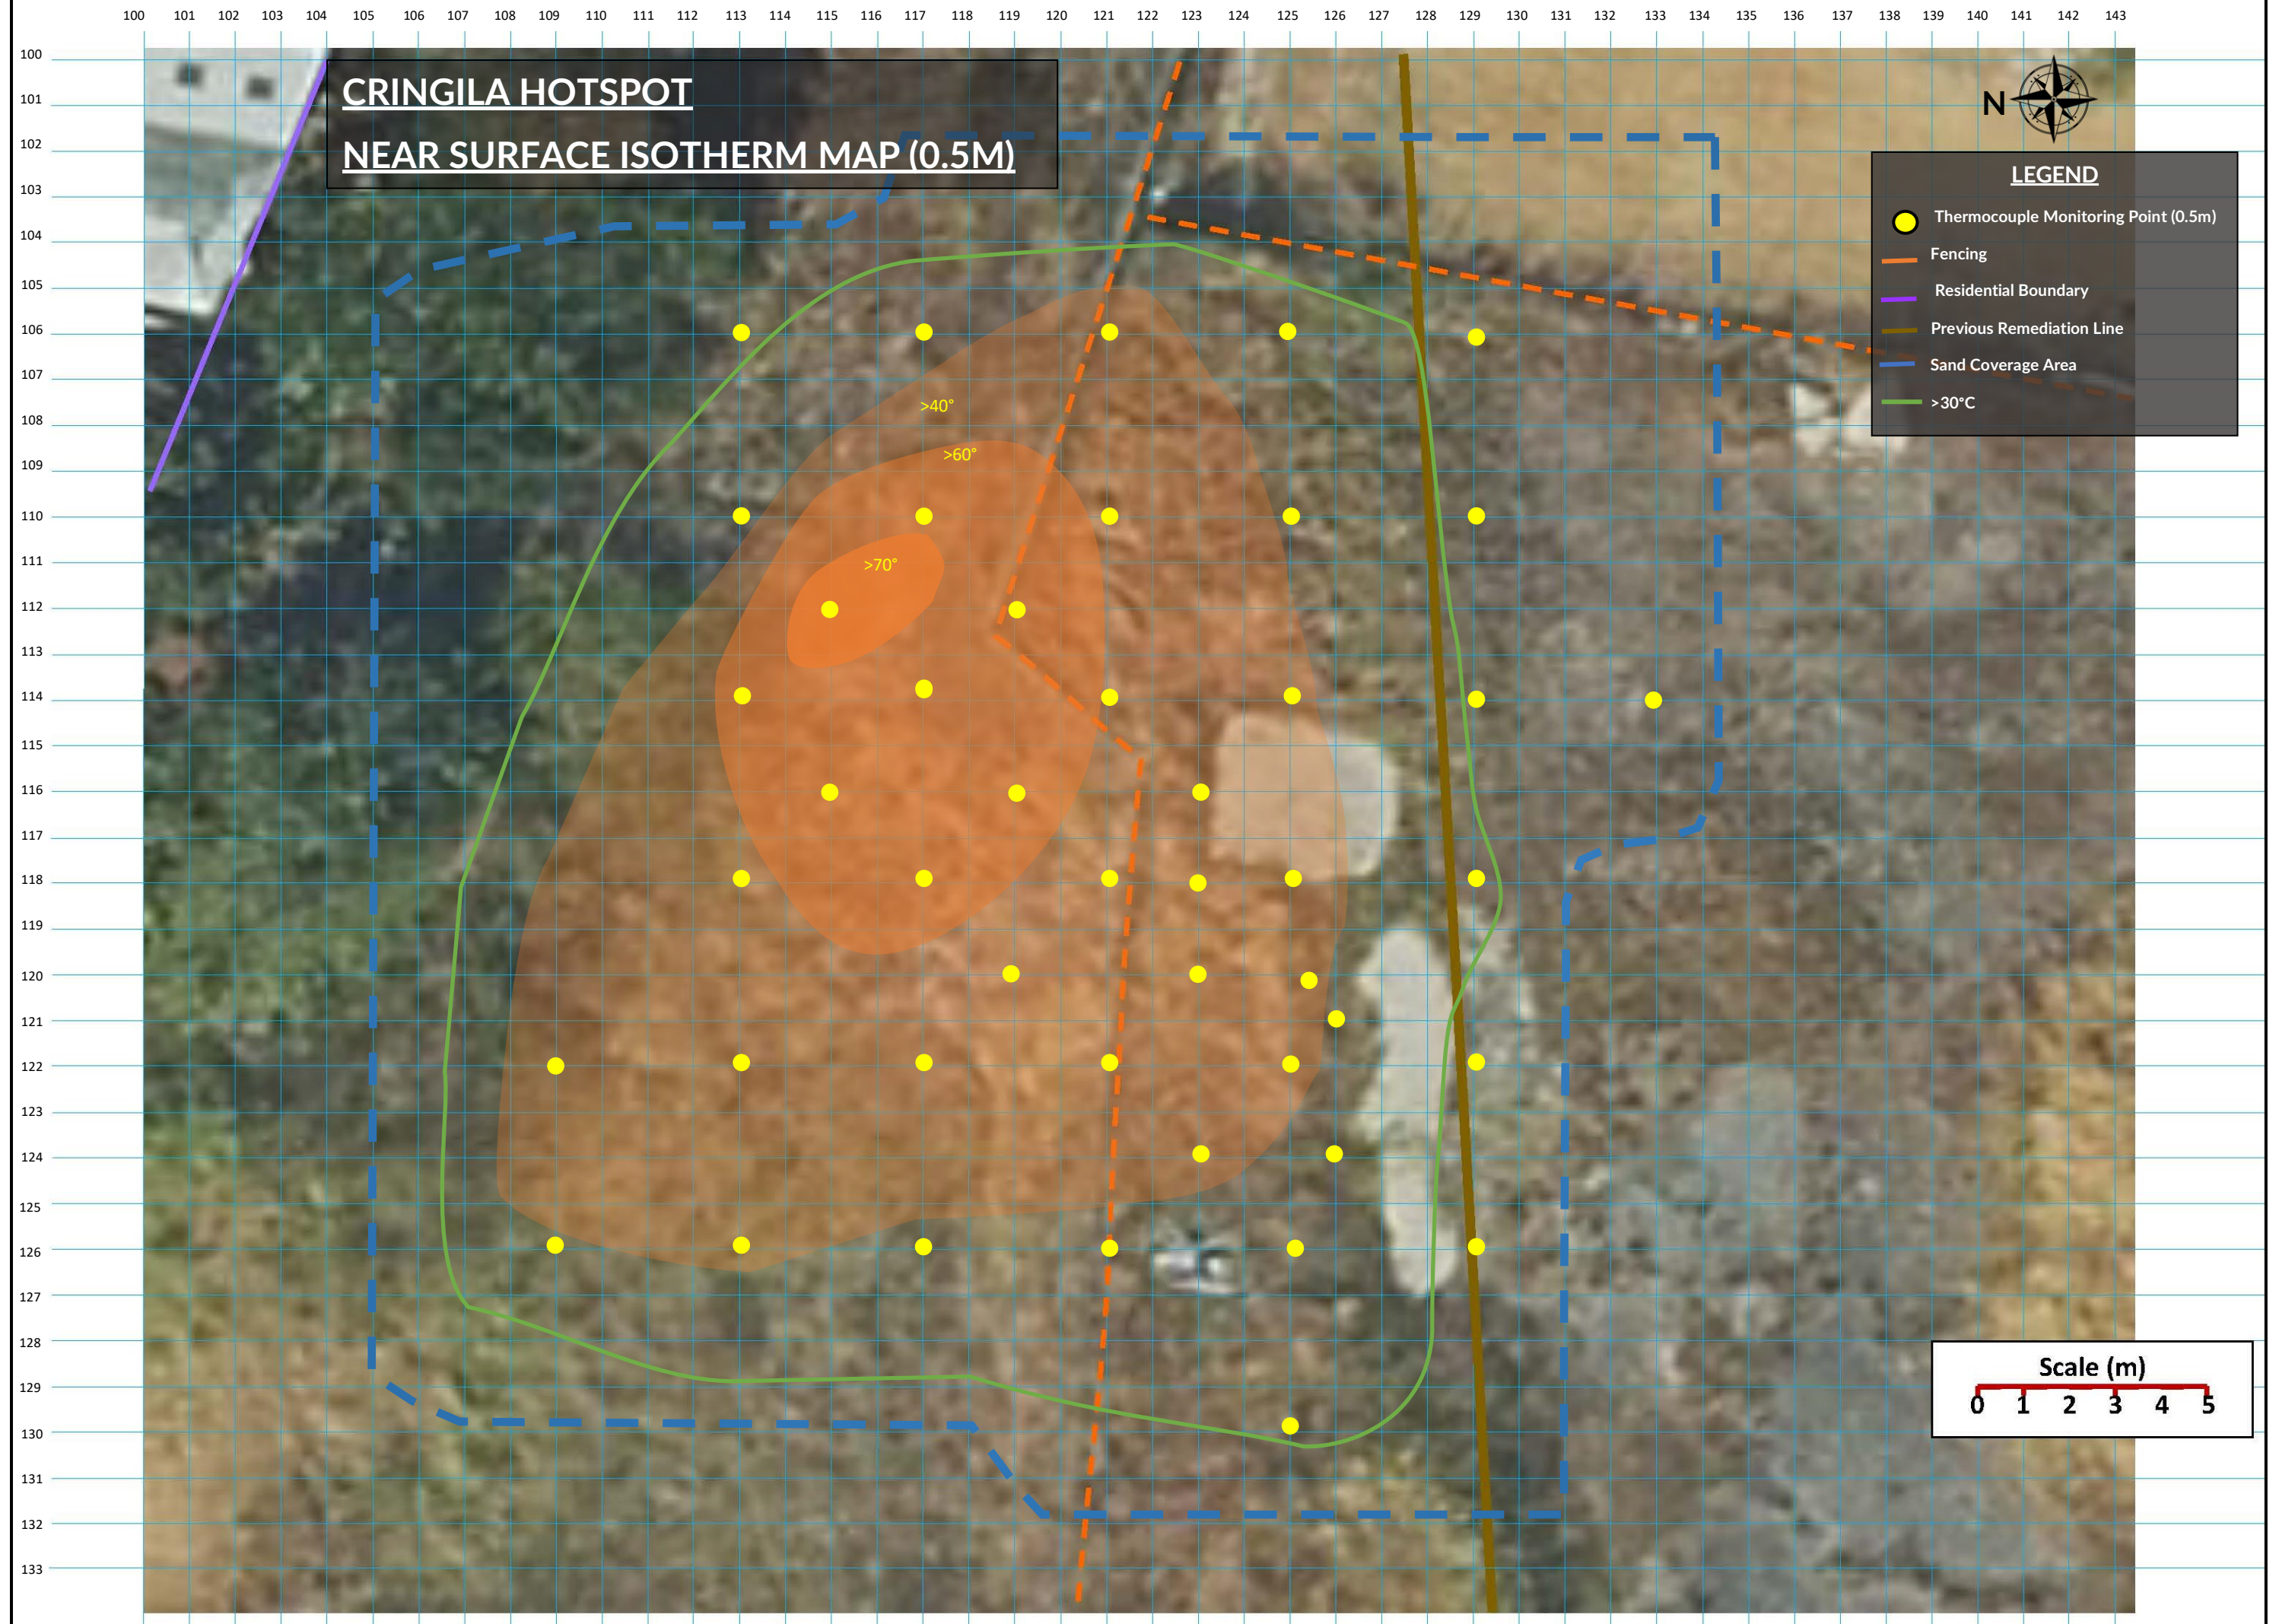
# CRINGILA HOTSPOT NEAR SURFACE ISOTHERM MAP (0.5M)

The isotherm map shows the general zone of influence for temperatures between 30°C and 75°C at 0.5m, coloured orange. The isotherm map suggests that the hotspot may extend deeper than 0.5m and that the increased temperature in these areas is a result of heat venting to the surface.

It is noted that temperature at the near-surface may be variable across the hotspot due to inconsistencies in the consolidation and compaction of subsurface materials.

The near-surface temperatures for representative monitoring locations, spread across the northwest Hotspot, are presented in the tables below. Temperature isotherms have been plotted on a site map to show an illustration of the near-surface temperatures in a spatial context. Refer to **Appendix B: Near Surface Temperature Isotherm Map (0.5m)**.
