## NEAR-SURFACE TEMPERATURE MONITORING INVESTIGATION CRINGILA PUBLIC SCHOOL - NW HOTSPOT

Summary Report  
27/07/2019 – 09/08/2019

NSW Department  
of Education  
Cringila Public School

35 Sheffield Street  
Cringila NSW 2502

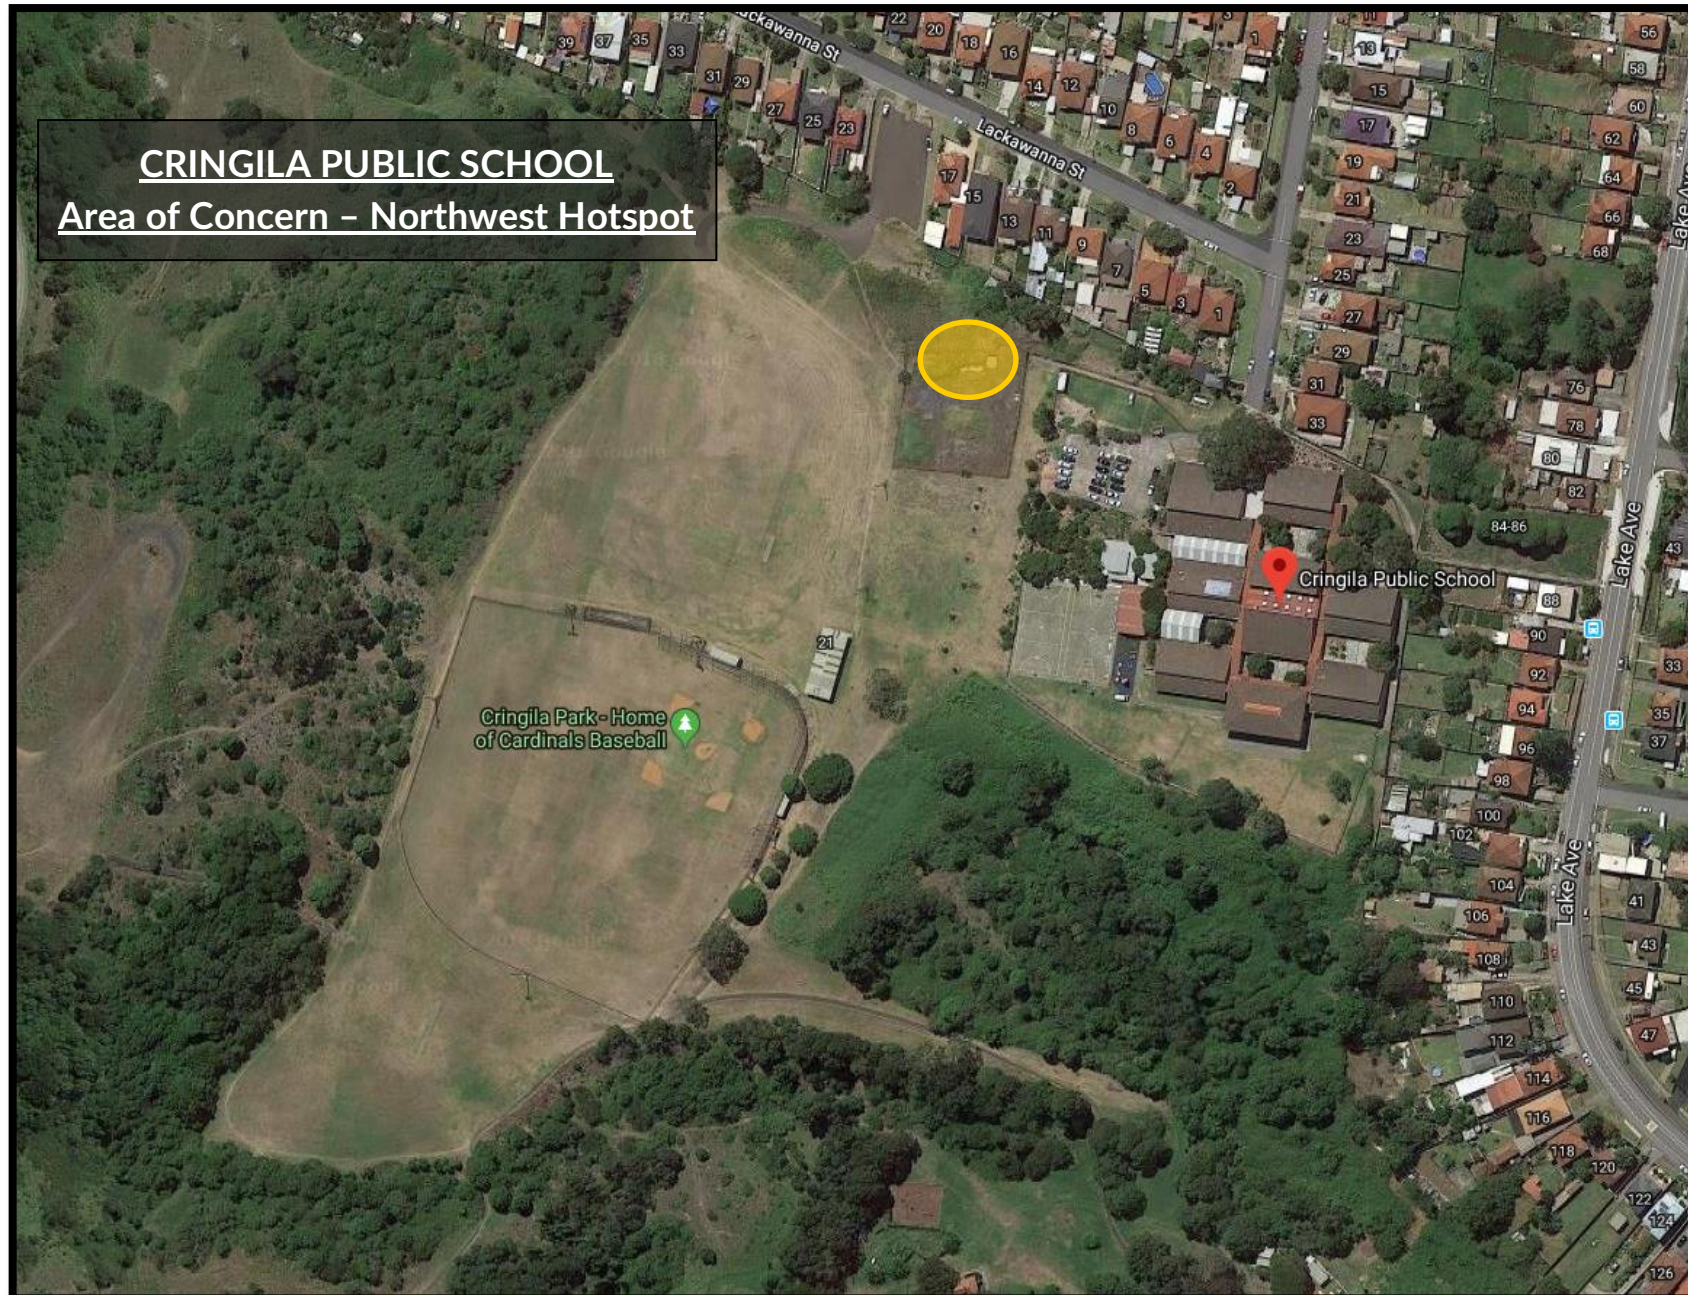
### Appendix A: Area of Concern – Northwest Hotspot Map

The near-surface temperature monitoring conducted between 27<sup>th</sup> July 2019 and 9<sup>th</sup> August 2019 indicates that the spatial extent of the northwest hotspot appears to remain localised.

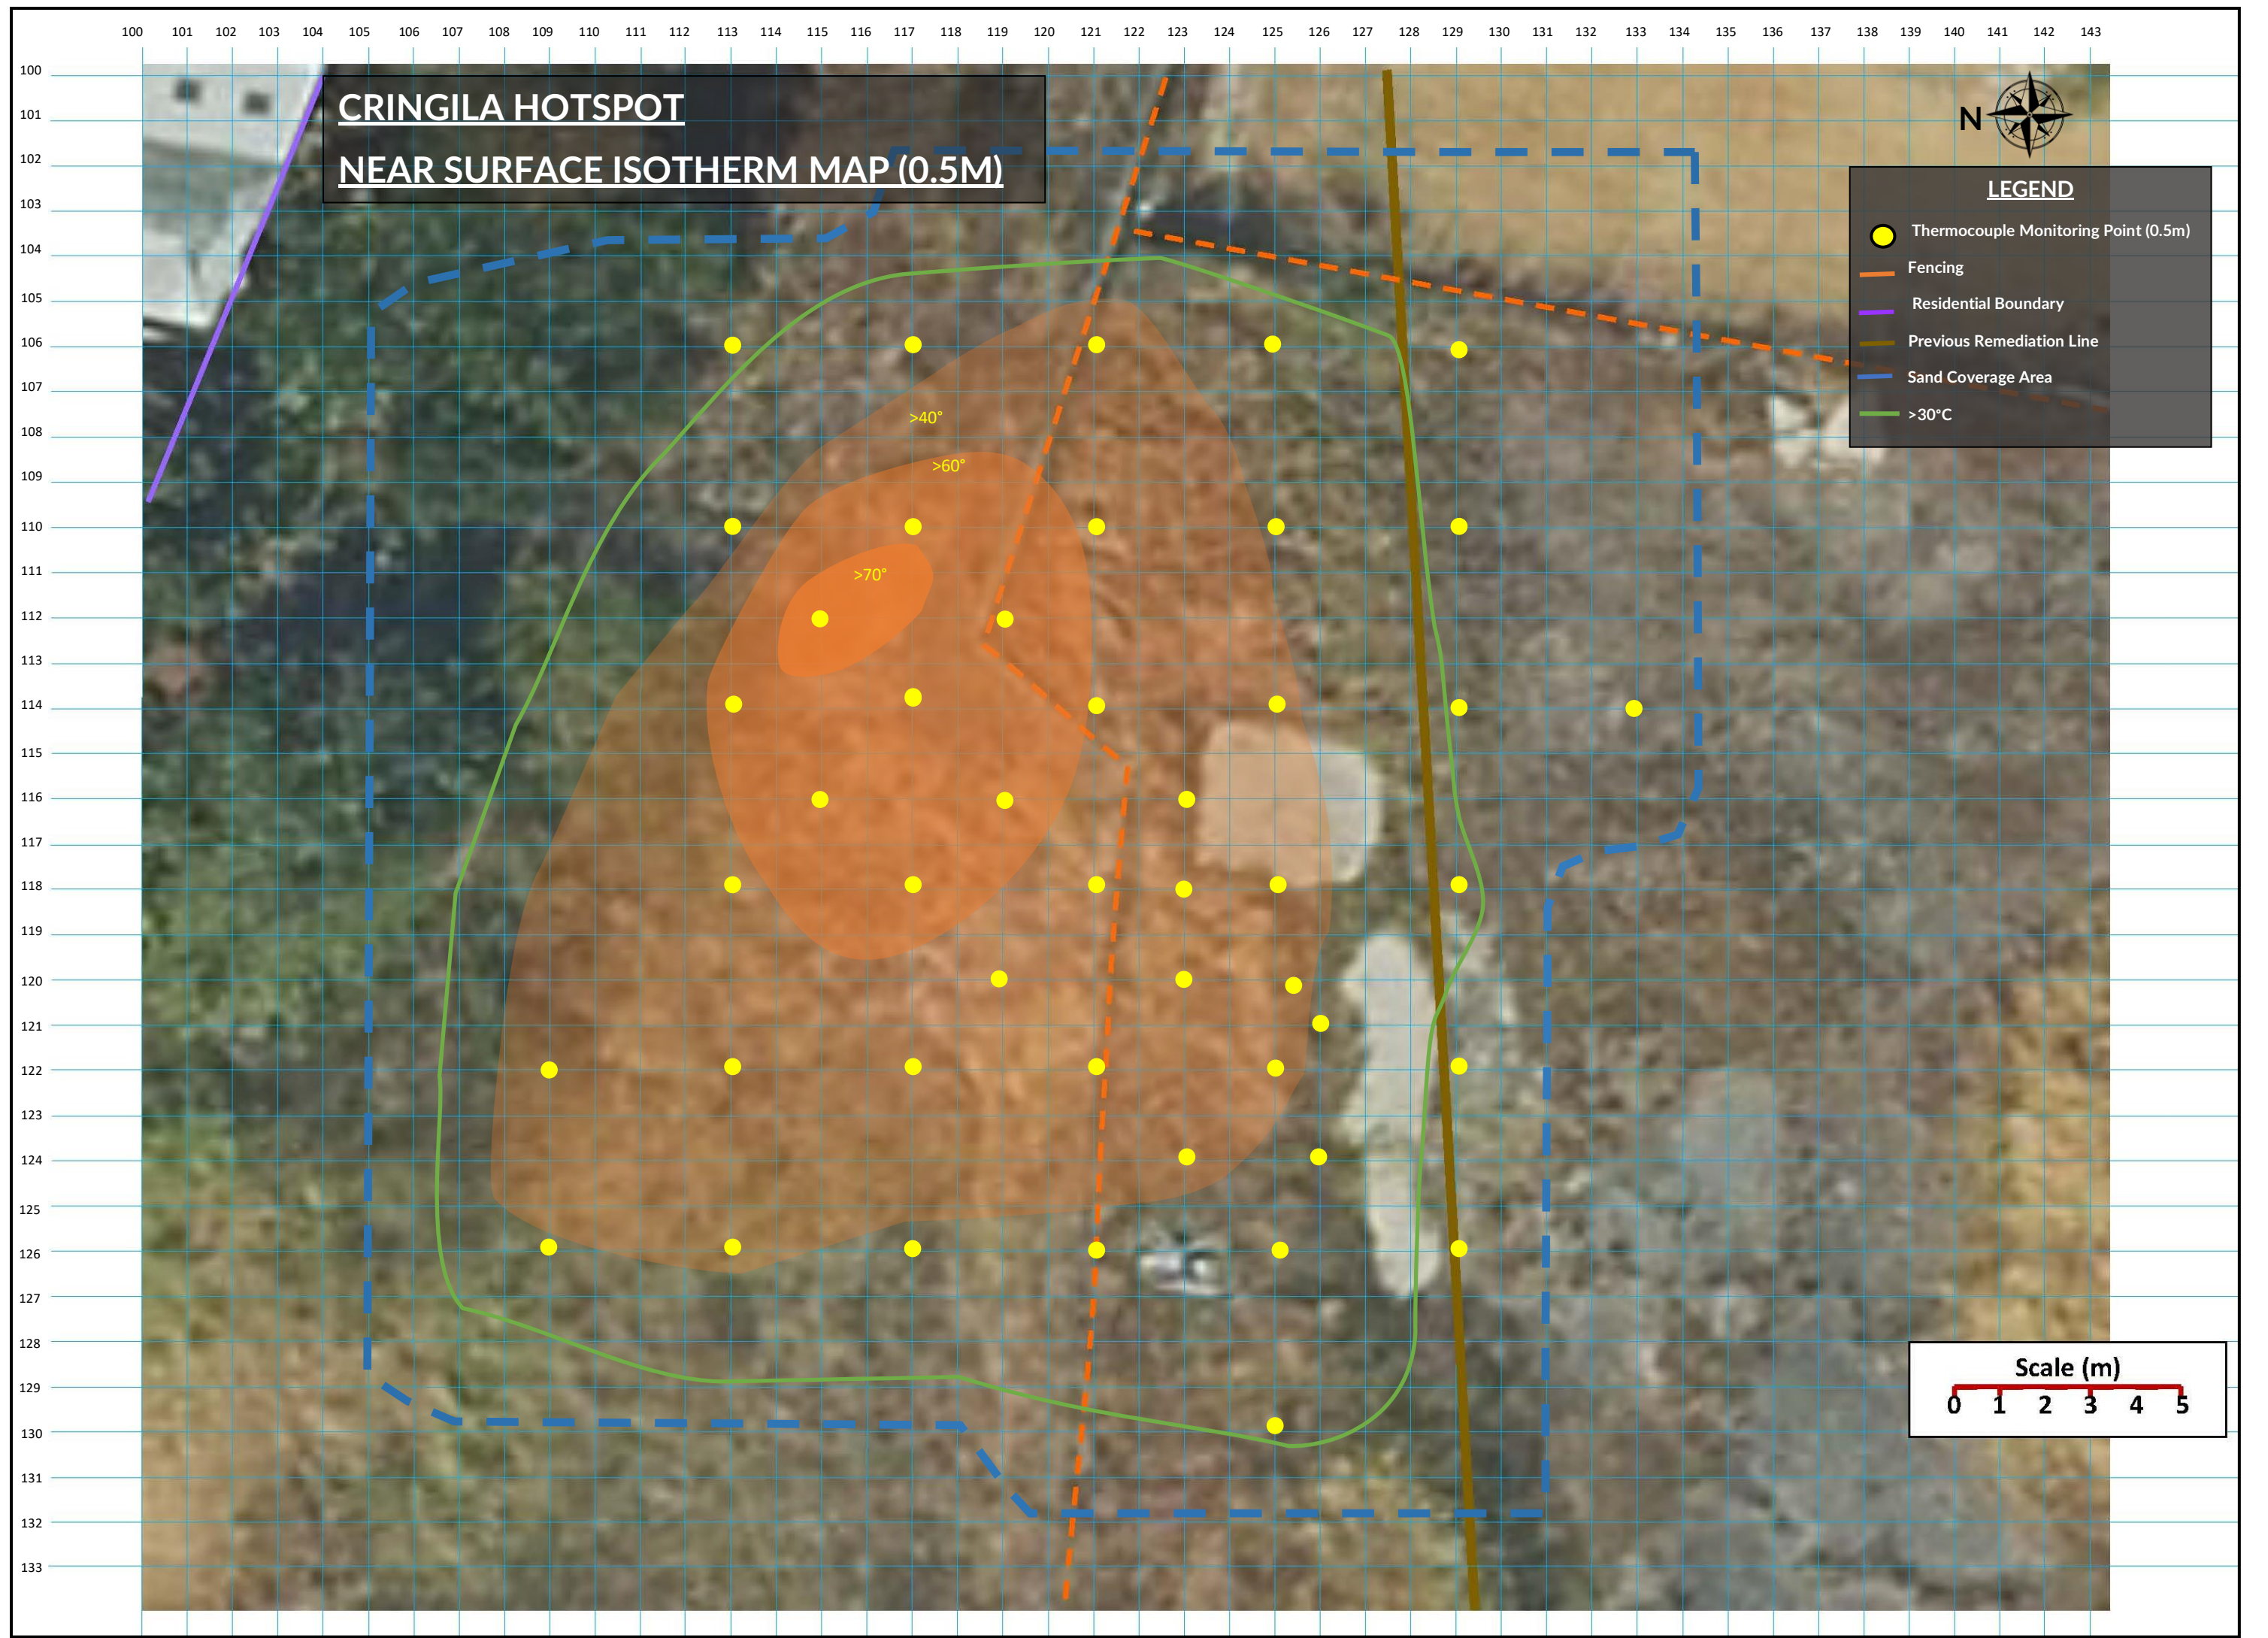
### Appendix B: Near-Surface Temperature Isotherm Map (0.5m)

The isotherm map shows the general zone of influence for temperatures between 30°C and 75°C at 0.5m, coloured orange. The isotherm map suggests that the hotspot may extend deeper than 0.5m and that the increased temperature in these areas is a result of heat venting to the surface.

It is noted that temperature at the near-surface may be variable across the hotspot due to inconsistencies in the consolidation and compaction of subsurface materials.

It is recommended that weekly site inspections and recording are continued to monitor the near-surface temperatures surrounding the subsurface hotspot identified at the site.
