MONTLY SITE INSPECTION REPORT

July 2019
J153825-03

NSW Department
of Education

Cringila Public School
35 Sheffield St, Cringila NSW 2502

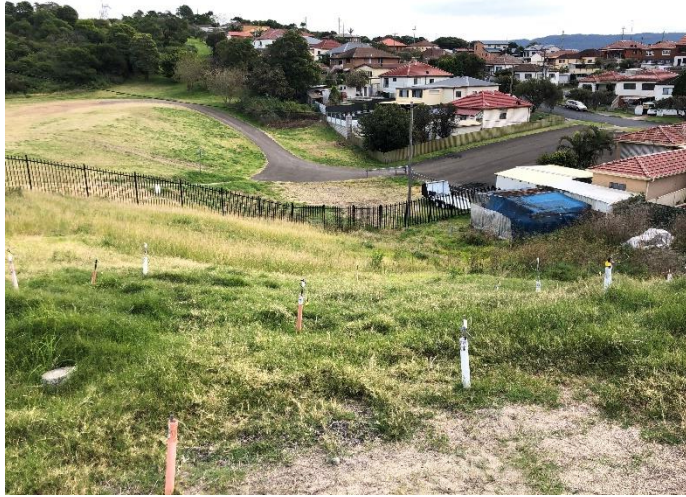
Picture 1 – Exclusion zone fencing surrounding north-western hotspot area

| Inspection Item | Yes | No | Action Required |
|---|---|---|---|
| <p>Was the exclusion zone fencing surrounding the north-western hotspot area intact?</p> | ✓ | | <p>Continue inspections of exclusion zone fencing on a weekly basis.</p> <p>If exclusion zone fencing is not intact, take a photo and mark the area of concern. Inform the School Principal.</p> |

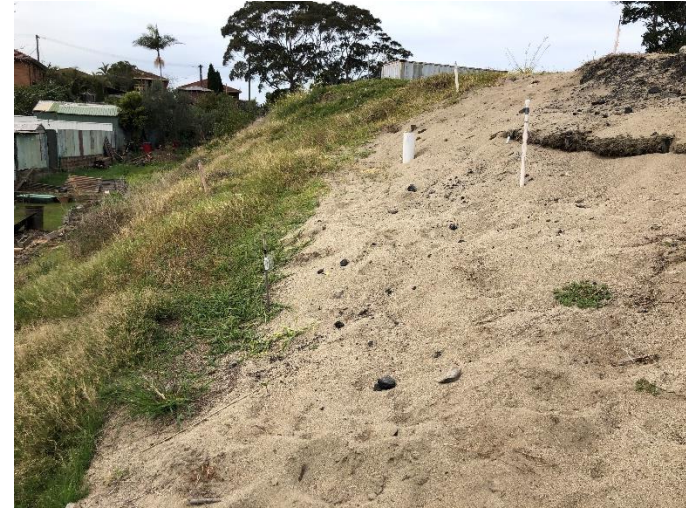
Picture 2 – Slope within north-western hotspot area

| Inspection Item | Yes | No | Action Required |
|---|---|---|---|
| <p>Was any evidence of subsidence or slope failure observed within the north-western hotspot area?</p> | | ✓ | <p>Continue inspections of north-western hotspot area on a weekly basis.</p> <p>If evidence of subsidence or slope failure is observed, take a photo and undertake spot monitoring for gases of concern. Inform the Greencap Project Managers (Sydney & Wollongong).</p> |

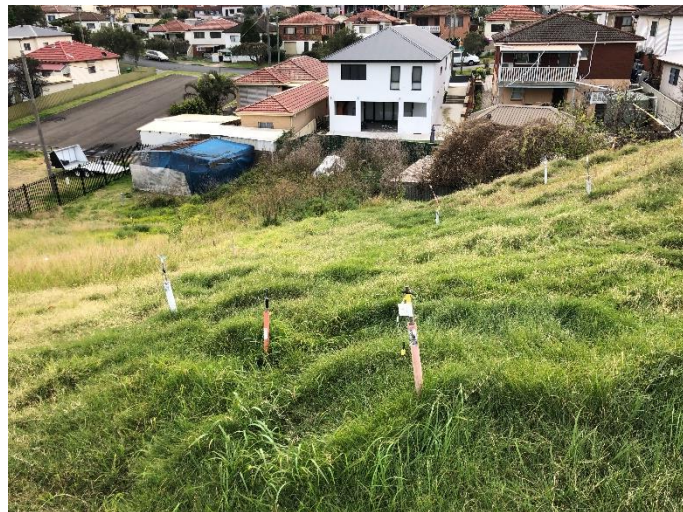
Picture 3 – Slope within north-western hotspot area

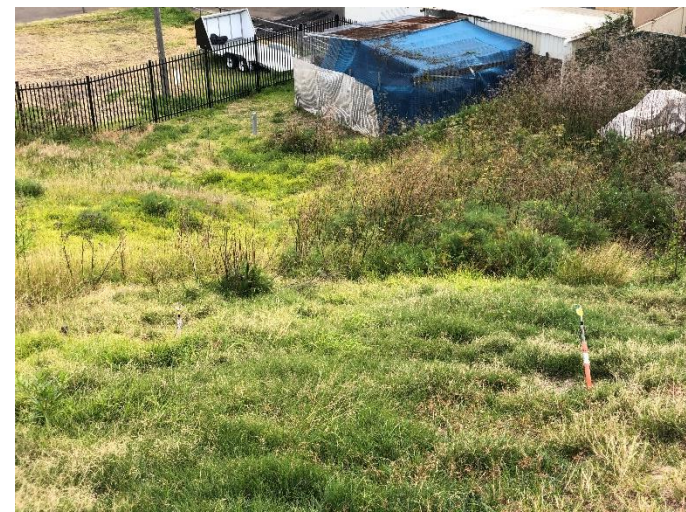
Picture 4 – Vegetation within north-western hotspot area

| Inspection Item | Yes | No | Action Required |
|---|---|---|---|
| <p>Was any evidence of deteriorating vegetation observed within the north-western hotspot area?</p> | | ✓ | <p>Continue inspections of north-western hotspot area on a weekly basis.</p> <p>If evidence of deteriorating vegetation is observed, take a photo and inform the Greencap Project Managers (Sydney & Wollongong).</p> |
