AIR MONITORING RISK ASSESSMENT - IAQ-03  
CRINGILA PUBLIC SCHOOL  
35 SHEFFIELD STREET  
CRINGILA NSW 2502

Summary Report  
26/08/2019 – 06/09/2019

Cringila Public School

September 2019  
C107471: J153825-03: RC

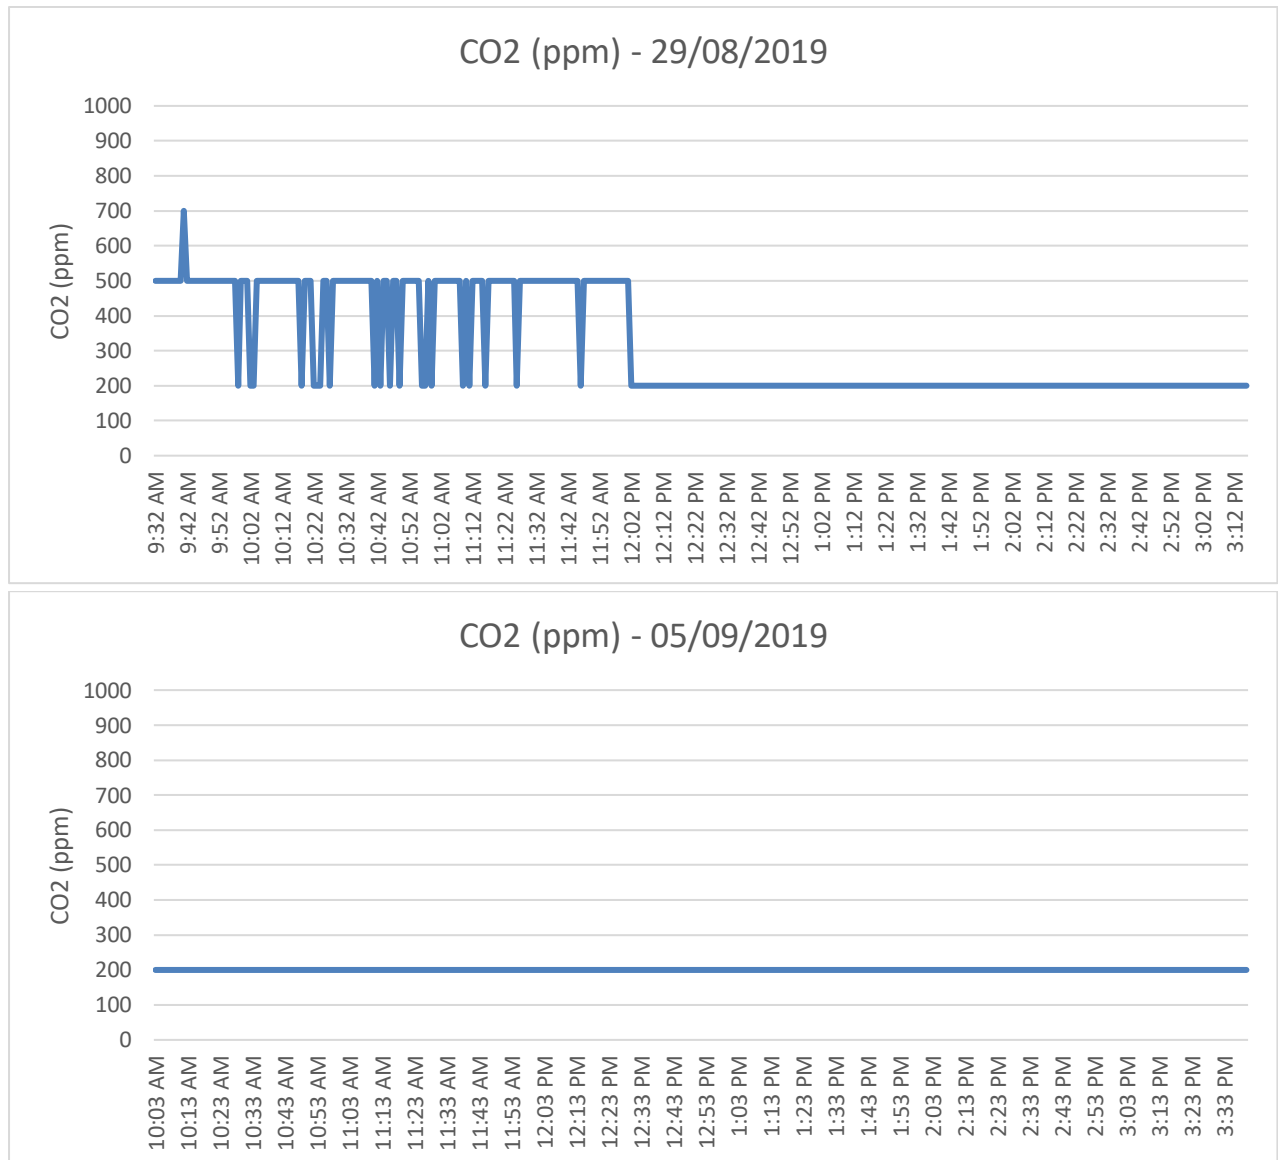
Figure 1: Carbon Dioxide (CO<sub>2</sub>) monitoring results

The Carbon Dioxide (CO<sub>2</sub>) concentration results for the monitoring conducted between 26<sup>th</sup> August & 6<sup>th</sup> September 2019 is summarised below in **Figure 1**. Monitoring locations are displayed in **Appendix A: Site Map and Sampling Locations**.

Generally, the peak monitoring results for CO<sub>2</sub> within the Reception Area (Room 6R0021) at Cringila Public School ranged between 200ppm and 700ppm during the periods of monitoring. All results were below the ASHRAE guideline level of 1,000 ppm.

This concludes the indoor air quality monitoring summary report for monitoring conducted between 26<sup>th</sup> August & 6<sup>th</sup> September 2019. It is recommended that weekly assessments are continued in order to gain firm and reliable data sets regarding the concentration of CO<sub>2</sub> and CO within indoor environments at the school whilst further investigation of the site is undertaken.

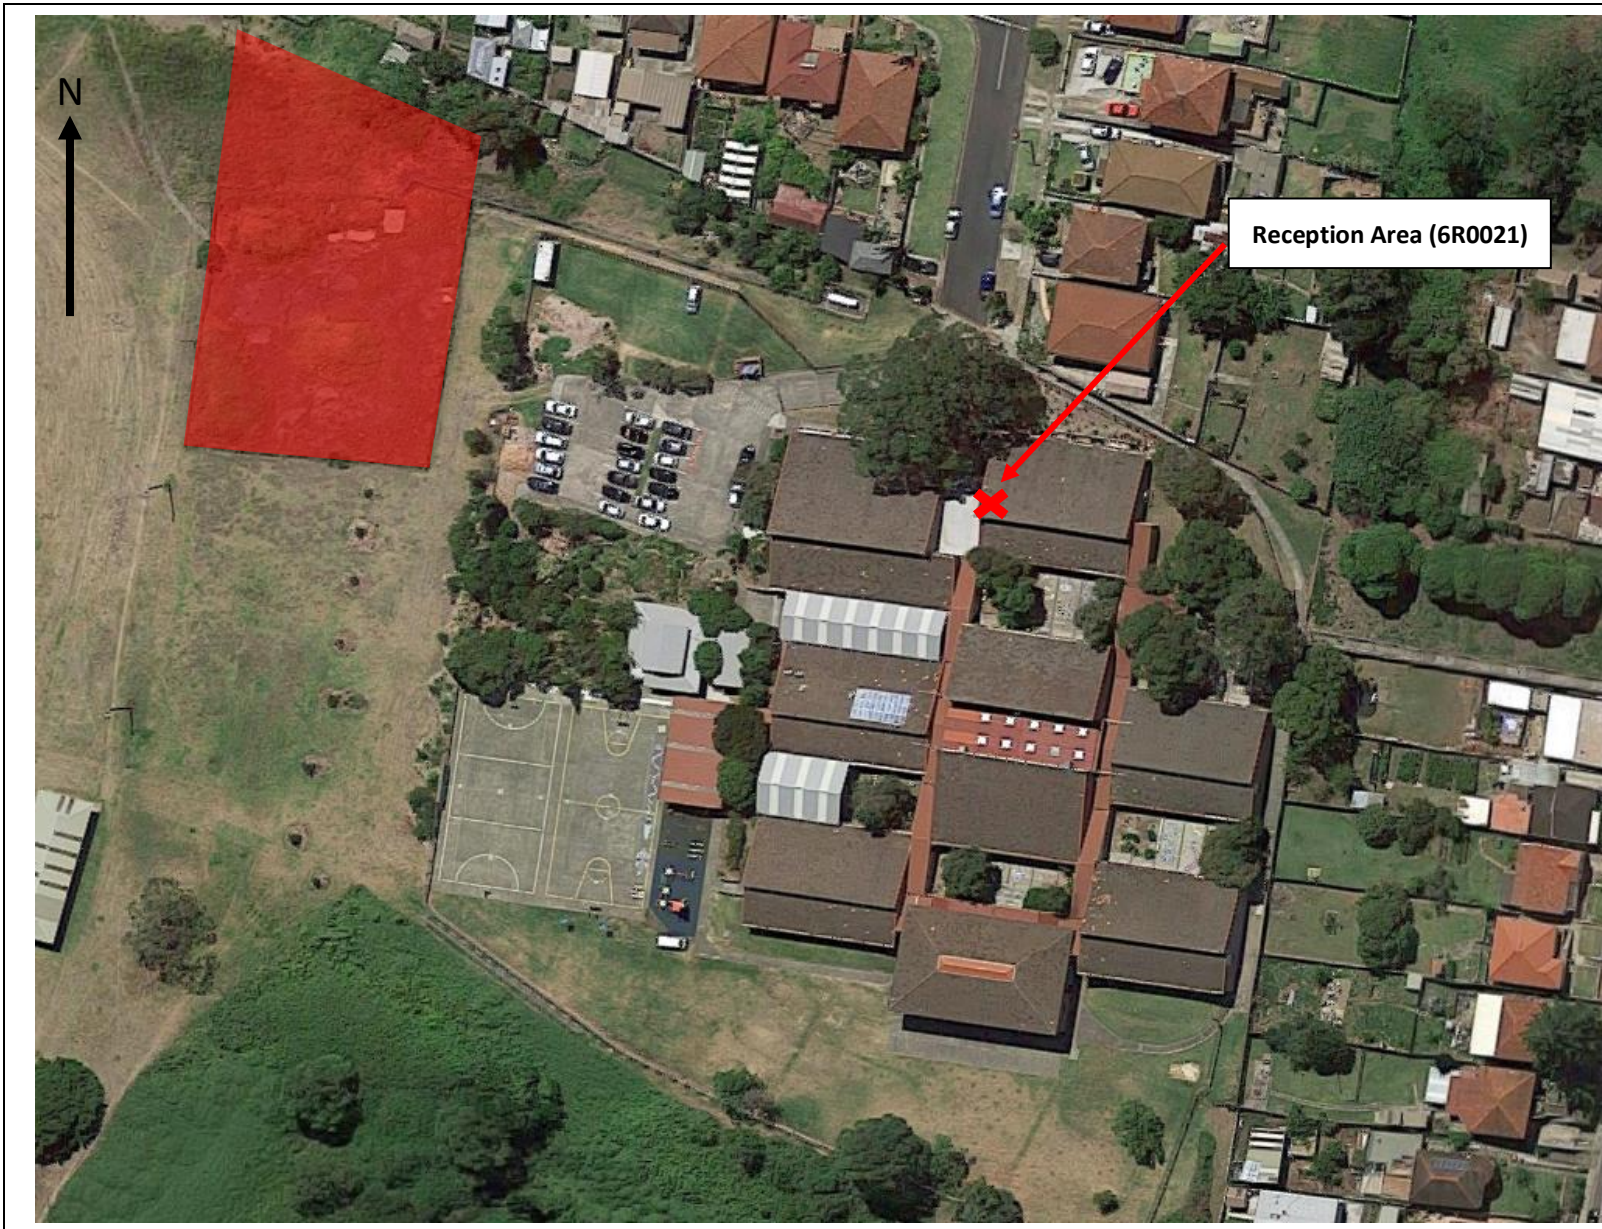
### Appendix A: Site Map and Sampling Locations

Site	Cringila Public School
Monitoring Location	Reception Area (6R0021)
Consultant	Rowan Clark
Date	26 <sup>th</sup> August - 6 <sup>th</sup> September 2019
Job Number	J153825-03
Report	AMR-IAQ-05
Version	1.0
