AIR MONITORING RISK ASSESSMENT - IAQ-06  
CRINGILA PUBLIC SCHOOL  
35 SHEFFIELD STREET  
CRINGILA NSW 2502

Summary Report  
09/09/2019 – 20/09/2019

Cringila Public School

September 2019  
C107471: J153825-03: RC

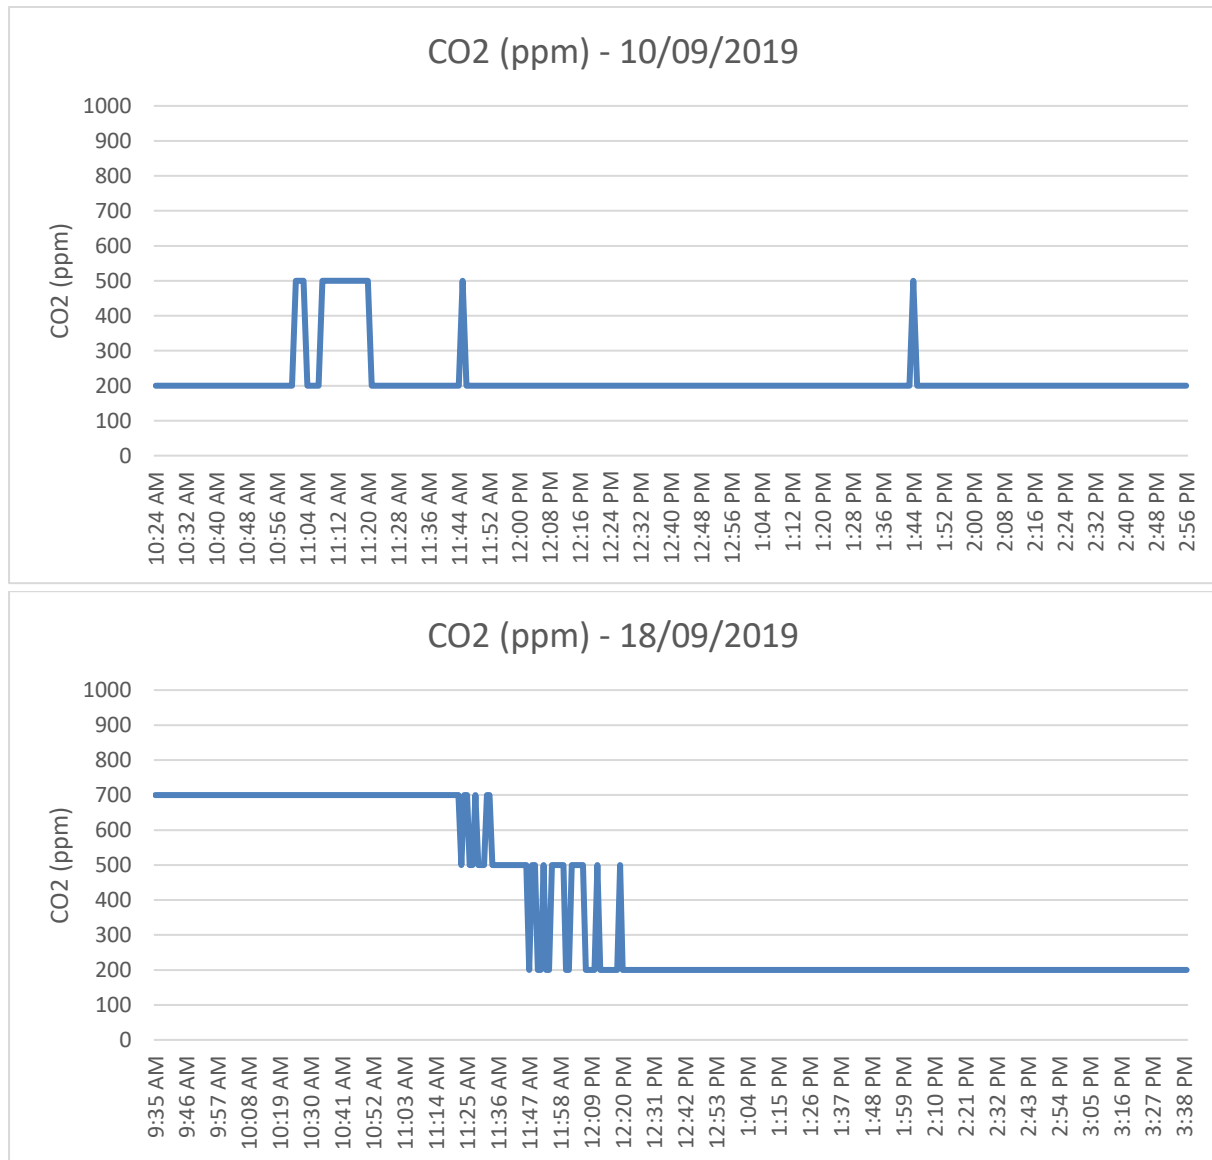
Figure 1: Carbon Dioxide (CO<sub>2</sub>) monitoring results

The Carbon Dioxide (CO<sub>2</sub>) concentration results for the monitoring conducted between 9<sup>th</sup> September & 20<sup>th</sup> September 2019 is summarised below in **Figure 1**. Monitoring locations are displayed in **Appendix A: Site Map and Sampling Locations**.

Generally, the peak monitoring results for CO<sub>2</sub> within the Reception Area (Room 6R0021) at Cringila Public School ranged between 200ppm and 700ppm during the periods of monitoring. All results were below the ASHRAE guideline level of 1,000 ppm.

This concludes the indoor air quality monitoring summary report for monitoring conducted between 9<sup>th</sup> September & 20<sup>th</sup> September 2019. It is recommended that weekly assessments are continued in order to gain firm and reliable data sets regarding the concentration of CO<sub>2</sub> and CO within indoor environments at the school whilst further investigation of the site is undertaken.

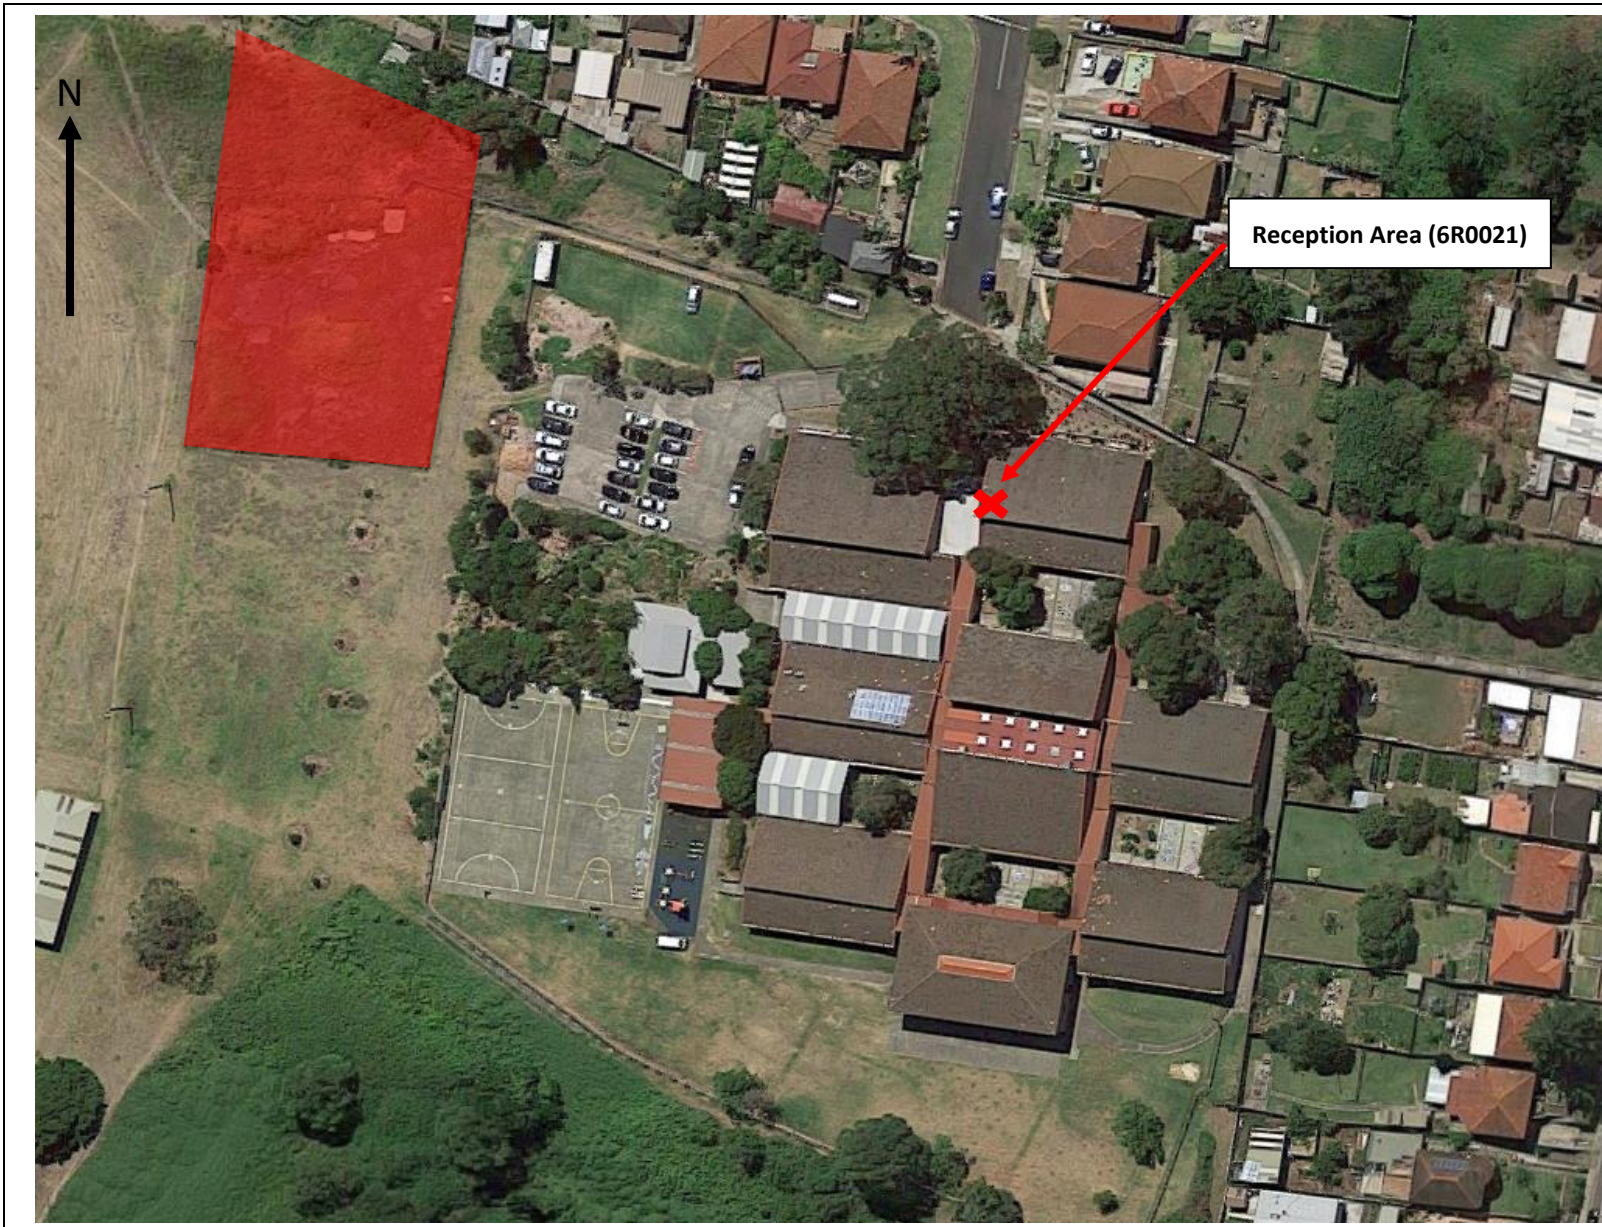
### **Appendix A: Site Map and Sampling Locations**

- ✕ Air Quality Monitoring Location
- North West Hotspot Investigation Area

Site	Cringila Public School
Monitoring Location	Reception Area (6R0021)
Consultant	Rowan Clark
Date	9 <sup>th</sup> September – 20 <sup>th</sup> September 2019
Job Number	J153825-03
Report	AMR-IAQ-06
Version	1.0
