AIR MONITORING RISK ASSESSMENT - IAQ-06
CRINGILA PUBLIC SCHOOL
35 SHEFFIELD STREET
CRINGILA NSW 2502

Summary Report 23/09/2019 - 04/10/2019

Cringila Public School

October 2019

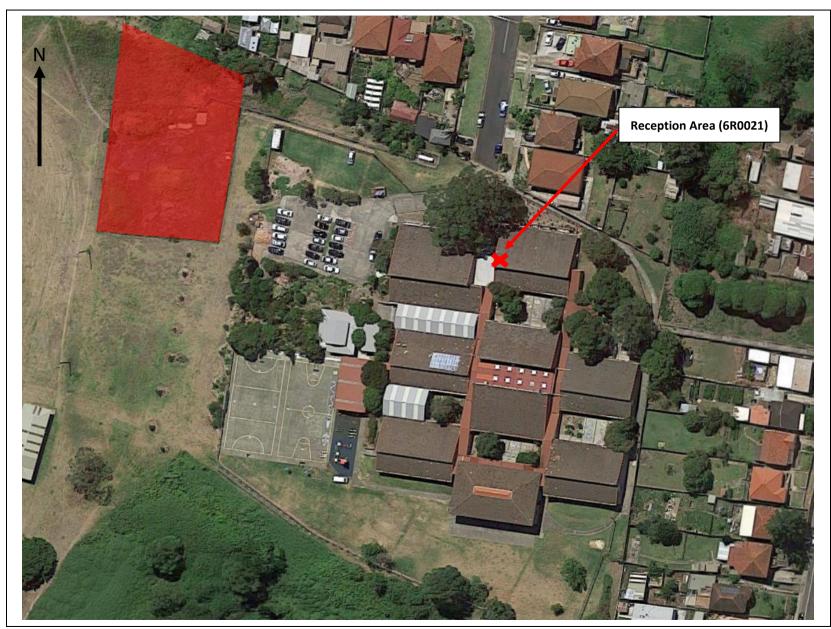
Appendix A: Site Map and Sampling Locations

Air Quality Monitoring Location

Site	Cringila Public School
Monitoring ∟ocation	Reception Area (6R0021)
Consultant	Tom Oyston
Date	23 rd September - 4 th October 2019
lob Number	J153825-03
Report	AMR-IAQ-07
Version	1.0
