AIR MONITORING RISK ASSESSMENT - IAQ-10  
CRINGILA PUBLIC SCHOOL  
35 SHEFFIELD STREET  
CRINGILA NSW 2502

Summary Report  
04/11/2019 – 15/11/2019

Cringila Public School

November 2019  
C107471: J153825-03: TO

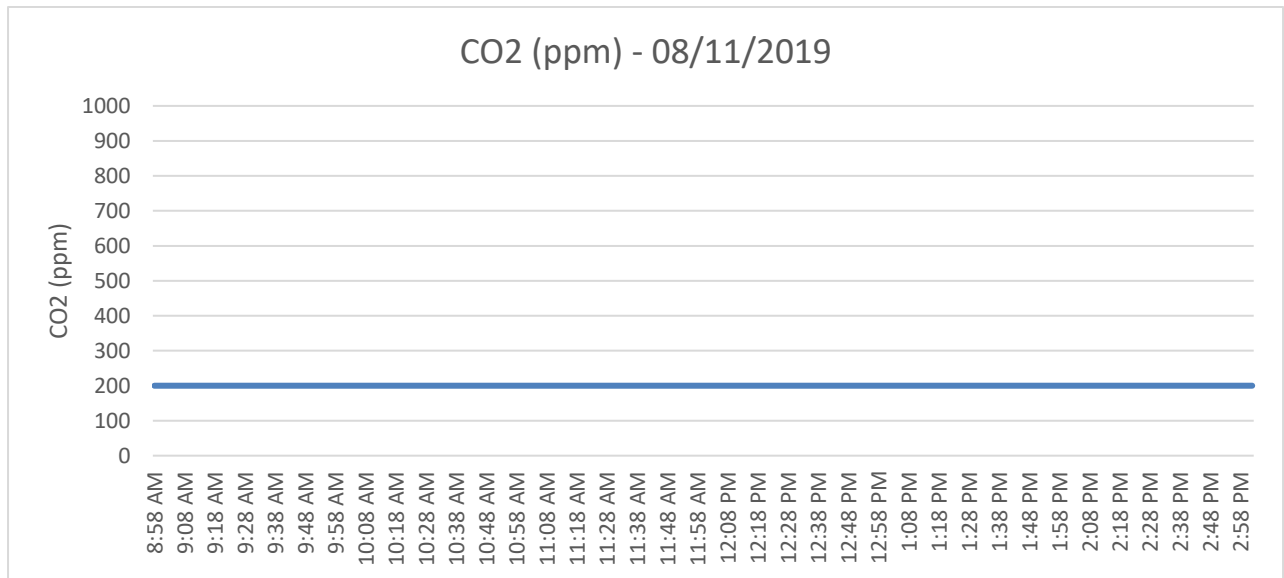
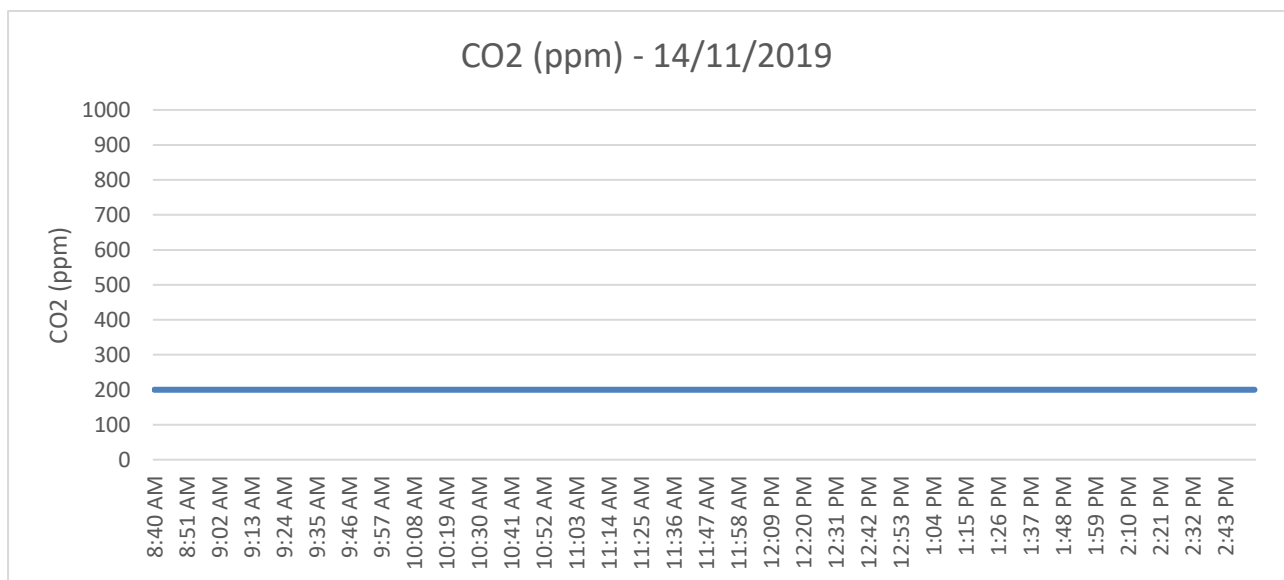
Figure 1: Carbon Dioxide (CO<sub>2</sub>) monitoring results

The Carbon Dioxide (CO<sub>2</sub>) concentration results for the monitoring conducted between 4<sup>th</sup> November 2019 and 15<sup>th</sup> November 2019 is summarised below in **Figure 1**. Monitoring locations are displayed in **Appendix A: Site Map and Sampling Locations**.

The monitoring results for CO<sub>2</sub> within the Reception Area (Room 6R0021) at Cringila Public School were consistently 200ppm during the period of monitoring. All results were below the ASHRAE guideline level of 1,000 ppm.

This concludes the indoor air quality monitoring summary report for monitoring conducted between 4<sup>th</sup> November 2019 and 15<sup>th</sup> November 2019. It is recommended that weekly assessments are continued in order to gain firm and reliable data sets regarding the concentration of CO<sub>2</sub> and CO within indoor environments at the school whilst further investigation of the site is undertaken.

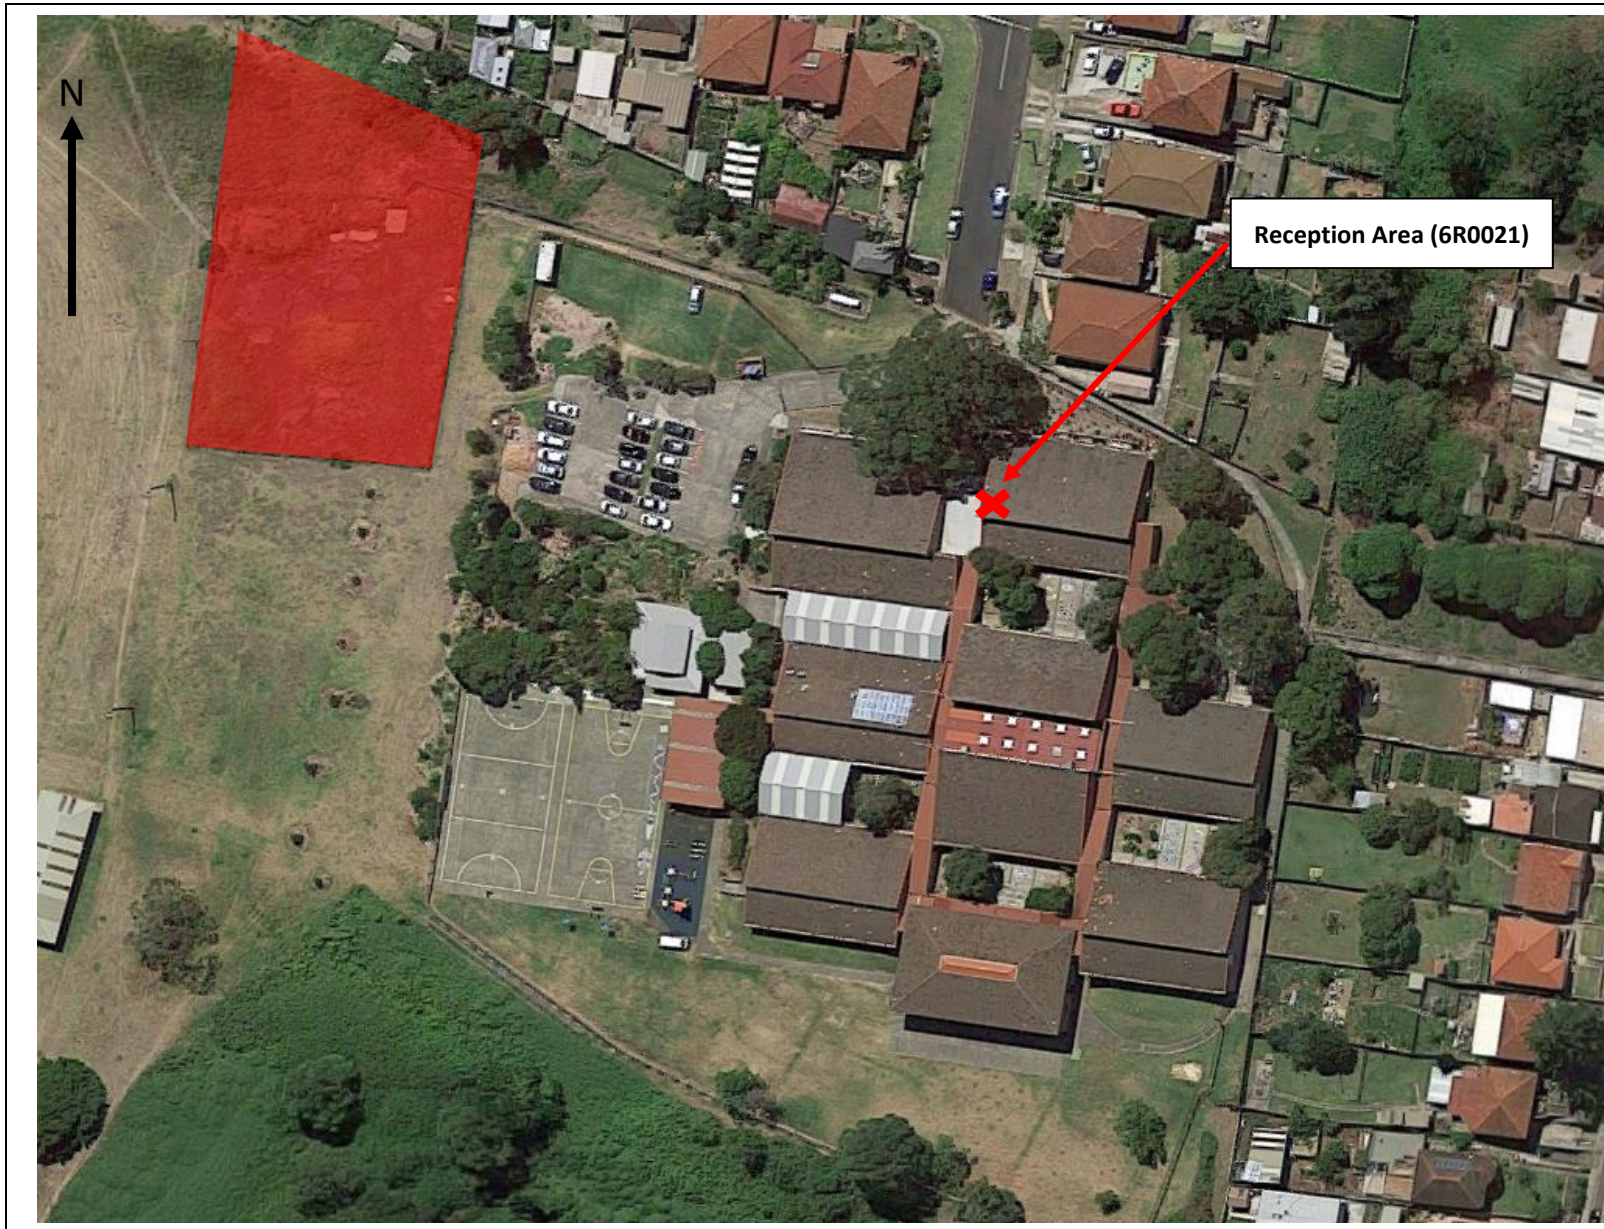
### **Appendix A: Site Map and Sampling Locations**

- ✕ Air Quality Monitoring Location
- North West Hotspot Investigation Area

Site	Cringila Public School
Monitoring Location	Reception Area (6R0021)
Consultant	Tom Oyston
Date	4 <sup>th</sup> November 2019 – 15 <sup>th</sup> November 2019
Job Number	J153825-03
Report	AMR-IAQ-10
Version	1.0
