NEAR-SURFACE TEMPERATURE MONITORING INVESTIGATION CRINGILA PUBLIC SCHOOL - NW HOTSPOT

Summary Report
26/08/2019 – 06/09/2019

NSW Department
of Education
Cringila Public School

September 2019
C107471: J153825-03: TO/RC

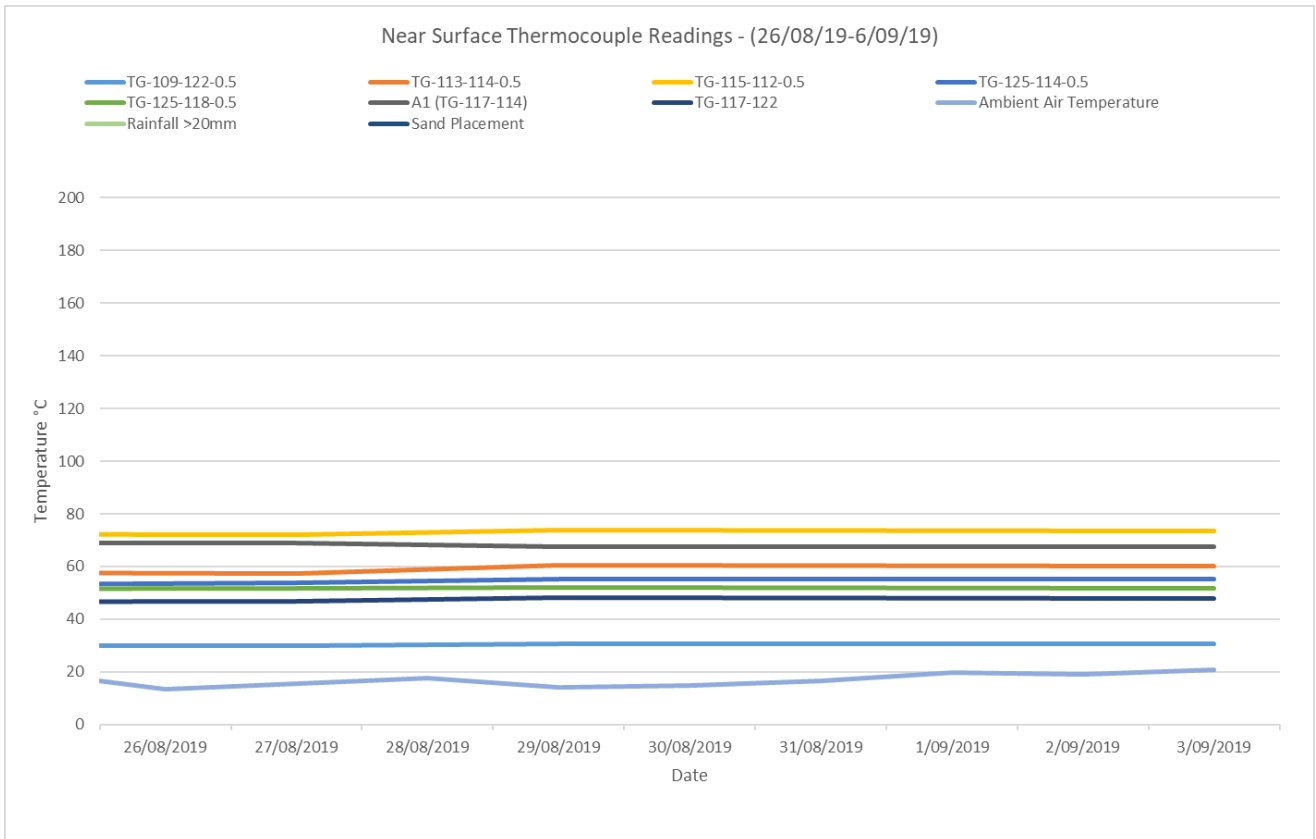
3.2. Near-Surface Temperature Graph – Selected Points (Fortnightly)

Near-surface temperature measurements for key thermocouple locations, over the monitoring period – 26th August 2019 and 6th September 2019.

The near-surface temperature at selected points across the northwest hotspot over the period of monitoring appear to remain consistent.

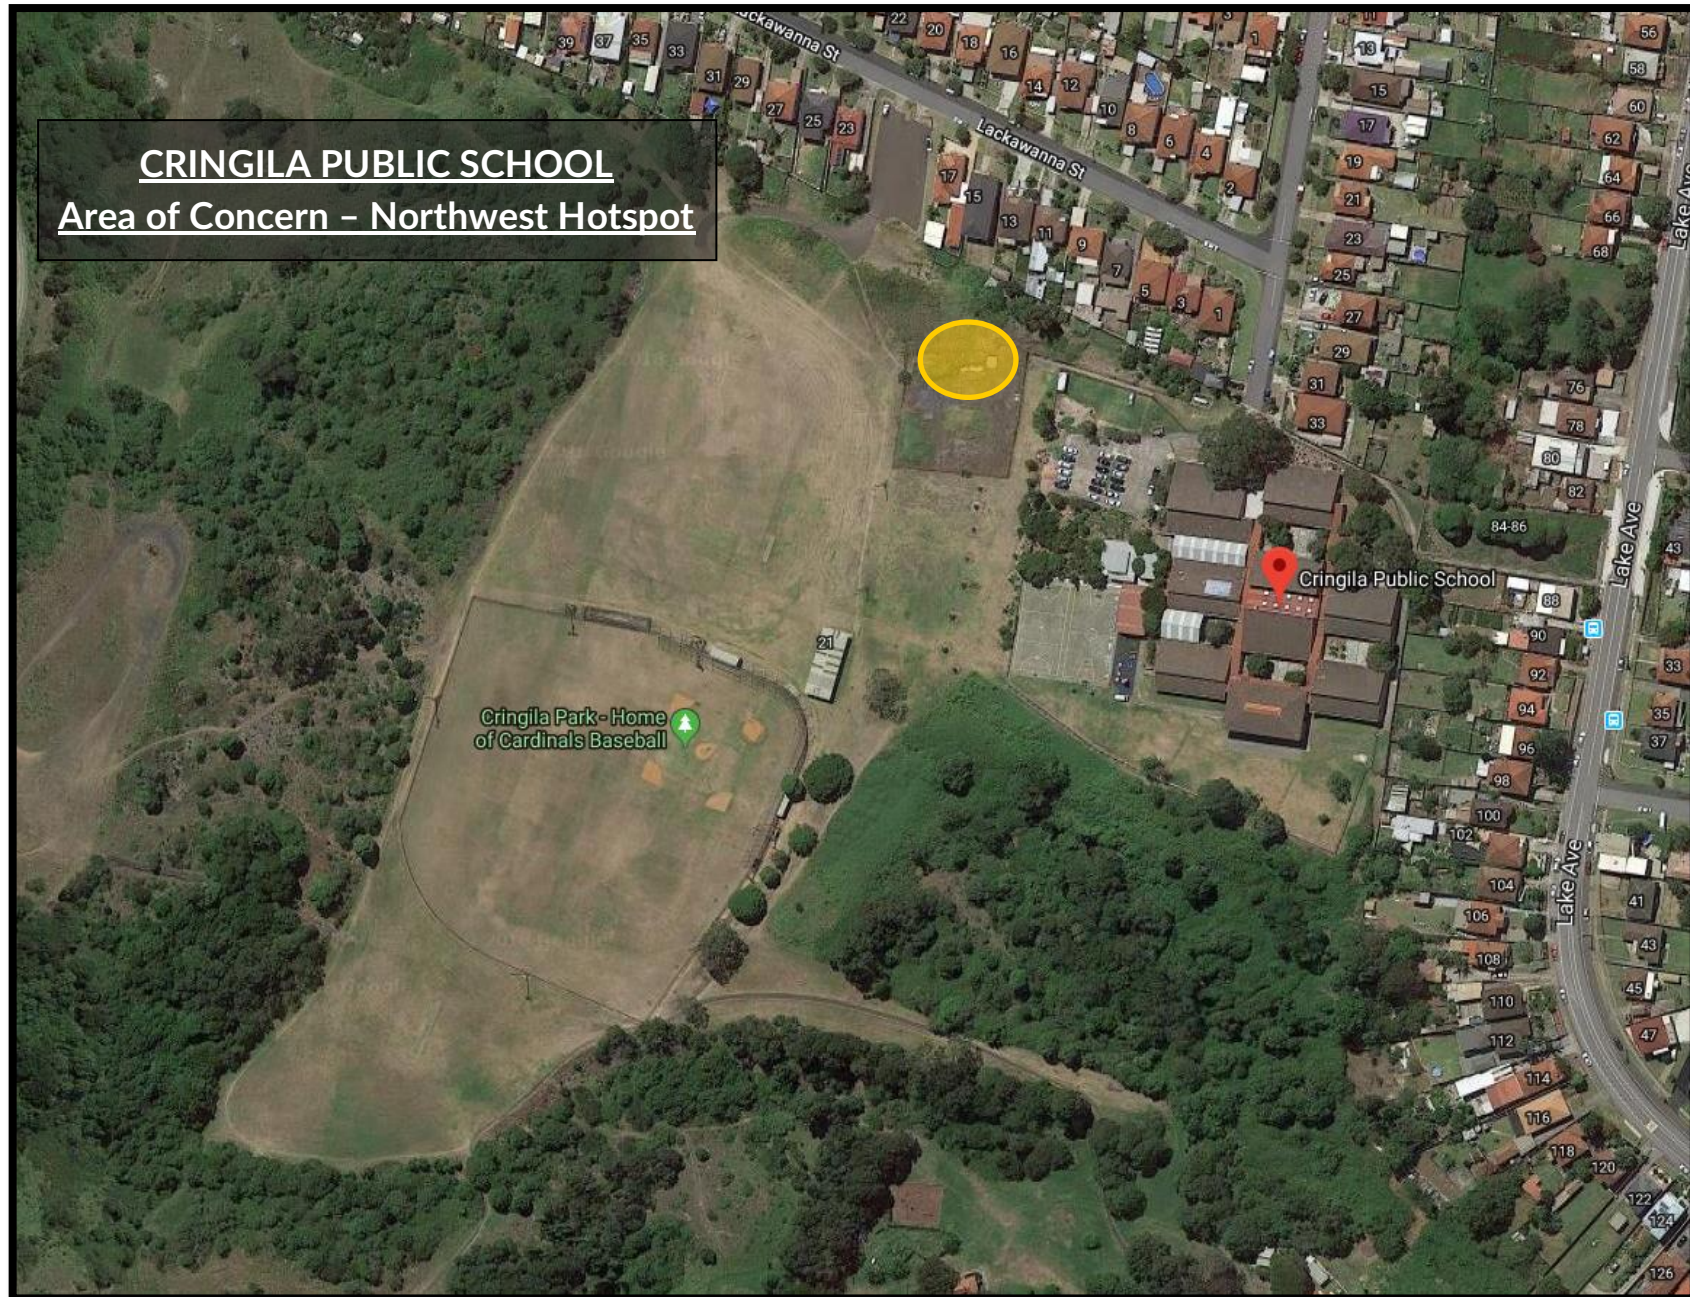
Appendix A: Area of Concern – Northwest Hotspot Map

CRINGILA PUBLIC SCHOOL
Area of Concern - Northwest Hotspot

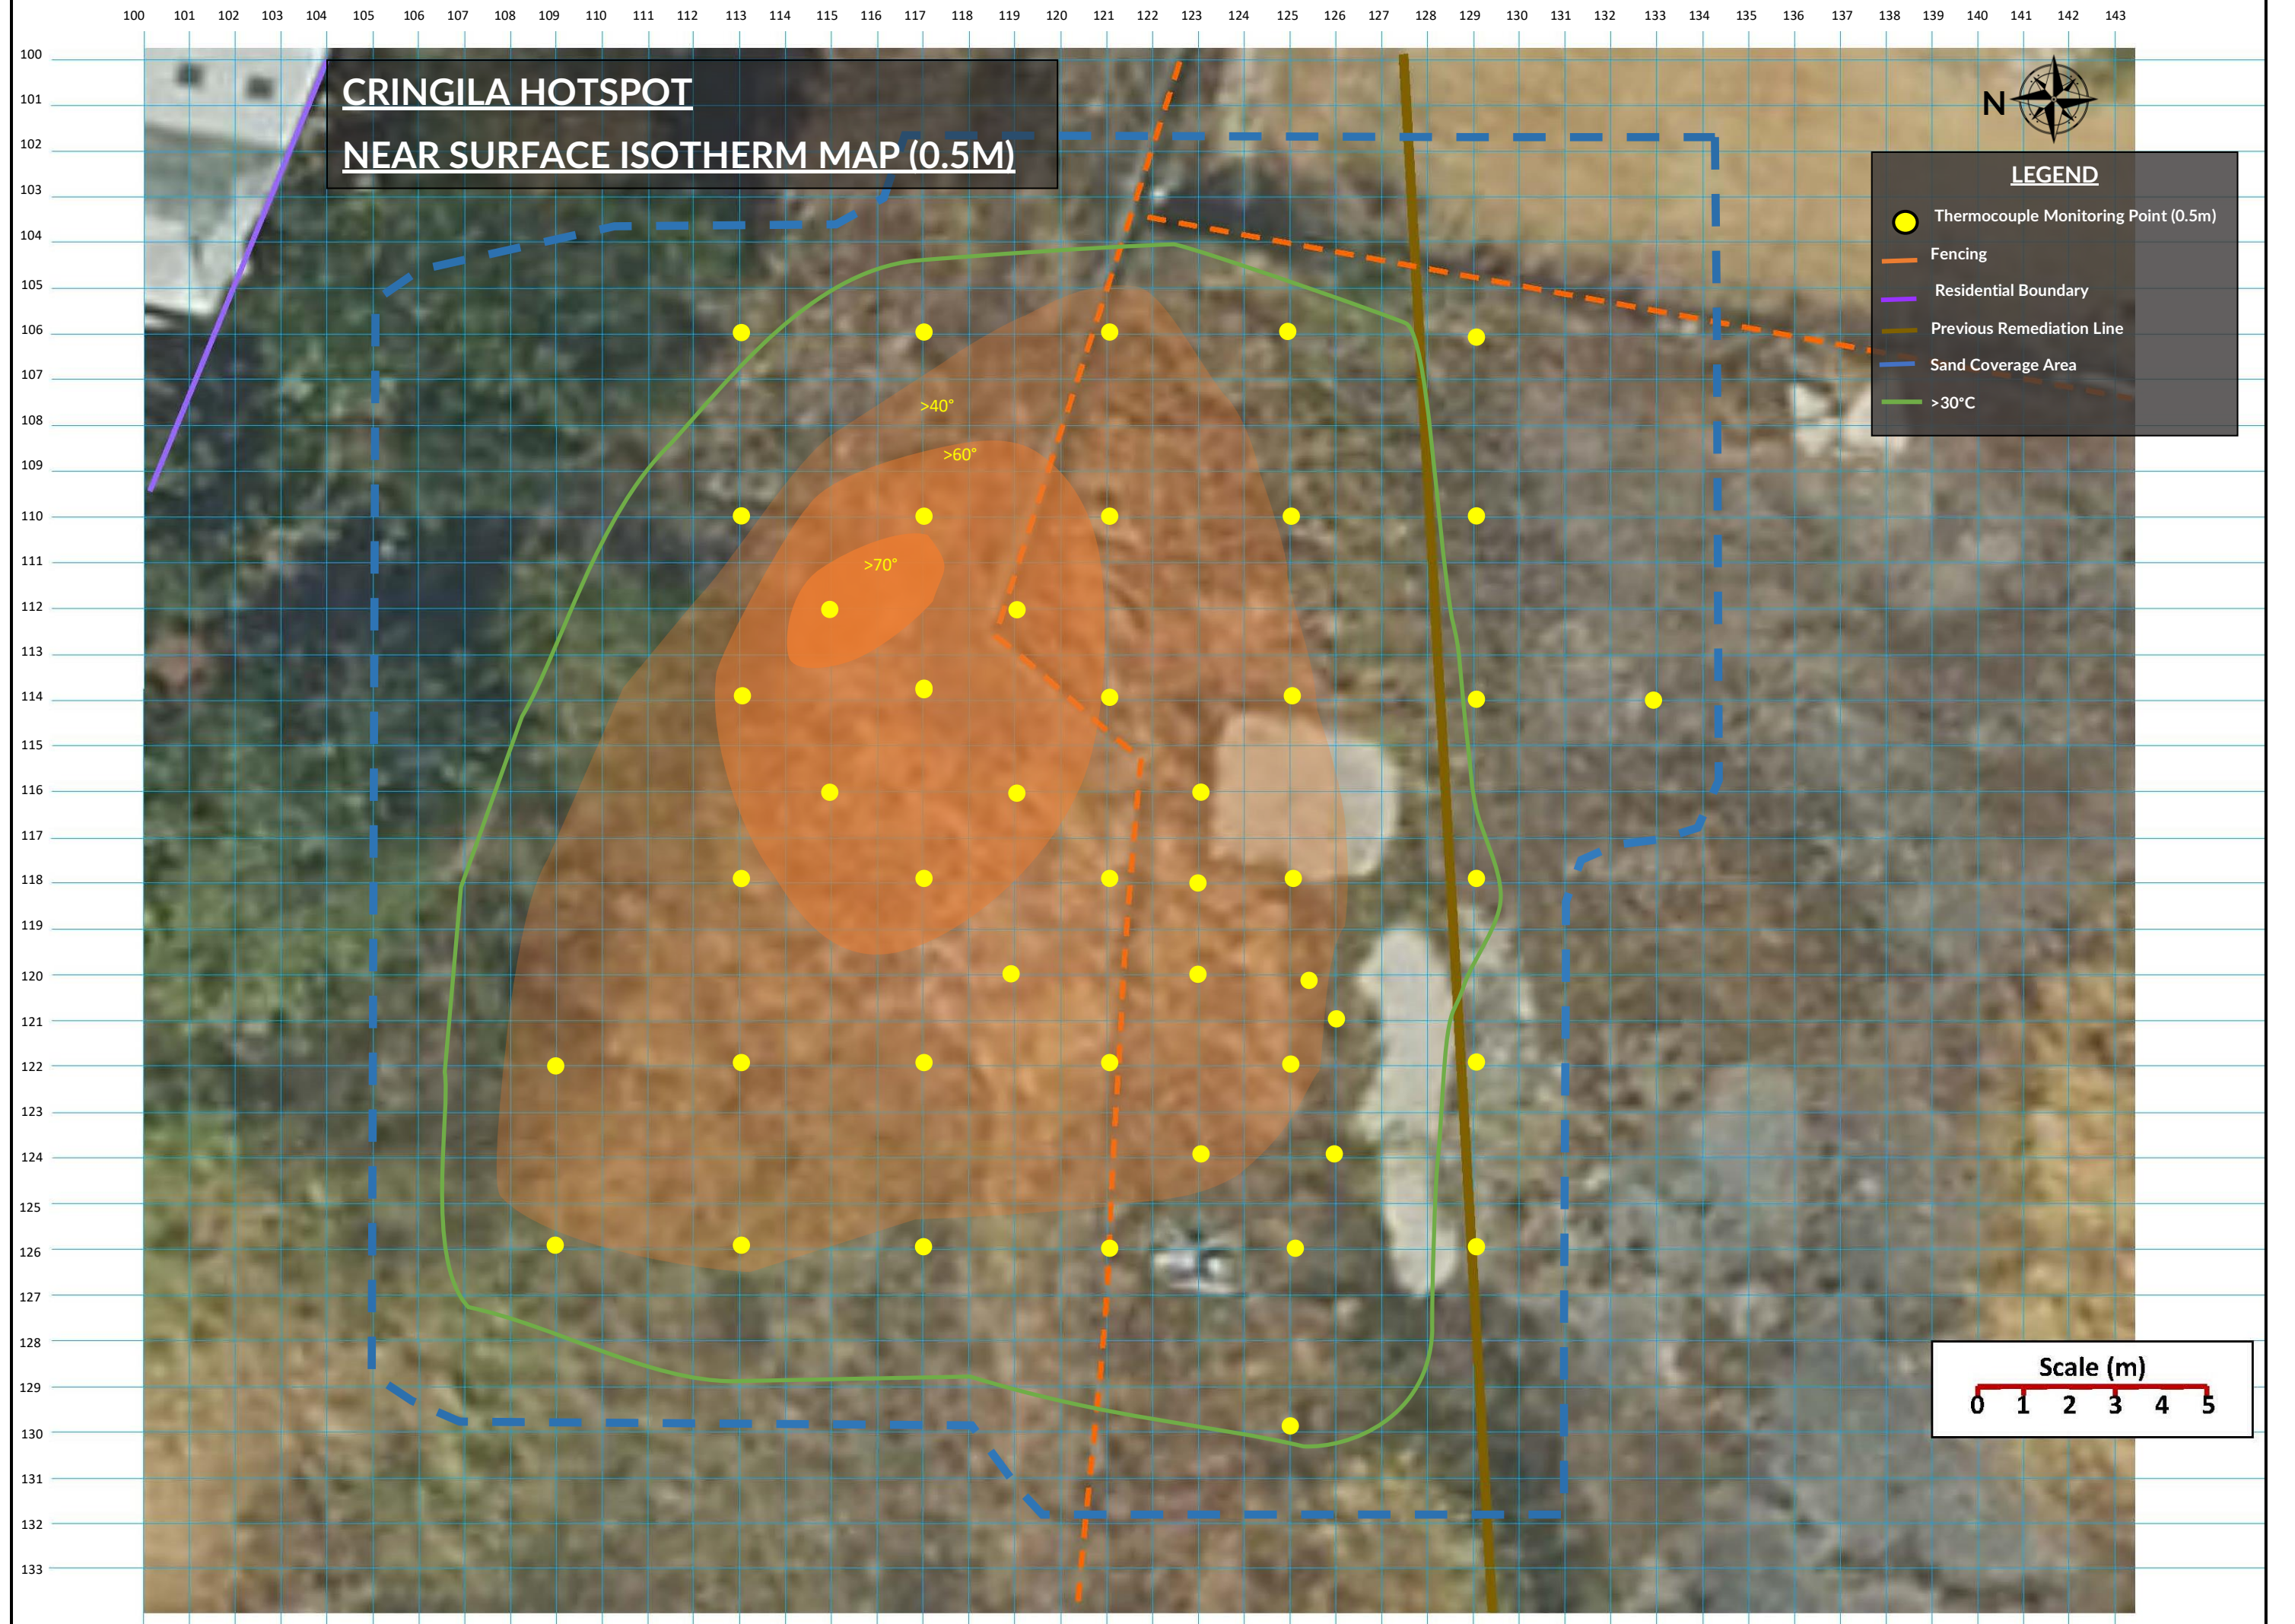
Appendix B: Near-Surface Temperature Isotherm Map (0.5m)

The isotherm map shows the general zone of influence for temperatures between 30°C and 78°C at 0.5m, coloured orange. The isotherm map suggests that the hotspot may extend deeper than 0.5m and that the increased temperature in these areas is a result of heat venting to the surface.

It is noted that temperature at the near-surface may be variable across the hotspot due to inconsistencies in the consolidation and compaction of subsurface materials.

CRINGILA HOTSPOT NEAR SURFACE ISOTHERM MAP (0.5M)

It is recommended that weekly site inspections and recording are continued to monitor the near-surface temperatures surrounding the subsurface hotspot identified at the site.
