NEAR-SURFACE TEMPERATURE MONITORING INVESTIGATION CRINGILA PUBLIC SCHOOL - NW HOTSPOT

Summary Report
09/09/2019 – 20/09/2019

NSW Department
of Education
Cringila Public School

35 Sheffield Street
Cringila NSW 2502

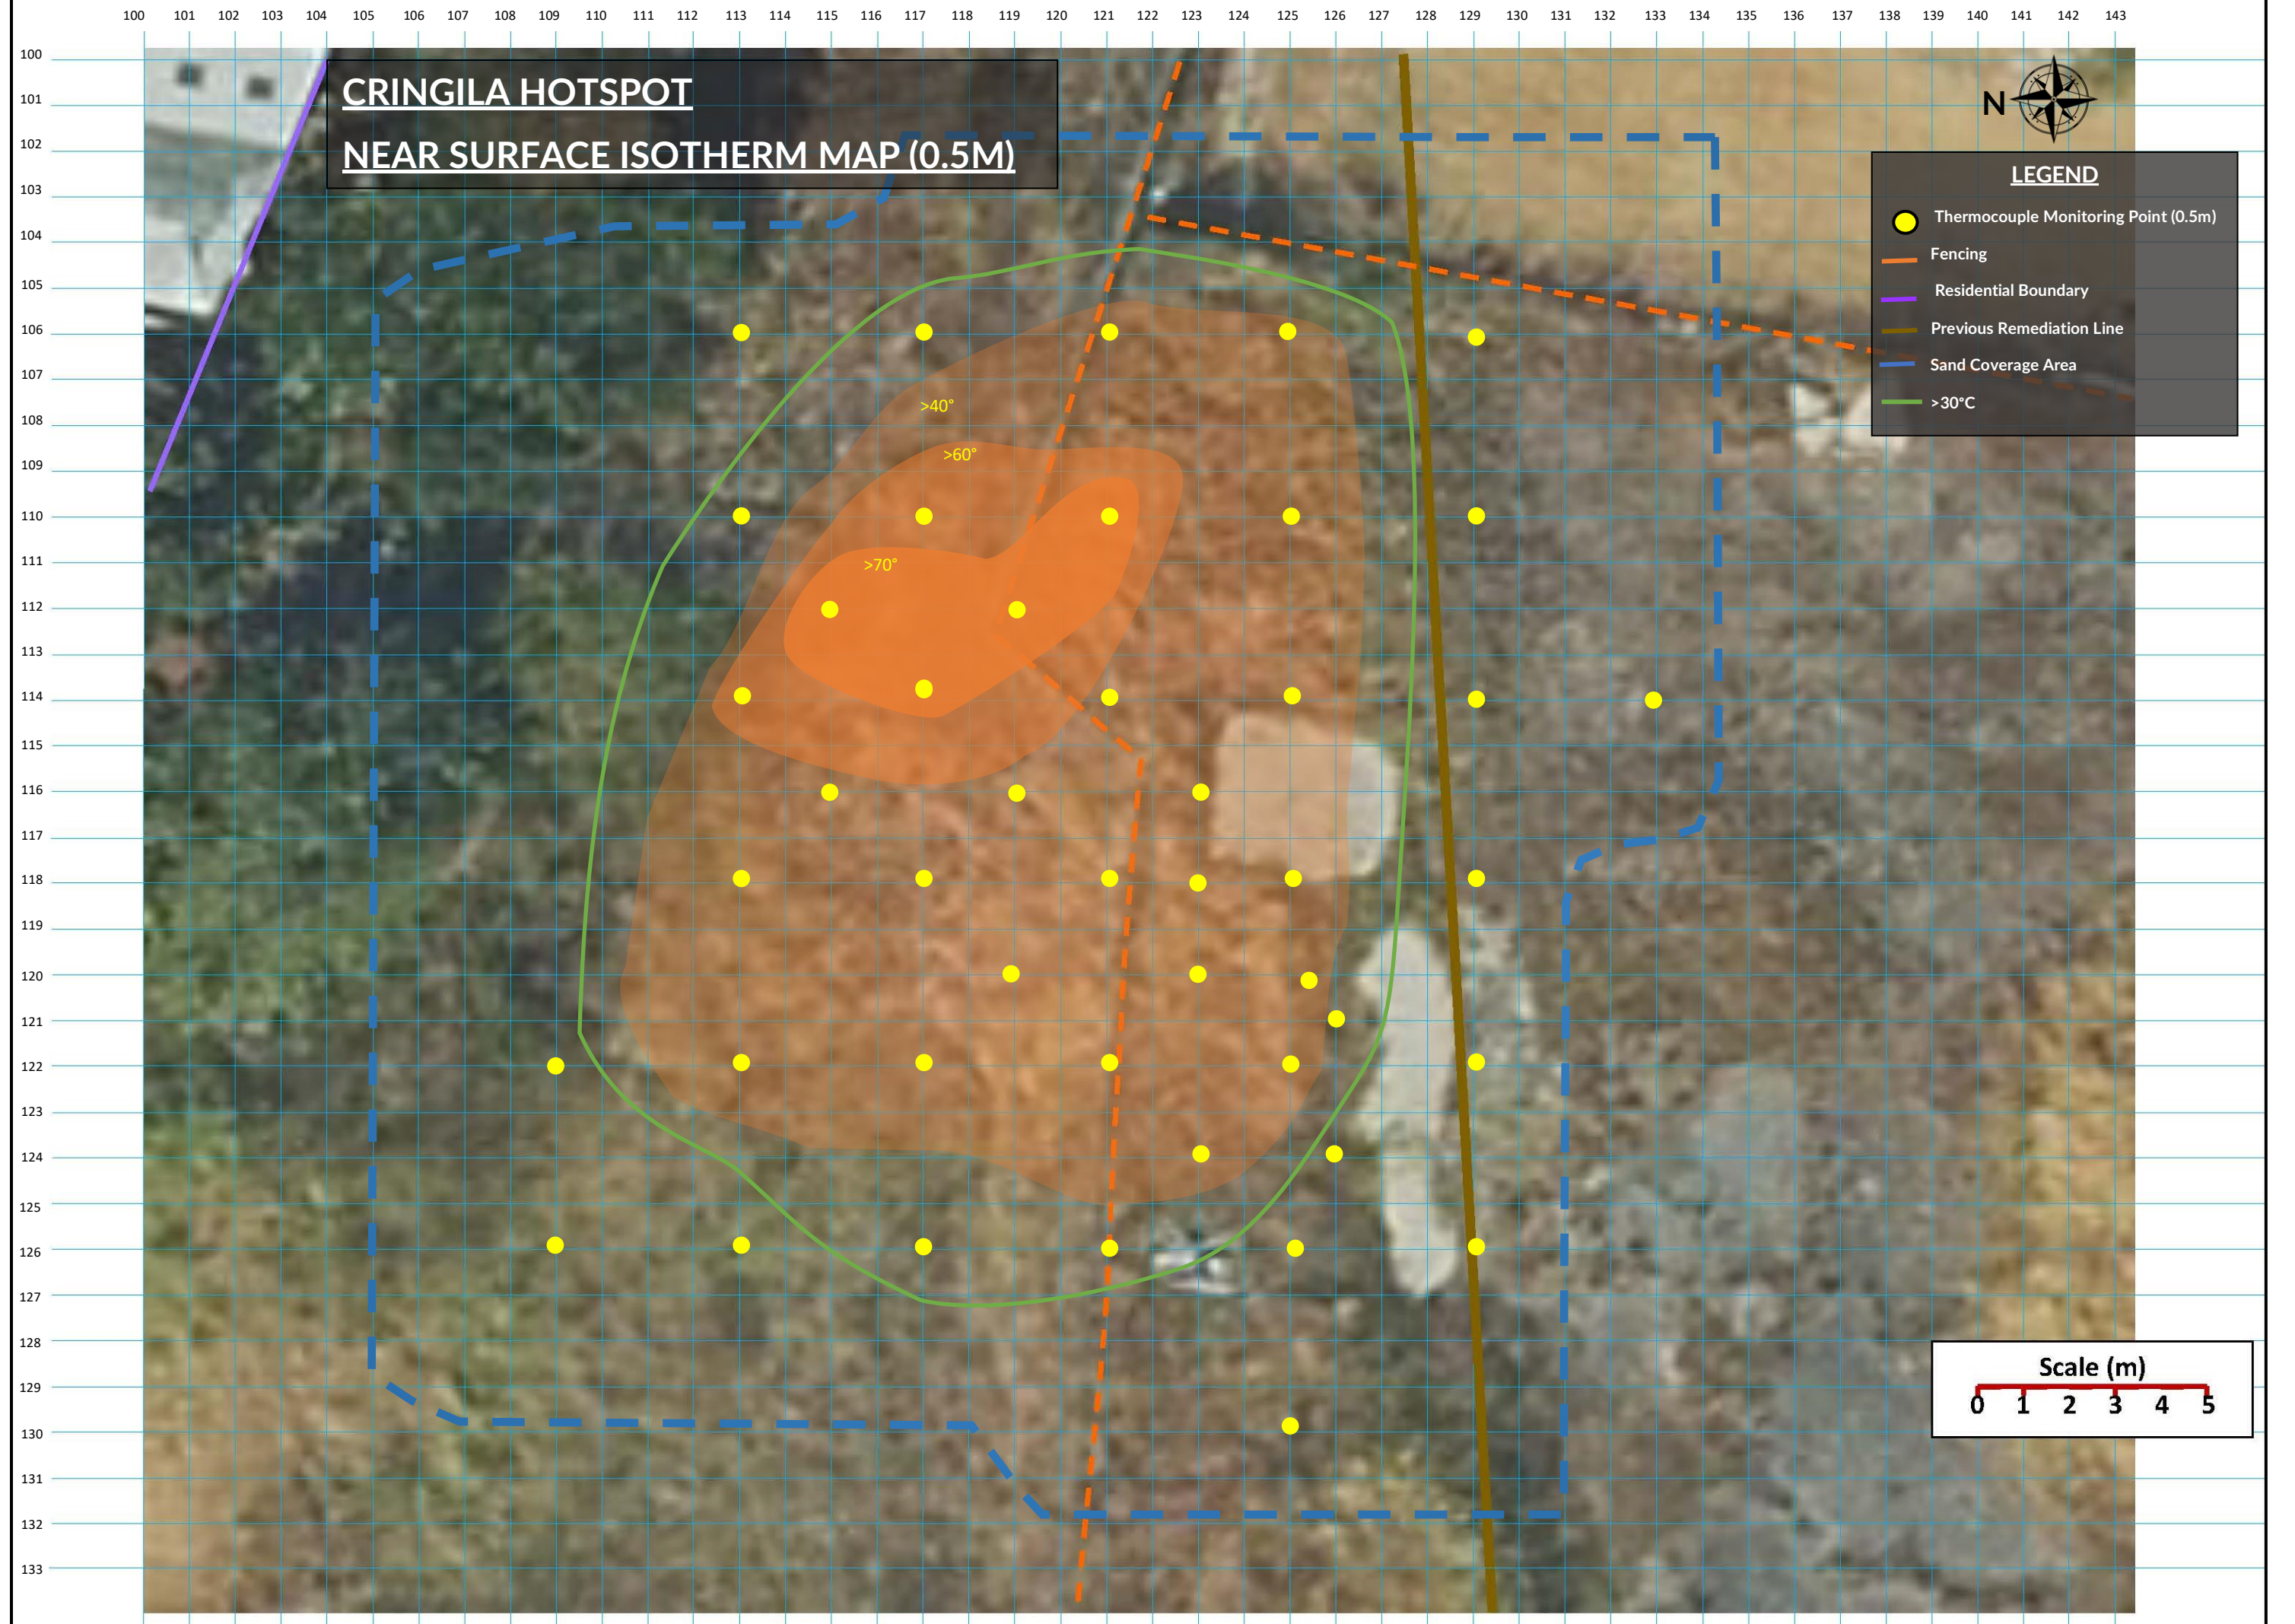
CRINGILA HOTSPOT NEAR SURFACE ISOTHERM MAP (0.5M)

The isotherm map shows the general zone of influence for temperatures between 30°C and 78°C at 0.5m, coloured orange. The isotherm map suggests that the hotspot may extend deeper than 0.5m and that the increased temperature in these areas is a result of heat venting to the surface.

It is noted that temperature at the near-surface may be variable across the hotspot due to inconsistencies in the consolidation and compaction of subsurface materials.

The near-surface temperature monitoring conducted between 9th September 2019 and 20th September 2019 indicates that the spatial extent of the northwest hotspot appears to remain localised.

It is recommended that weekly site inspections and recording are continued to monitor the near-surface temperatures surrounding the subsurface hotspot identified at the site.
