NEAR-SURFACE TEMPERATURE MONITORING INVESTIGATION CRINGILA PUBLIC SCHOOL - NW HOTSPOT

Summary Report
23/09/2019 – 04/10/2019

NSW Department
of Education
Cringila Public School

35 Sheffield Street
Cringila NSW 2502

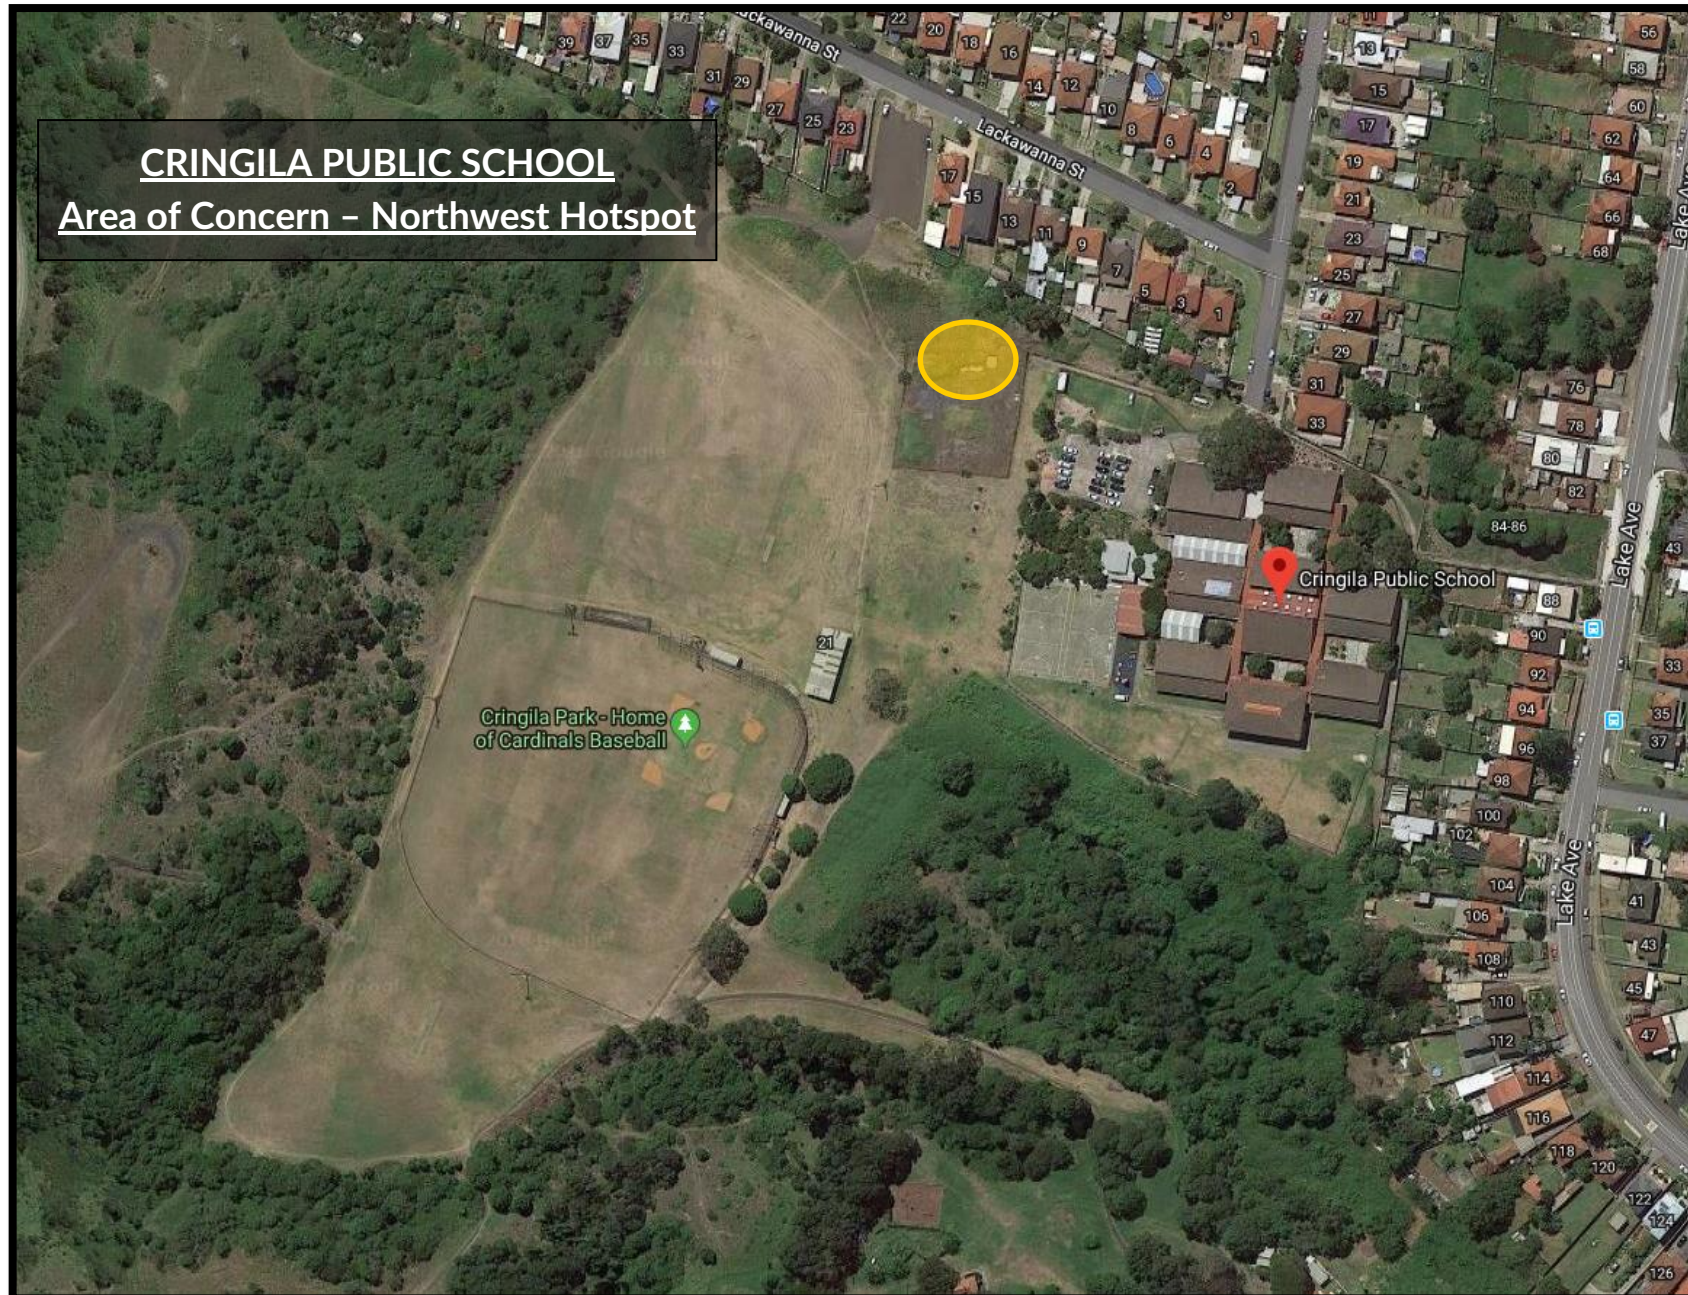
Appendix A: Area of Concern – Northwest Hotspot Map

CRINGILA PUBLIC SCHOOL
Area of Concern - Northwest Hotspot

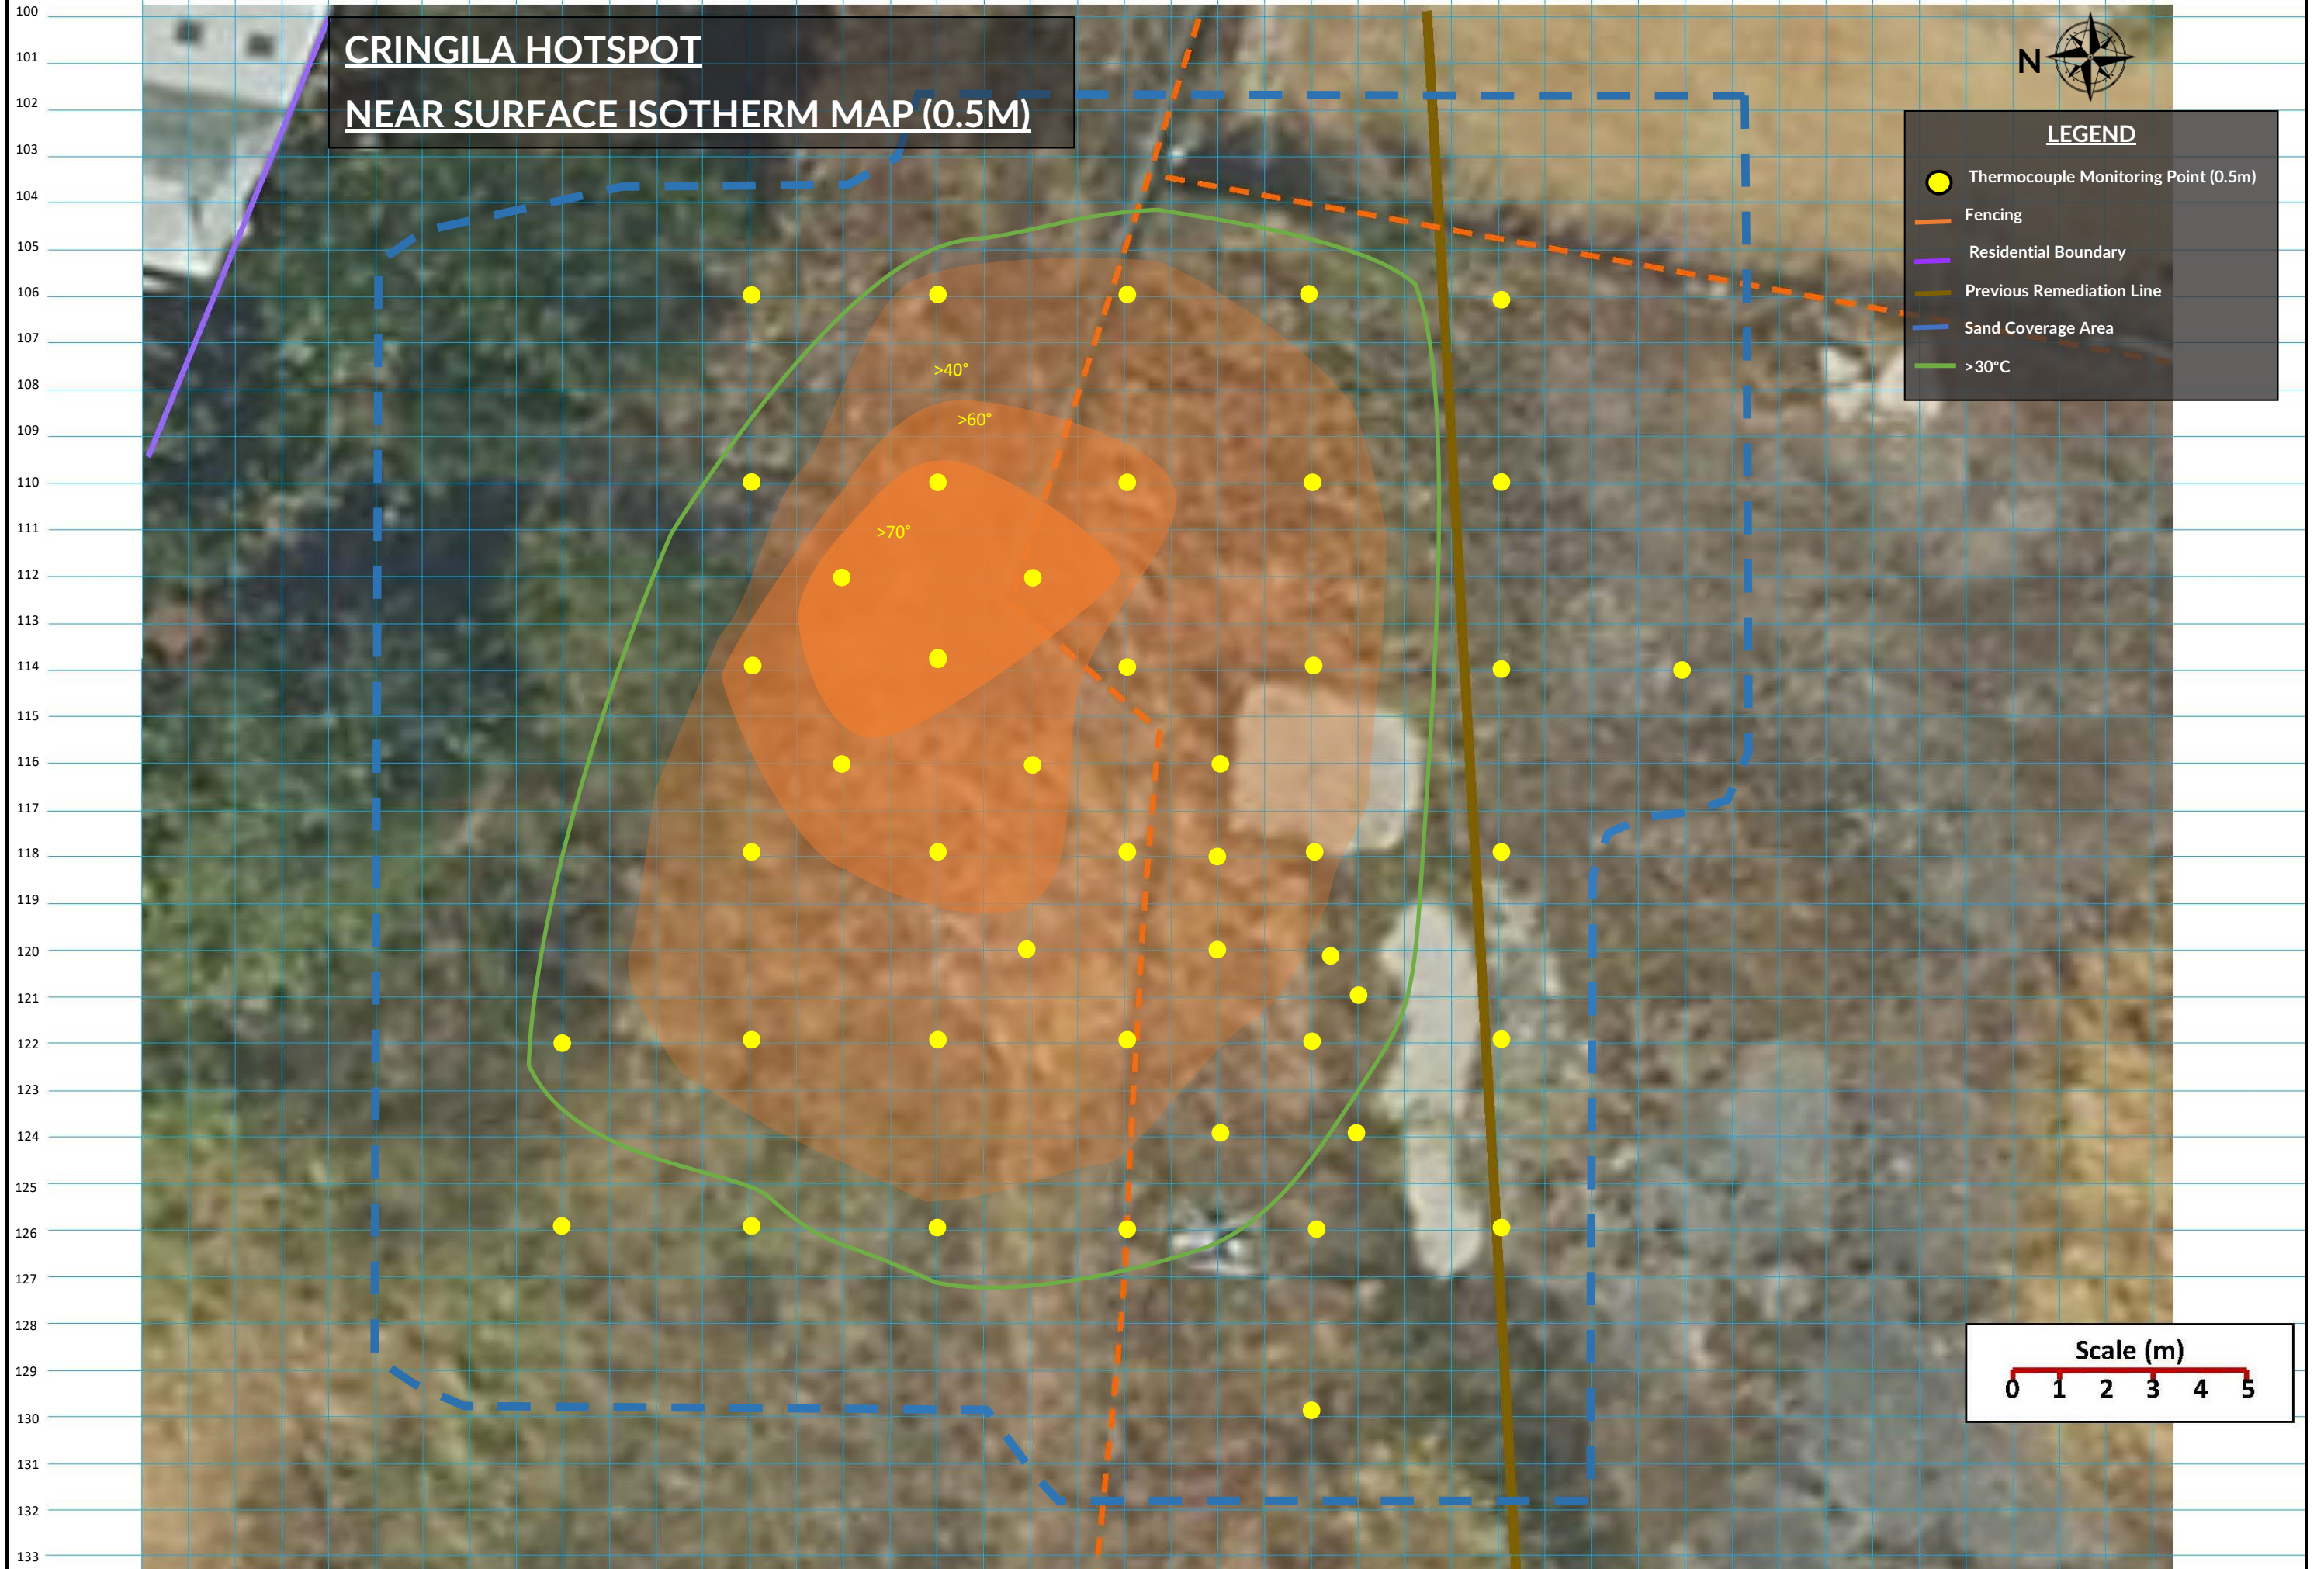
Appendix B: Near-Surface Temperature Isotherm Map (0.5m)

The isotherm map shows the general zone of influence for temperatures between 30°C and 78°C at 0.5m, coloured orange. The isotherm map suggests that the hotspot may extend deeper than 0.5m and that the increased temperature in these areas is a result of heat venting to the surface.

It is noted that temperature at the near-surface may be variable across the hotspot due to inconsistencies in the consolidation and compaction of subsurface materials.

CRINGILA HOTSPOT NEAR SURFACE ISOTHERM MAP (0.5M)

It is recommended that weekly site inspections and recording are continued to monitor the near-surface temperatures surrounding the subsurface hotspot identified at the site.
