## NEAR-SURFACE TEMPERATURE MONITORING INVESTIGATION CRINGILA PUBLIC SCHOOL - NW HOTSPOT

Summary Report  
07/10/2019 - 18/10/2019

NSW Department  
of Education  
Cringila Public School

35 Sheffield Street  
Cringila NSW 2502

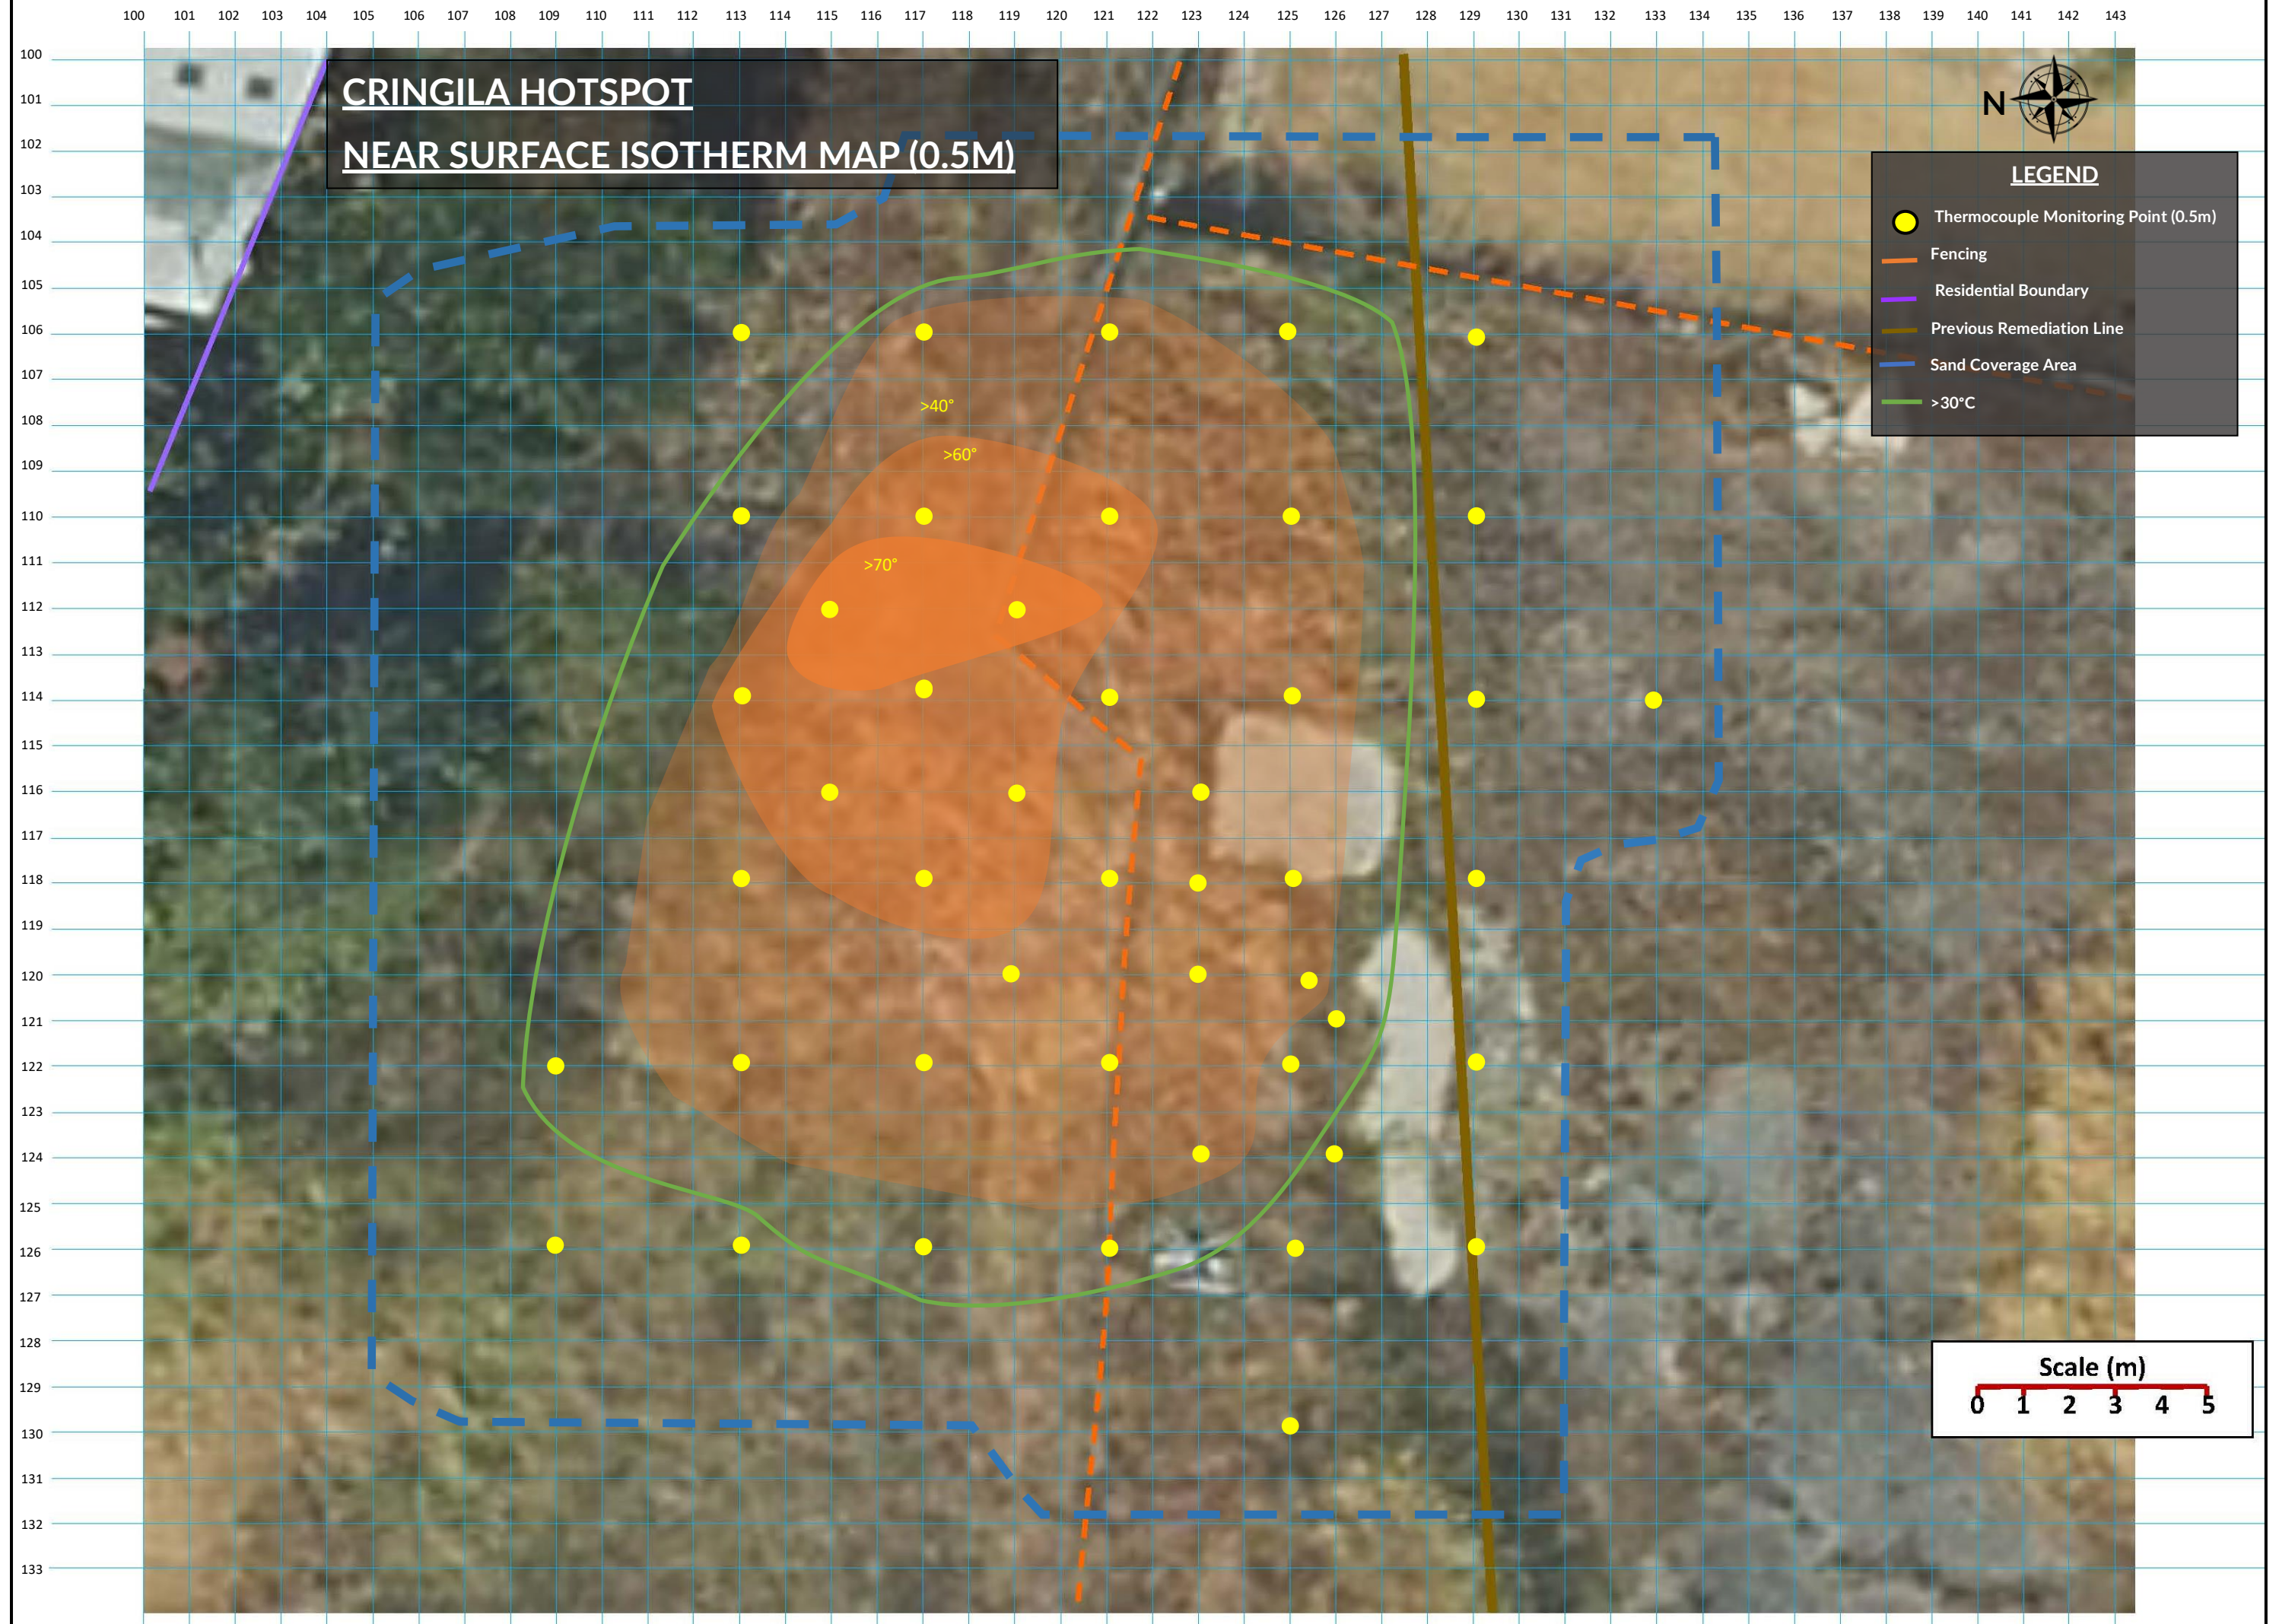
# CRINGILA HOTSPOT NEAR SURFACE ISOTHERM MAP (0.5M)

The isotherm map shows the general zone of influence for temperatures between 30°C and 78°C at 0.5m, coloured orange. The isotherm map suggests that the hotspot may extend deeper than 0.5m and that the increased temperature in these areas is a result of heat venting to the surface.

It is noted that temperature at the near-surface may be variable across the hotspot due to inconsistencies in the consolidation and compaction of subsurface materials.

The near-surface temperatures for representative monitoring locations, spread across the northwest Hotspot, are presented in the tables below. Temperature isotherms have been plotted on a site map to show an illustration of the near-surface temperatures in a spatial context. Refer to **Appendix B: Near Surface Temperature Isotherm Map (0.5m)**.
