NEAR-SURFACE TEMPERATURE MONITORING INVESTIGATION CRINGILA PUBLIC SCHOOL - NW HOTSPOT

Summary Report
21/10/2019 - 01/11/2019

NSW Department
of Education
Cringila Public School

October 2019
C107471: J153825-03: TO/RC

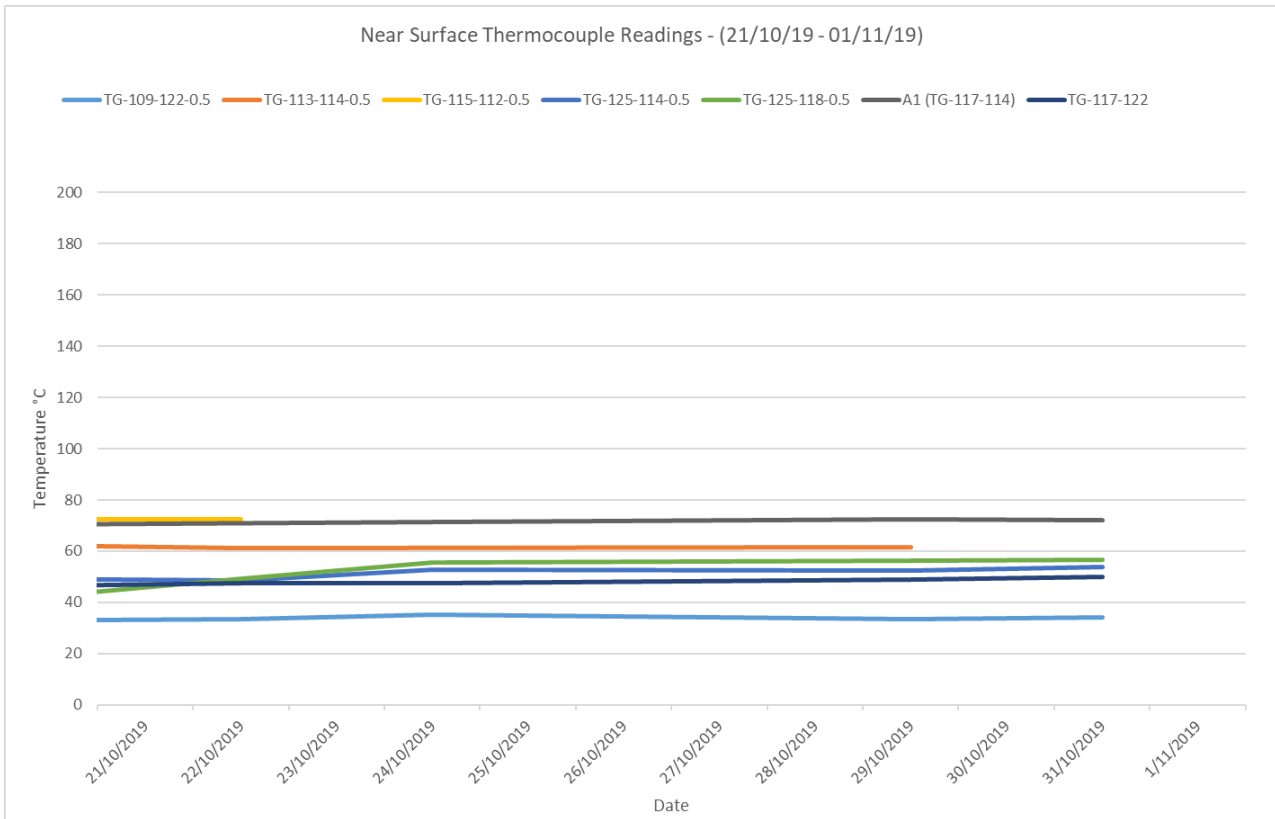
3.2. Near-Surface Temperature Graph – Selected Points (Fortnightly)

Near-surface temperature measurements for key thermocouple locations, over the monitoring period – 21st October 2019 to 1st November 2019.

The near-surface temperature at selected points across the northwest hotspot over the period of monitoring appear to remain consistent.

The near-surface temperature monitoring conducted between 21st October 2019 and 1st November 2019 indicates that the spatial extent of the northwest hotspot appears to remain localised.

There were no significant near-surface temperature variations identified during the period of monitoring.

It is recommended that weekly site inspections and recording are continued to monitor the near-surface temperatures surrounding the subsurface hotspot identified at the site.

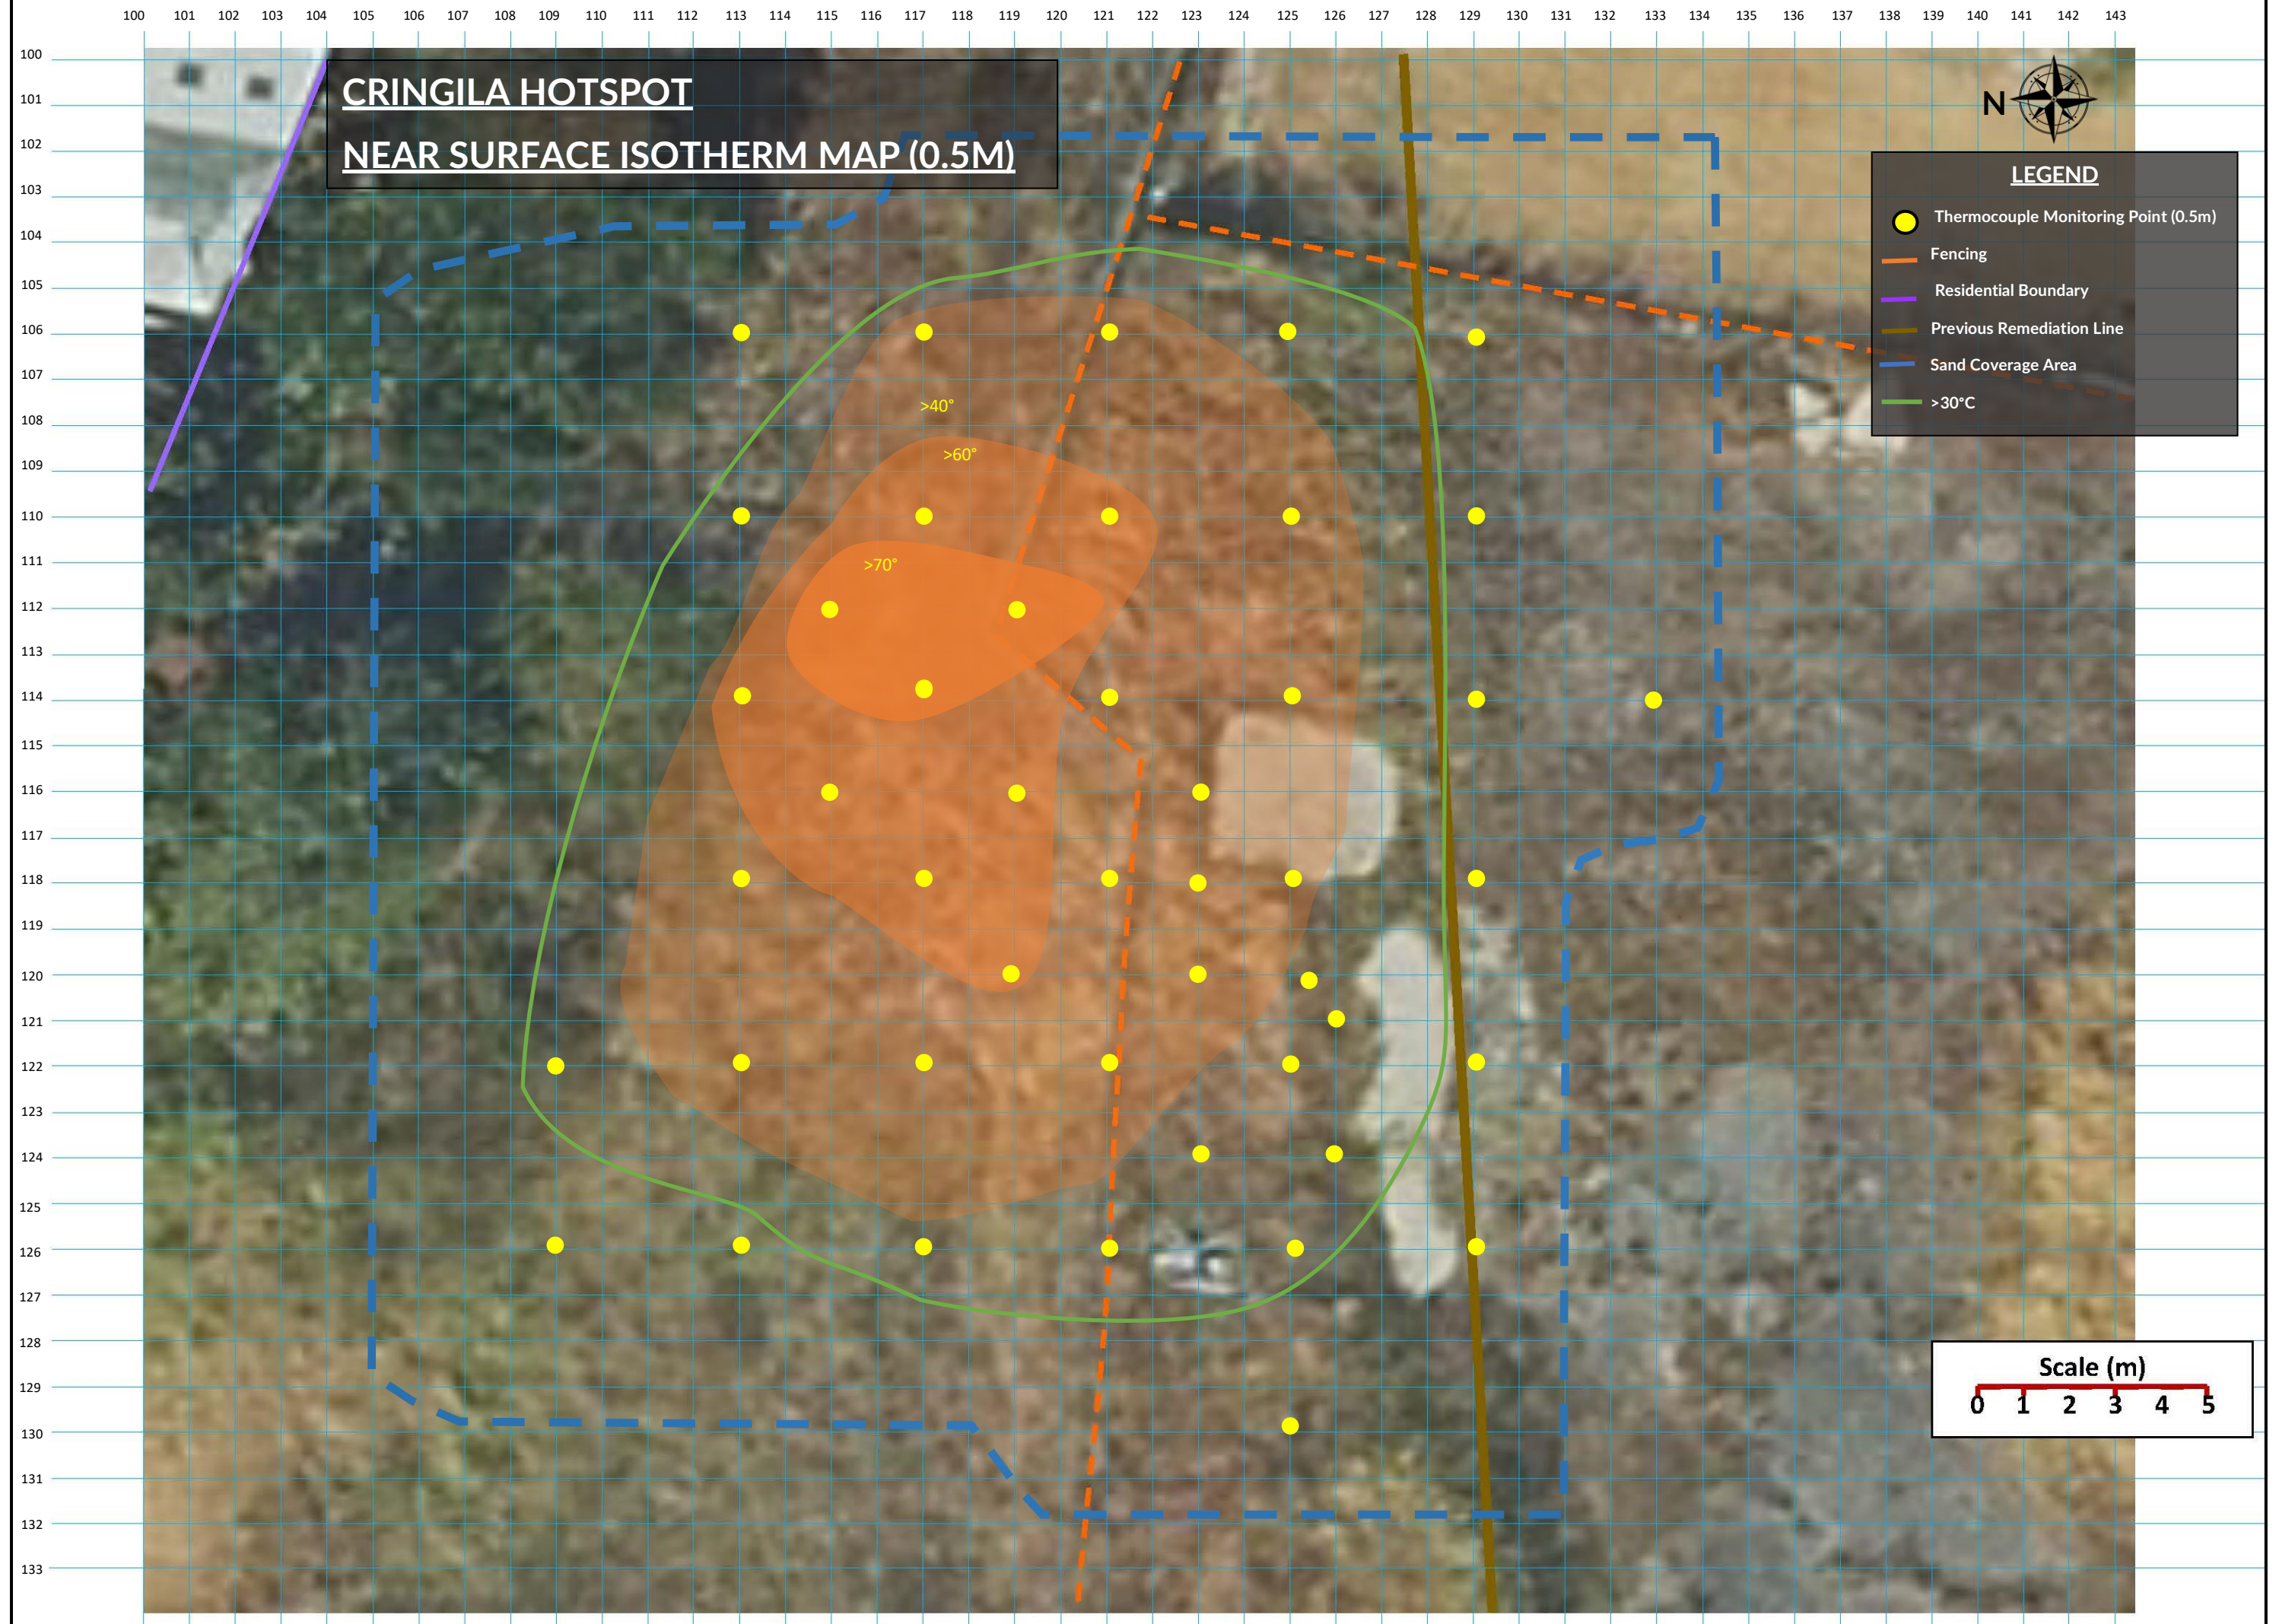
CRINGILA HOTSPOT NEAR SURFACE ISOTHERM MAP (0.5M)

The isotherm map shows the general zone of influence for temperatures between 30°C and 70°C at 0.5m, coloured orange. The isotherm map suggests that the hotspot may extend deeper than 0.5m and that the increased temperature in these areas is a result of heat venting to the surface.

It is noted that temperature at the near-surface may be variable across the hotspot due to inconsistencies in the consolidation and compaction of subsurface materials.

The near-surface temperatures for representative monitoring locations, spread across the northwest Hotspot, are presented in the tables below. Temperature isotherms have been plotted on a site map to show an illustration of the near-surface temperatures in a spatial context. Refer to **Appendix B: Near Surface Temperature Isotherm Map (0.5m)**.
