## NEAR-SURFACE TEMPERATURE MONITORING INVESTIGATION CRINGILA PUBLIC SCHOOL - NW HOTSPOT

Summary Report  
04/11/2019 - 15/11/2019

NSW Department  
of Education  
Cringila Public School

November 2019  
C107471: J153825-03: TO

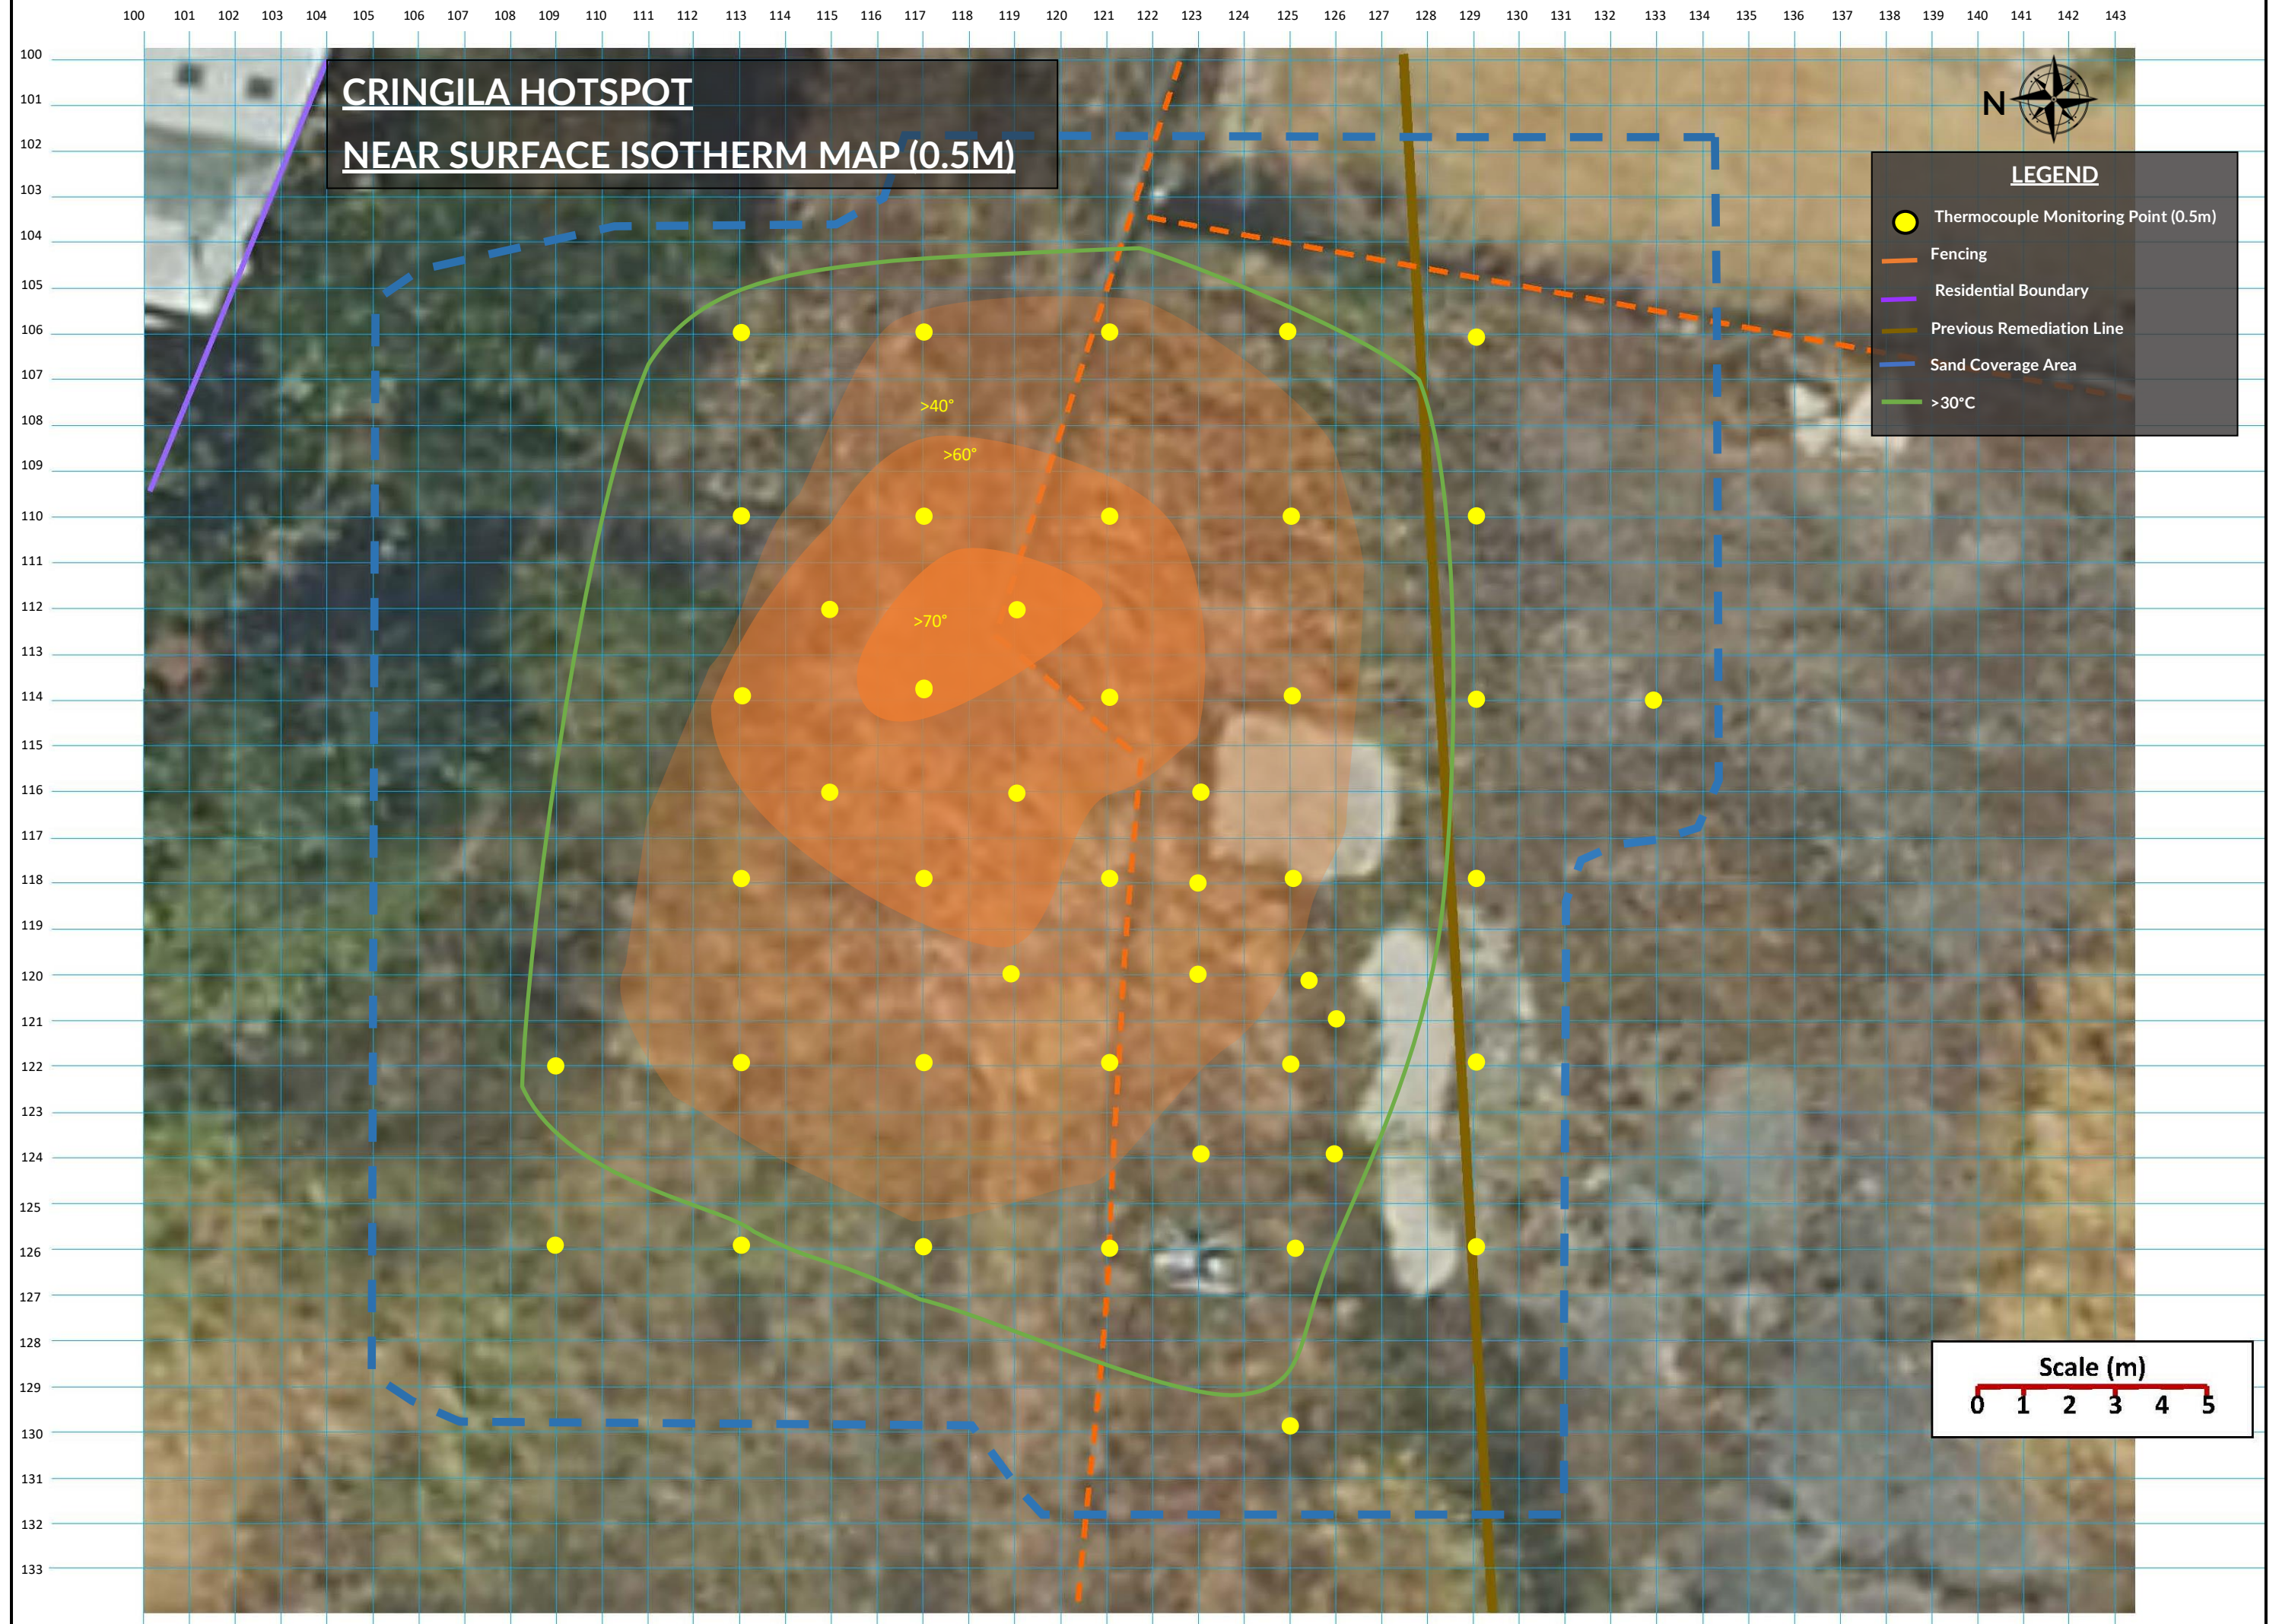
### Appendix B: Near-Surface Temperature Isotherm Map (0.5m)

The isotherm map shows the general zone of influence for temperatures between 30°C and 70°C at 0.5m, coloured orange. The isotherm map suggests that the hotspot may extend deeper than 0.5m and that the increased temperature in these areas is a result of heat venting to the surface.

It is noted that temperature at the near-surface may be variable across the hotspot due to inconsistencies in the consolidation and compaction of subsurface materials.

It is recommended that weekly site inspections and recording are continued to monitor the near-surface temperatures surrounding the subsurface hotspot identified at the site.
