## NEAR-SURFACE TEMPERATURE MONITORING INVESTIGATION CRINGILA PUBLIC SCHOOL - NW HOTSPOT

Summary Report  
18/11/2019 – 29/11/2019

NSW Department  
of Education  
Cringila Public School

November 2019  
C107471: J153825-03: TO

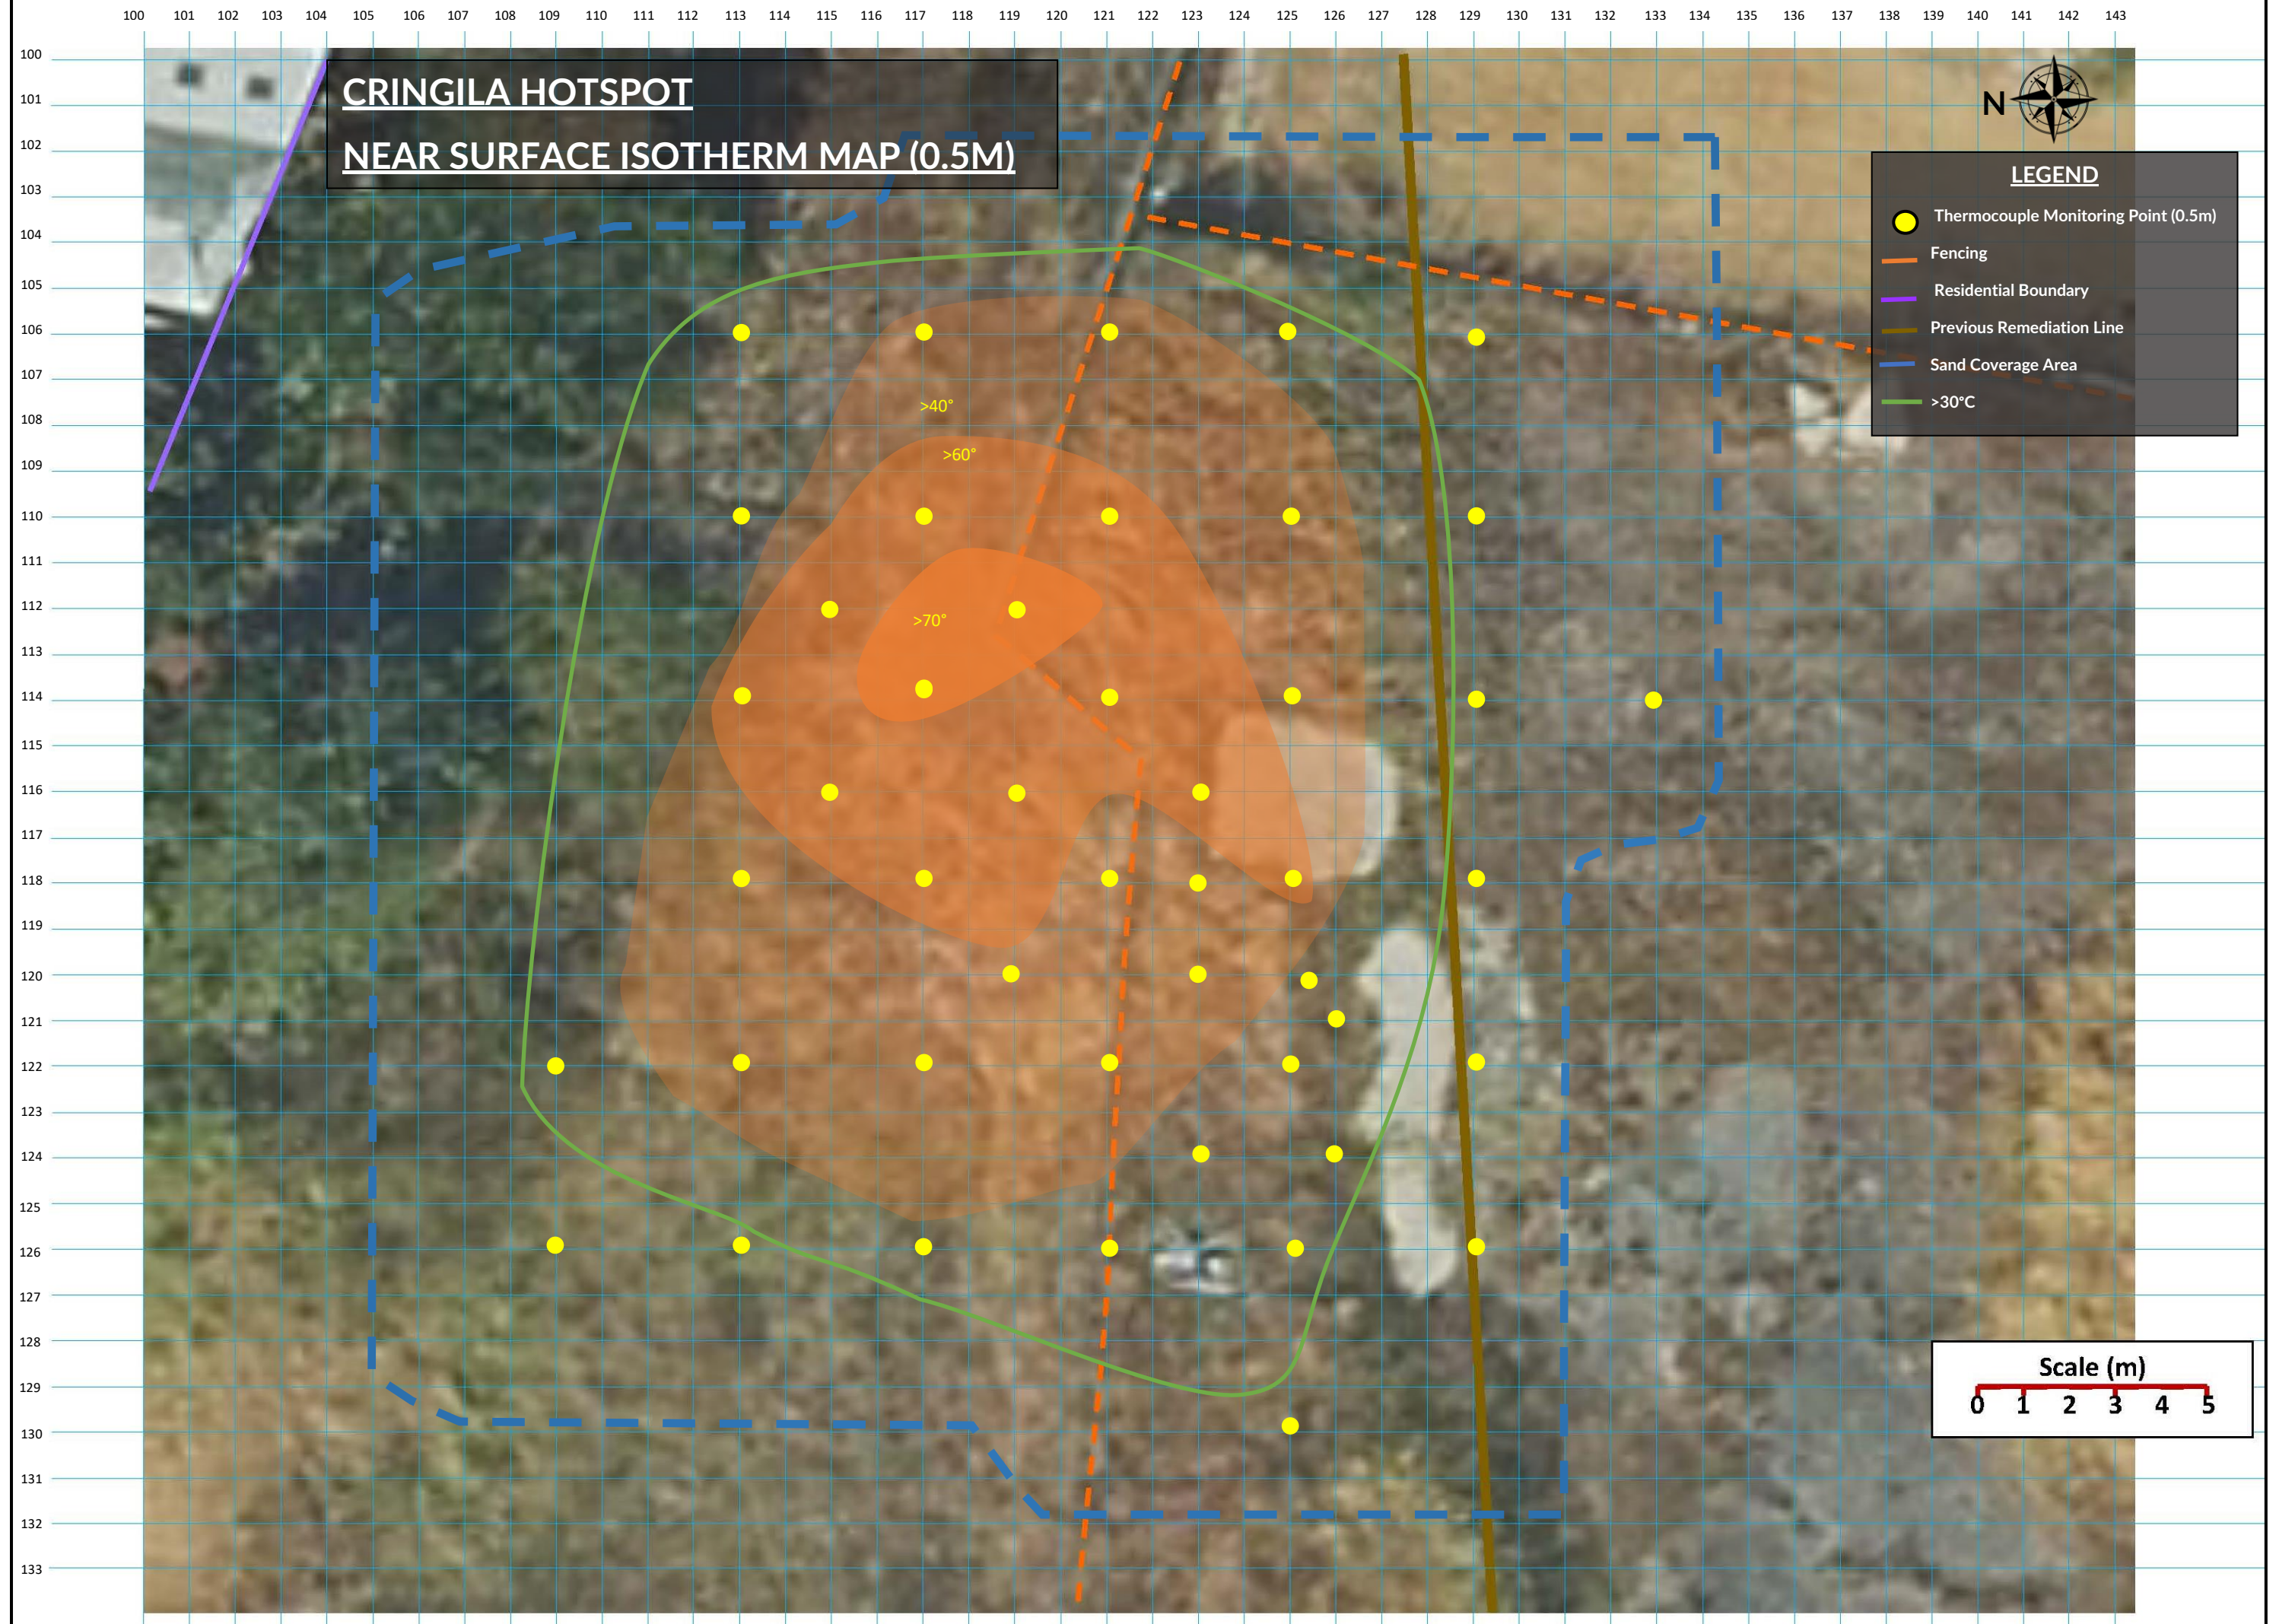
# CRINGILA HOTSPOT NEAR SURFACE ISOTHERM MAP (0.5M)

The isotherm map shows the general zone of influence for temperatures between 30°C and 70°C at 0.5m, coloured orange. The isotherm map suggests that the hotspot may extend deeper than 0.5m and that the increased temperature in these areas is a result of heat venting to the surface.

It is noted that temperature at the near-surface may be variable across the hotspot due to inconsistencies in the consolidation and compaction of subsurface materials.

It is recommended that weekly site inspections and recording are continued to monitor the near-surface temperatures surrounding the subsurface hotspot identified at the site.
