## NEAR-SURFACE TEMPERATURE MONITORING INVESTIGATION CRINGILA PUBLIC SCHOOL - NW HOTSPOT

Summary Report  
02/12/2019 - 13/12/2019

NSW Department  
of Education  
Cringila Public School

35 Sheffield Street  
Cringila NSW 2502

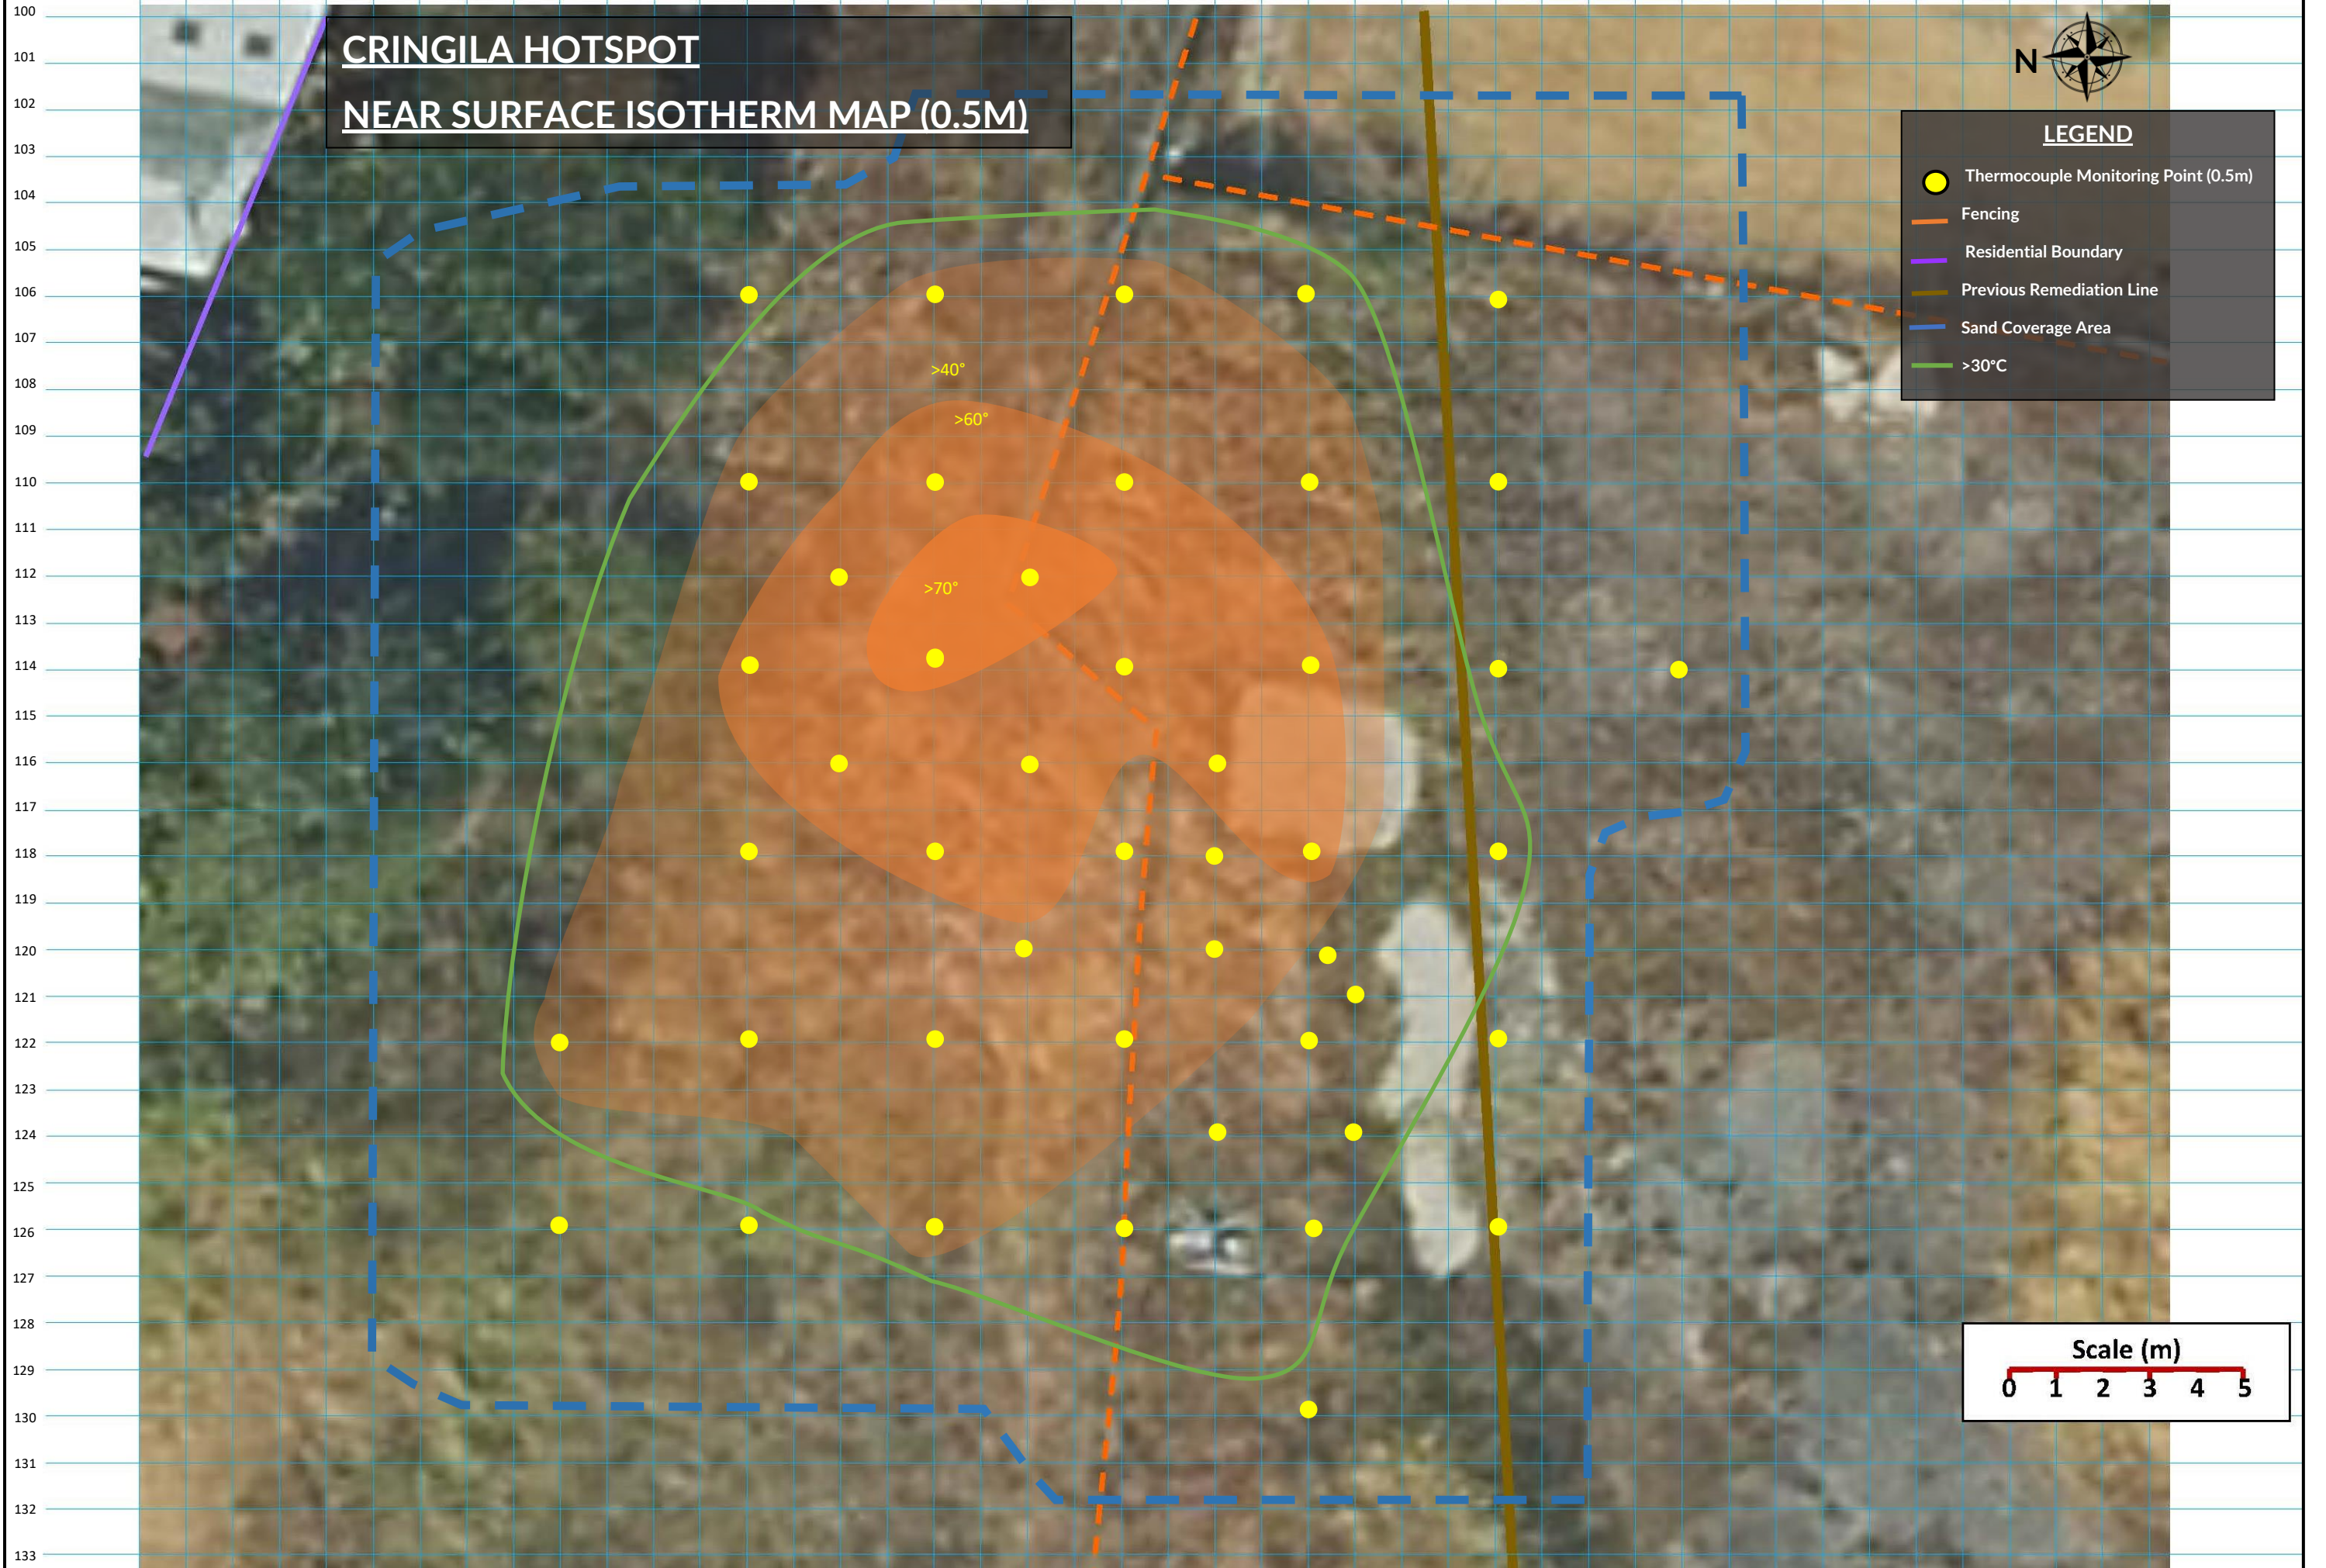
### Appendix B: Near-Surface Temperature Isotherm Map (0.5m)

The isotherm map shows the general zone of influence for temperatures between 30°C and 80°C at 0.5m, coloured orange. The isotherm map suggests that the hotspot may extend deeper than 0.5m and that the increased temperature in these areas is a result of heat venting to the surface.

It is noted that temperature at the near-surface may be variable across the hotspot due to inconsistencies in the consolidation and compaction of subsurface materials.

It is recommended that weekly site inspections and recording are continued to monitor the near-surface temperatures surrounding the subsurface hotspot identified at the site.
