NEAR-SURFACE TEMPERATURE MONITORING INVESTIGATION CRINGILA PUBLIC SCHOOL - NW HOTSPOT

Summary Report
16/12/2019 - 27/12/2019

NSW Department
of Education
Cringila Public School

35 Sheffield Street
Cringila NSW 2502

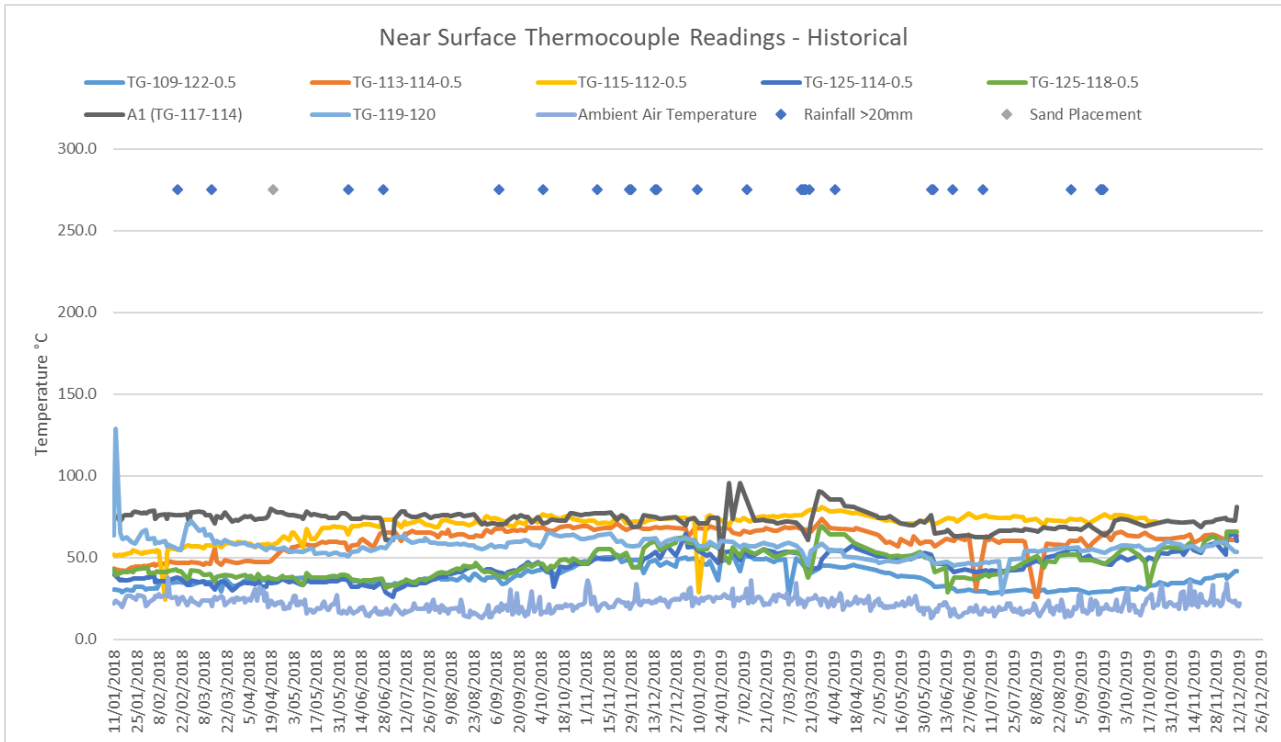
3.1. Near-Surface Temperature Graph – Selected Points (Historical)

Near surface temperature measurements for key thermocouple locations, progressive from Thursday 11th January 2018 to present.

The near surface temperature appears to be trending downwards following the placement of sand (approximately 100mm) across the surface of the northwest hotspot grid monitoring area.

Fluctuations in near-surface temperature are evident following significant rain events (i.e. over 20mm rain).

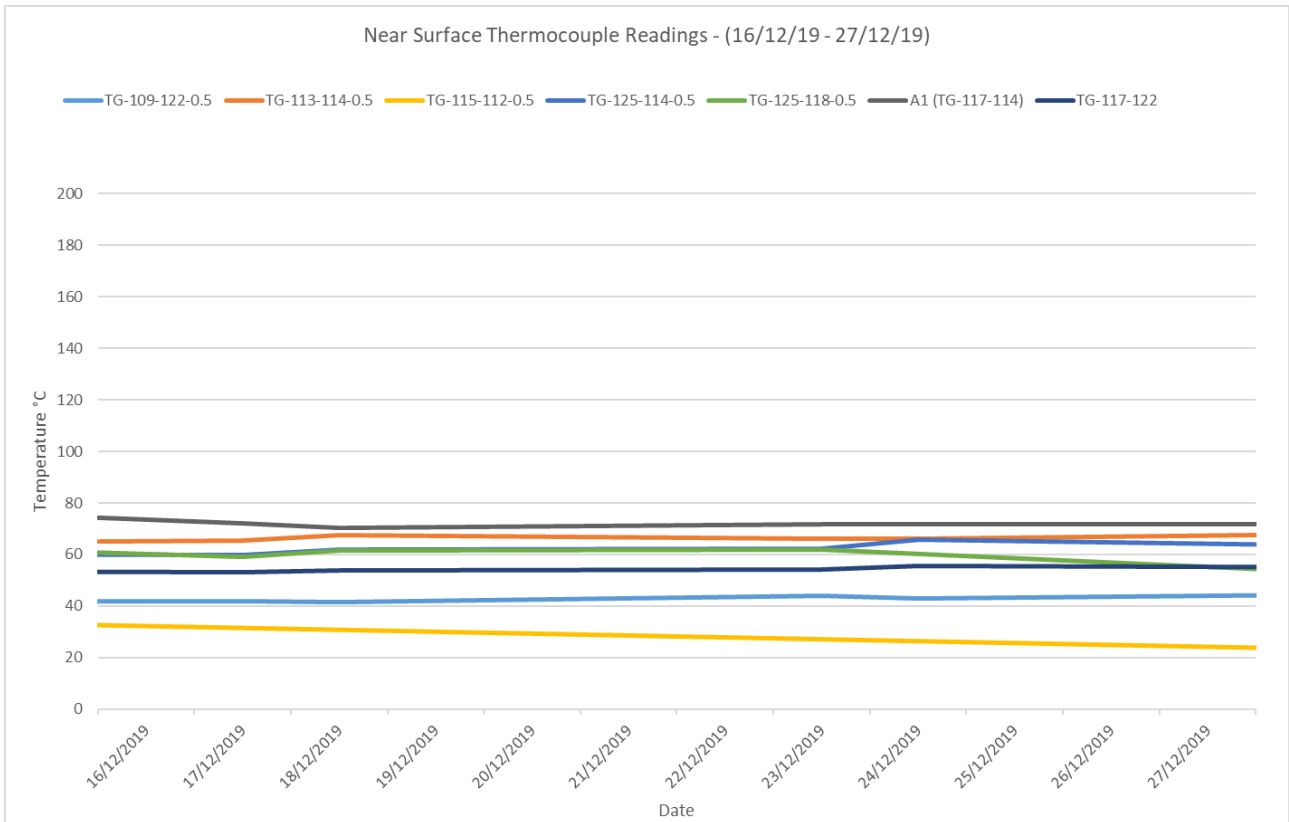
3.2. Near-Surface Temperature Graph – Selected Points (Fortnightly)

Near-surface temperature measurements for key thermocouple locations, over the monitoring period – 16th December 2019 and 27th December 2019.

The near-surface temperature at selected points across the northwest hotspot over the period of monitoring appear to remain consistent.

The near-surface temperature monitoring conducted between 16th December 2019 and 27th December 2019 indicates that the spatial extent of the northwest hotspot appears to remain localised.

There were no significant near-surface temperature variations identified during the period of monitoring.

It is recommended that weekly site inspections and recording are continued to monitor the near-surface temperatures surrounding the subsurface hotspot identified at the site.

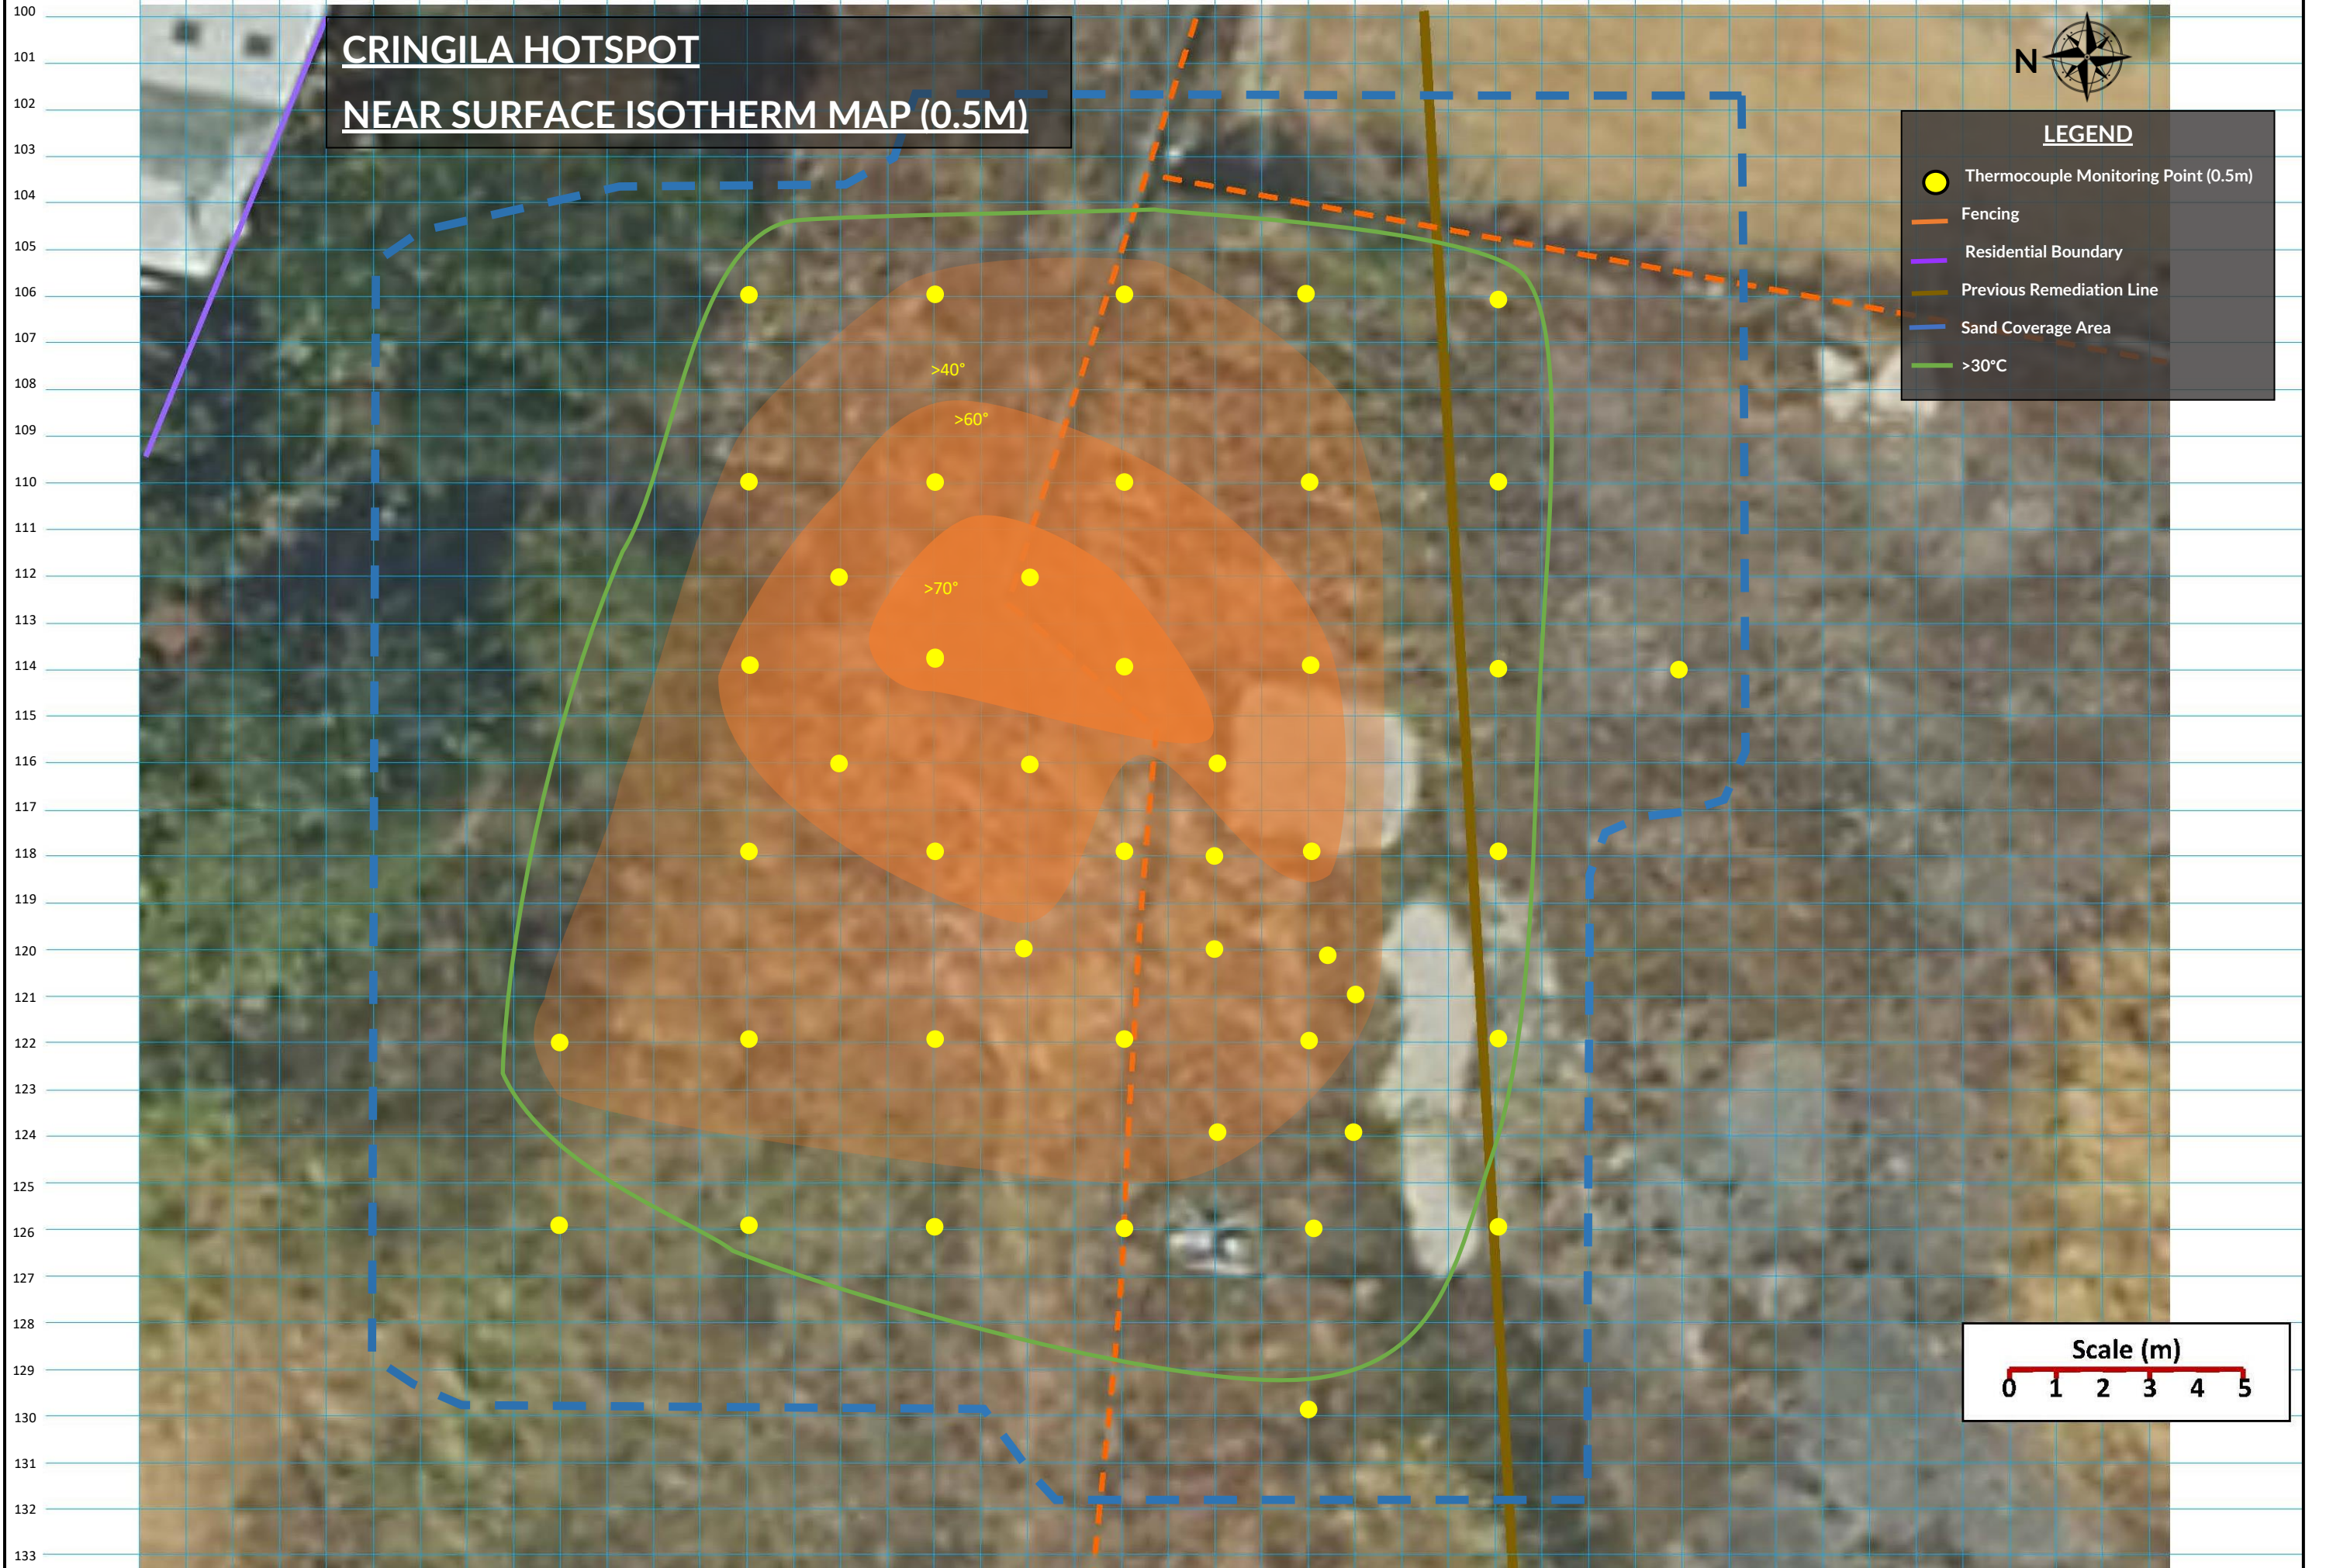
CRINGILA HOTSPOT NEAR SURFACE ISOTHERM MAP (0.5M)

The isotherm map shows the general zone of influence for temperatures between 30°C and 70°C at 0.5m, coloured orange. The isotherm map suggests that the hotspot may extend deeper than 0.5m and that the increased temperature in these areas is a result of heat venting to the surface.

It is noted that temperature at the near-surface may be variable across the hotspot due to inconsistencies in the consolidation and compaction of subsurface materials.

The near-surface temperatures for representative monitoring locations, spread across the northwest Hotspot, are presented in the tables below. Temperature isotherms have been plotted on a site map to show an illustration of the near-surface temperatures in a spatial context. Refer to **Appendix B: Near Surface Temperature Isotherm Map (0.5m)**.
