## NEAR-SURFACE TEMPERATURE MONITORING INVESTIGATION CRINGILA PUBLIC SCHOOL - NW HOTSPOT

Summary Report  
30/12/2019 - 10/01/2020

NSW Department  
of Education  
Cringila Public School

January 2020  
C107471: J153825-03: TO/RC

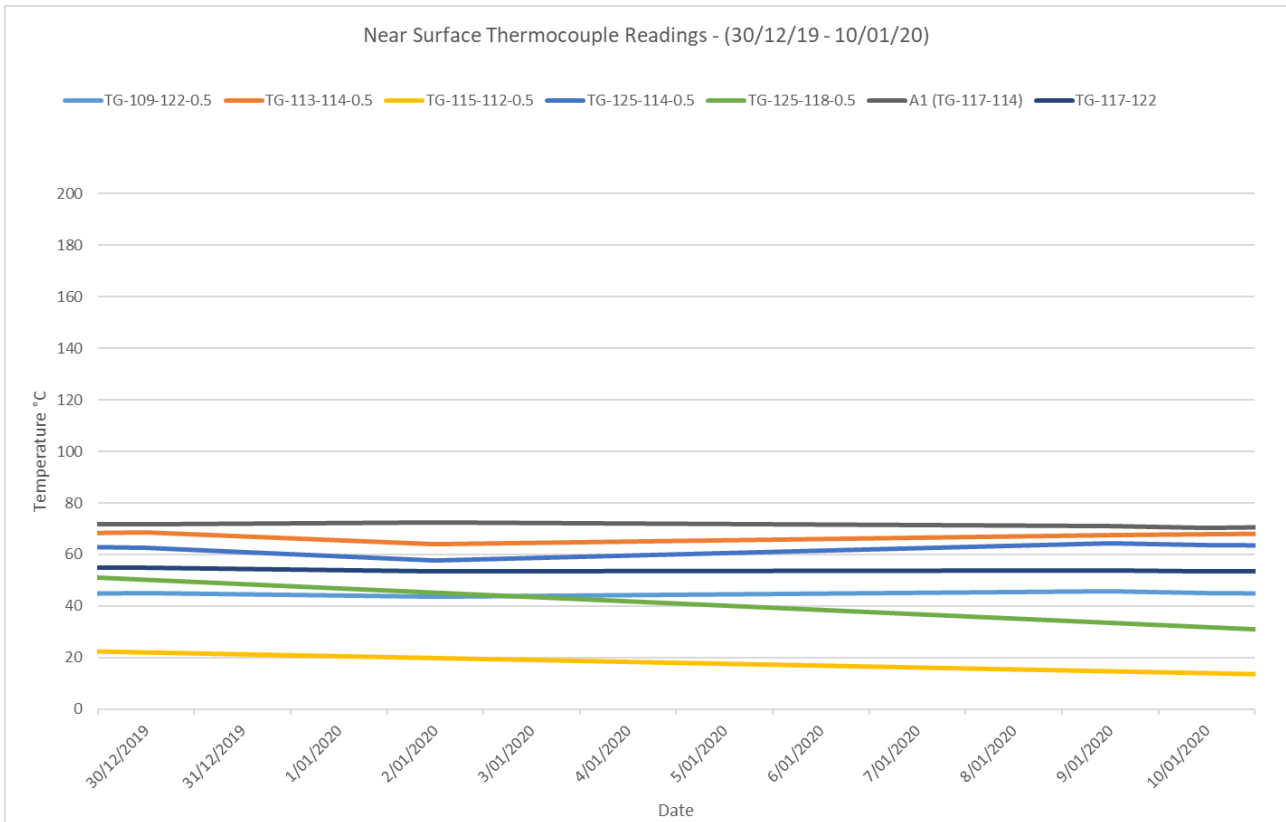
### 3.2. Near-Surface Temperature Graph – Selected Points (Fortnightly)

Near-surface temperature measurements for key thermocouple locations, over the monitoring period – 30<sup>th</sup> December 2019 and 10<sup>th</sup> January 2020.

The near-surface temperature at selected points across the northwest hotspot over the period of monitoring appear to remain consistent.

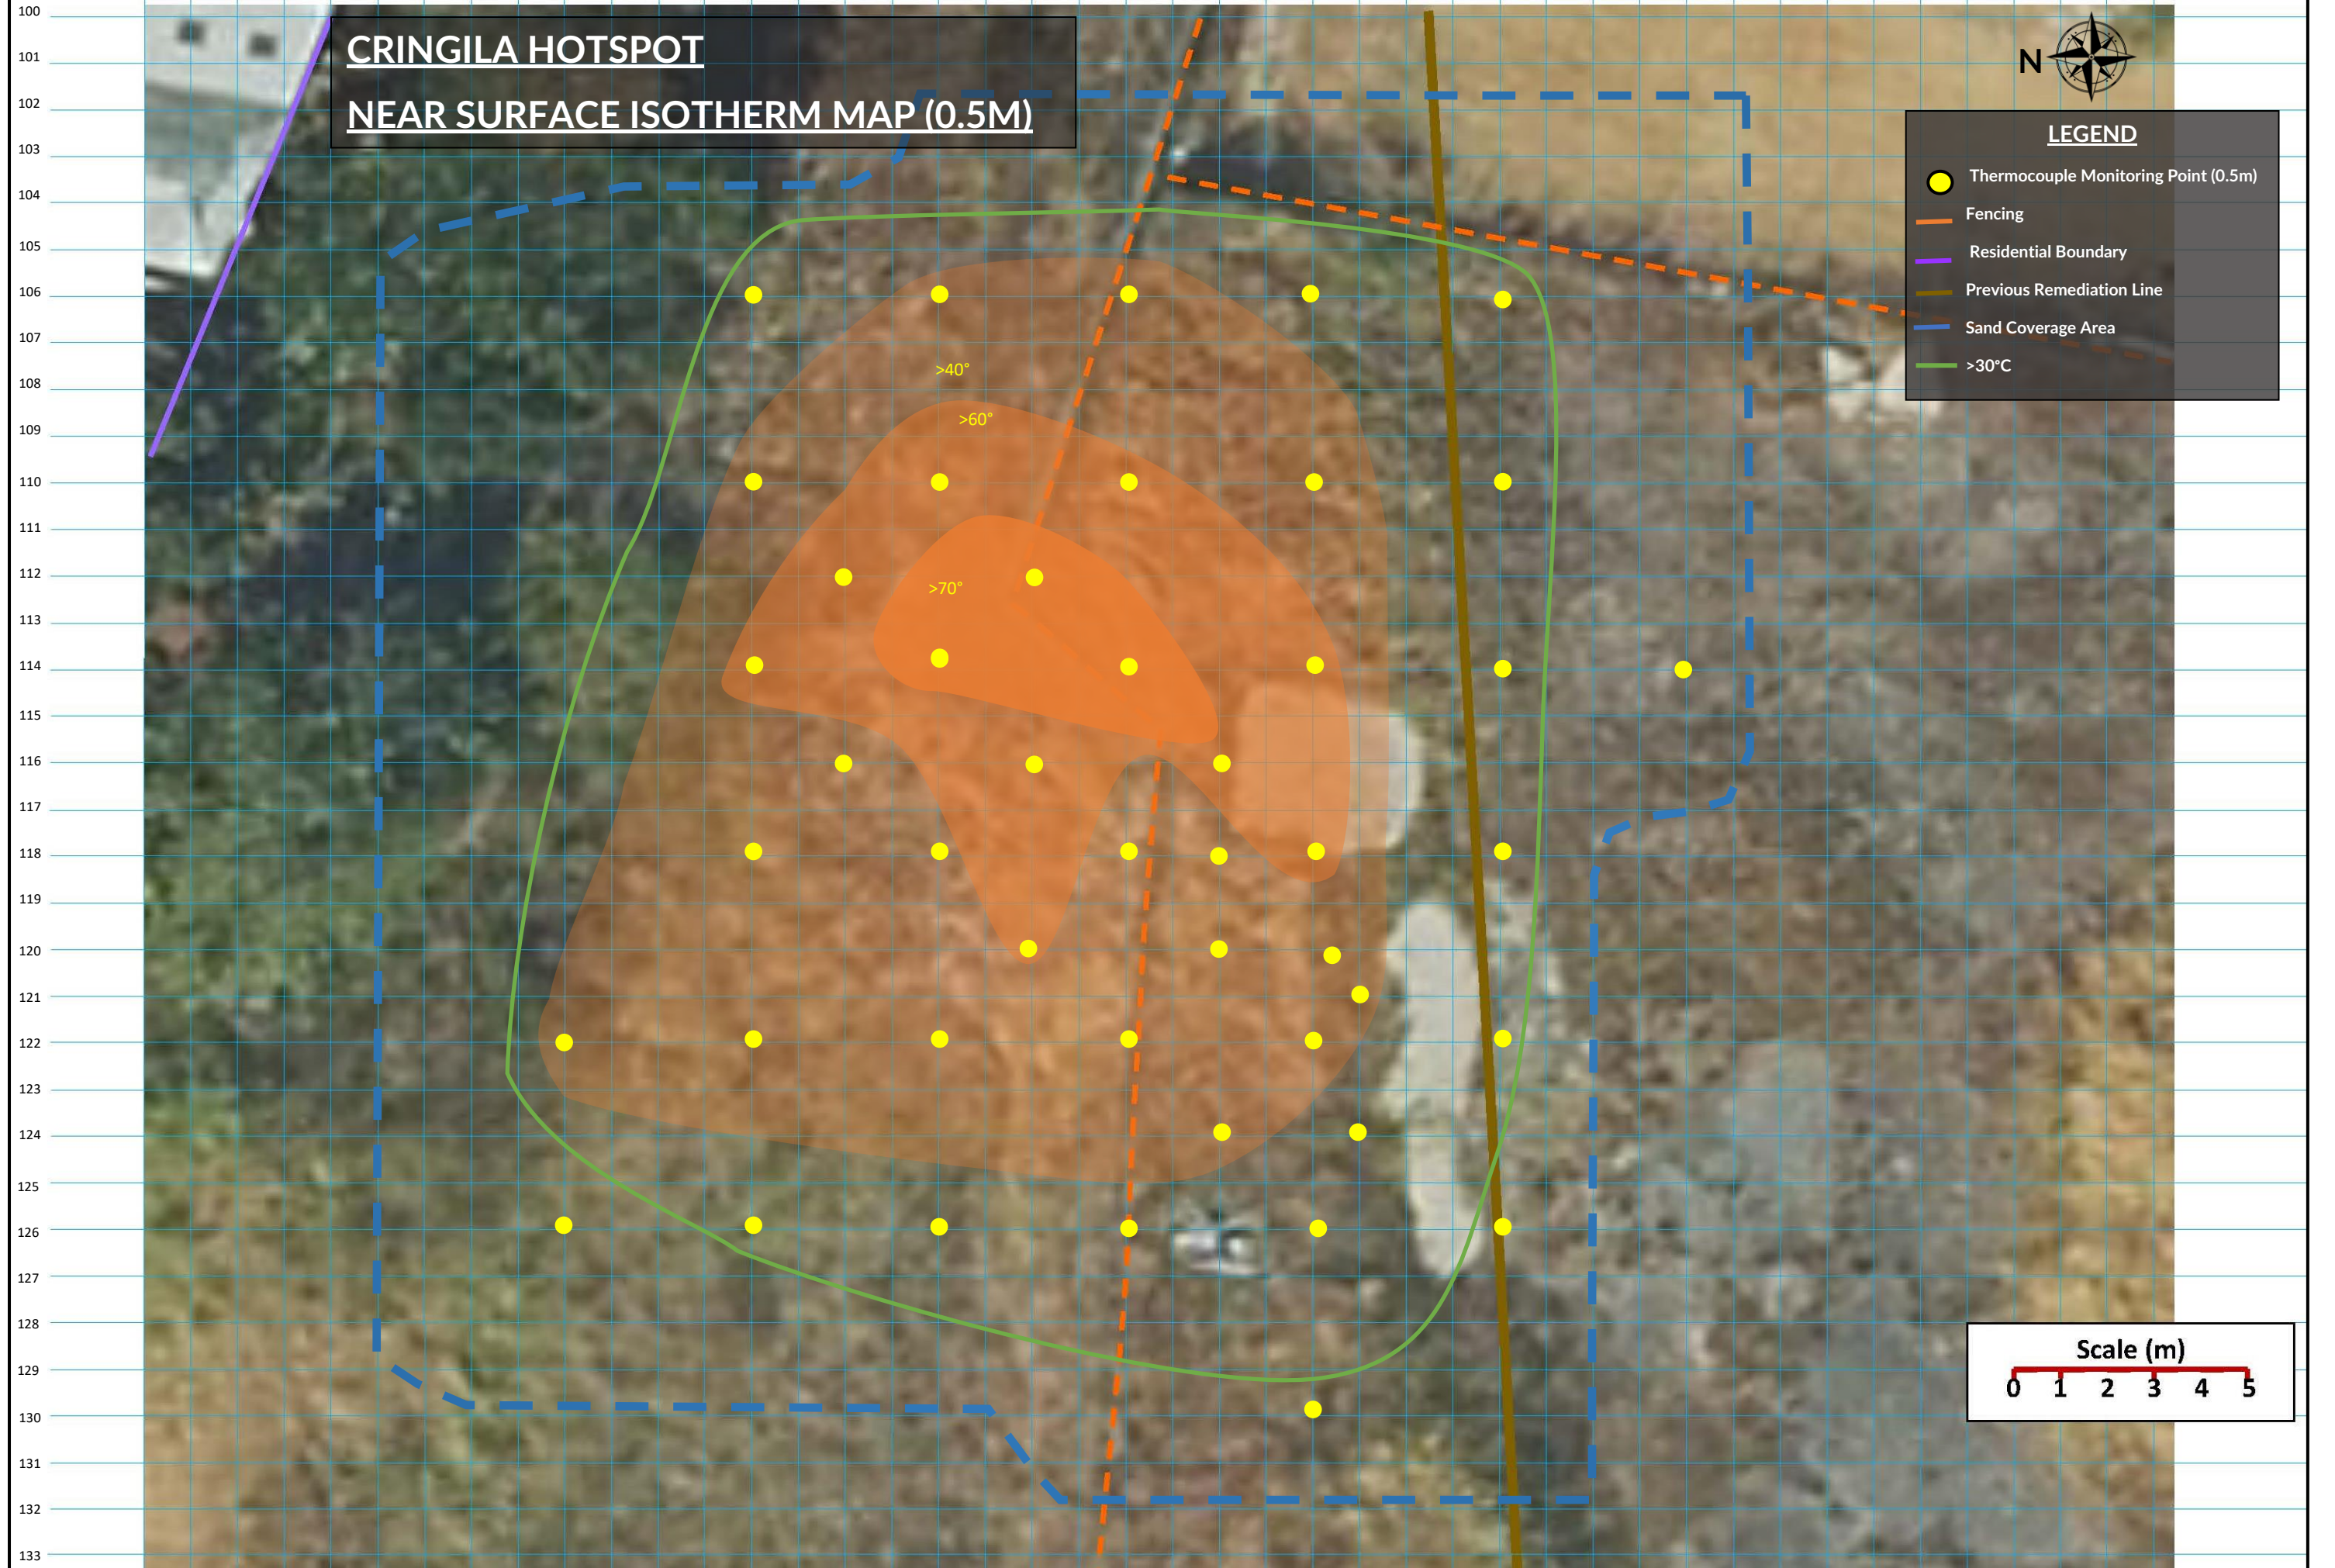
### Appendix B: Near-Surface Temperature Isotherm Map (0.5m)

The isotherm map shows the general zone of influence for temperatures between 30°C and 70°C at 0.5m, coloured orange. The isotherm map suggests that the hotspot may extend deeper than 0.5m and that the increased temperature in these areas is a result of heat venting to the surface.

It is noted that temperature at the near-surface may be variable across the hotspot due to inconsistencies in the consolidation and compaction of subsurface materials.

It is recommended that weekly site inspections and recording are continued to monitor the near-surface temperatures surrounding the subsurface hotspot identified at the site.
