## NEAR-SURFACE TEMPERATURE MONITORING INVESTIGATION CRINGILA PUBLIC SCHOOL - NW HOTSPOT

Summary Report  
27/01/2020 - 07/02/2020

NSW Department  
of Education  
Cringila Public School

February 2020  
C107471: J153825-03: TO/RC

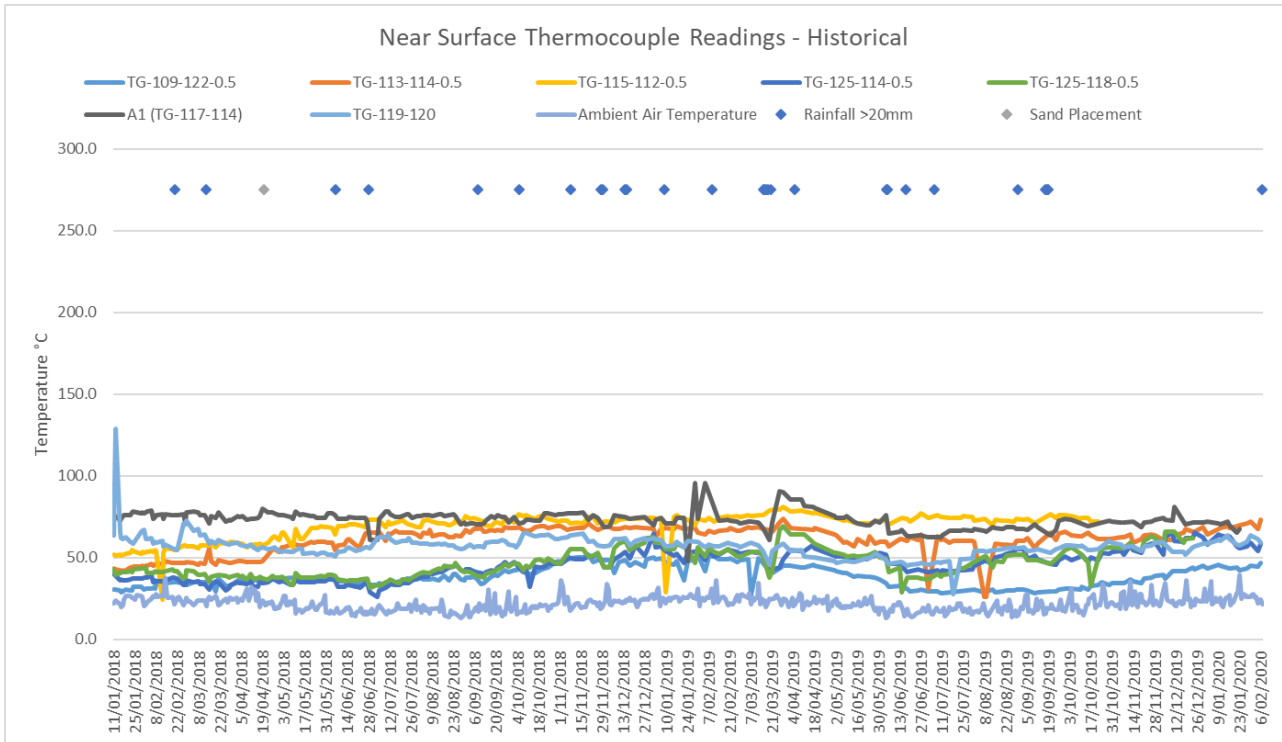
### 3.1. Near-Surface Temperature Graph – Selected Points (Historical)

Near surface temperature measurements for key thermocouple locations, progressive from Thursday 11<sup>th</sup> January 2018 to present.

The near-surface temperature appears to fluctuate seasonally across the surface of the northwest hotspot grid monitoring area.

Fluctuations in near-surface temperature are also evident following significant rain events (i.e. over 20mm rain).

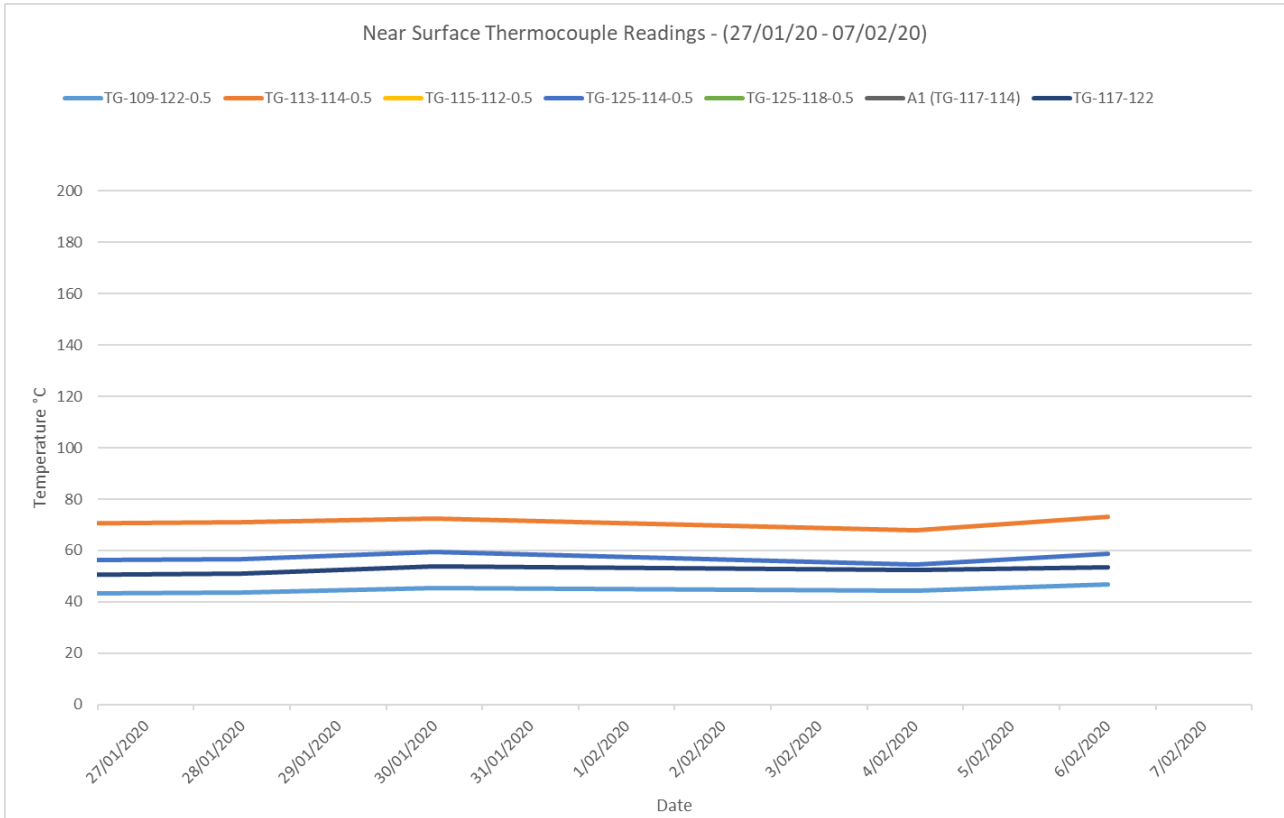
### 3.2. Near-Surface Temperature Graph – Selected Points (Fortnightly)

Near-surface temperature measurements for key thermocouple locations, over the monitoring period – 27<sup>th</sup> January 2020 to 7<sup>th</sup> February 2020. Please note – data from certain points was not available within this date range due to technical constraints.

The near-surface temperature at selected points across the northwest hotspot over the period of monitoring appear to remain consistent.

The near-surface temperature monitoring conducted between 27<sup>th</sup> January 2020 and 7<sup>th</sup> February 2020 indicates that the spatial extent of the northwest hotspot appears to remain localised.

There were no significant near-surface temperature variations identified during the period of monitoring.

It is recommended that weekly site inspections and recording are continued to monitor the near-surface temperatures surrounding the subsurface hotspot identified at the site.

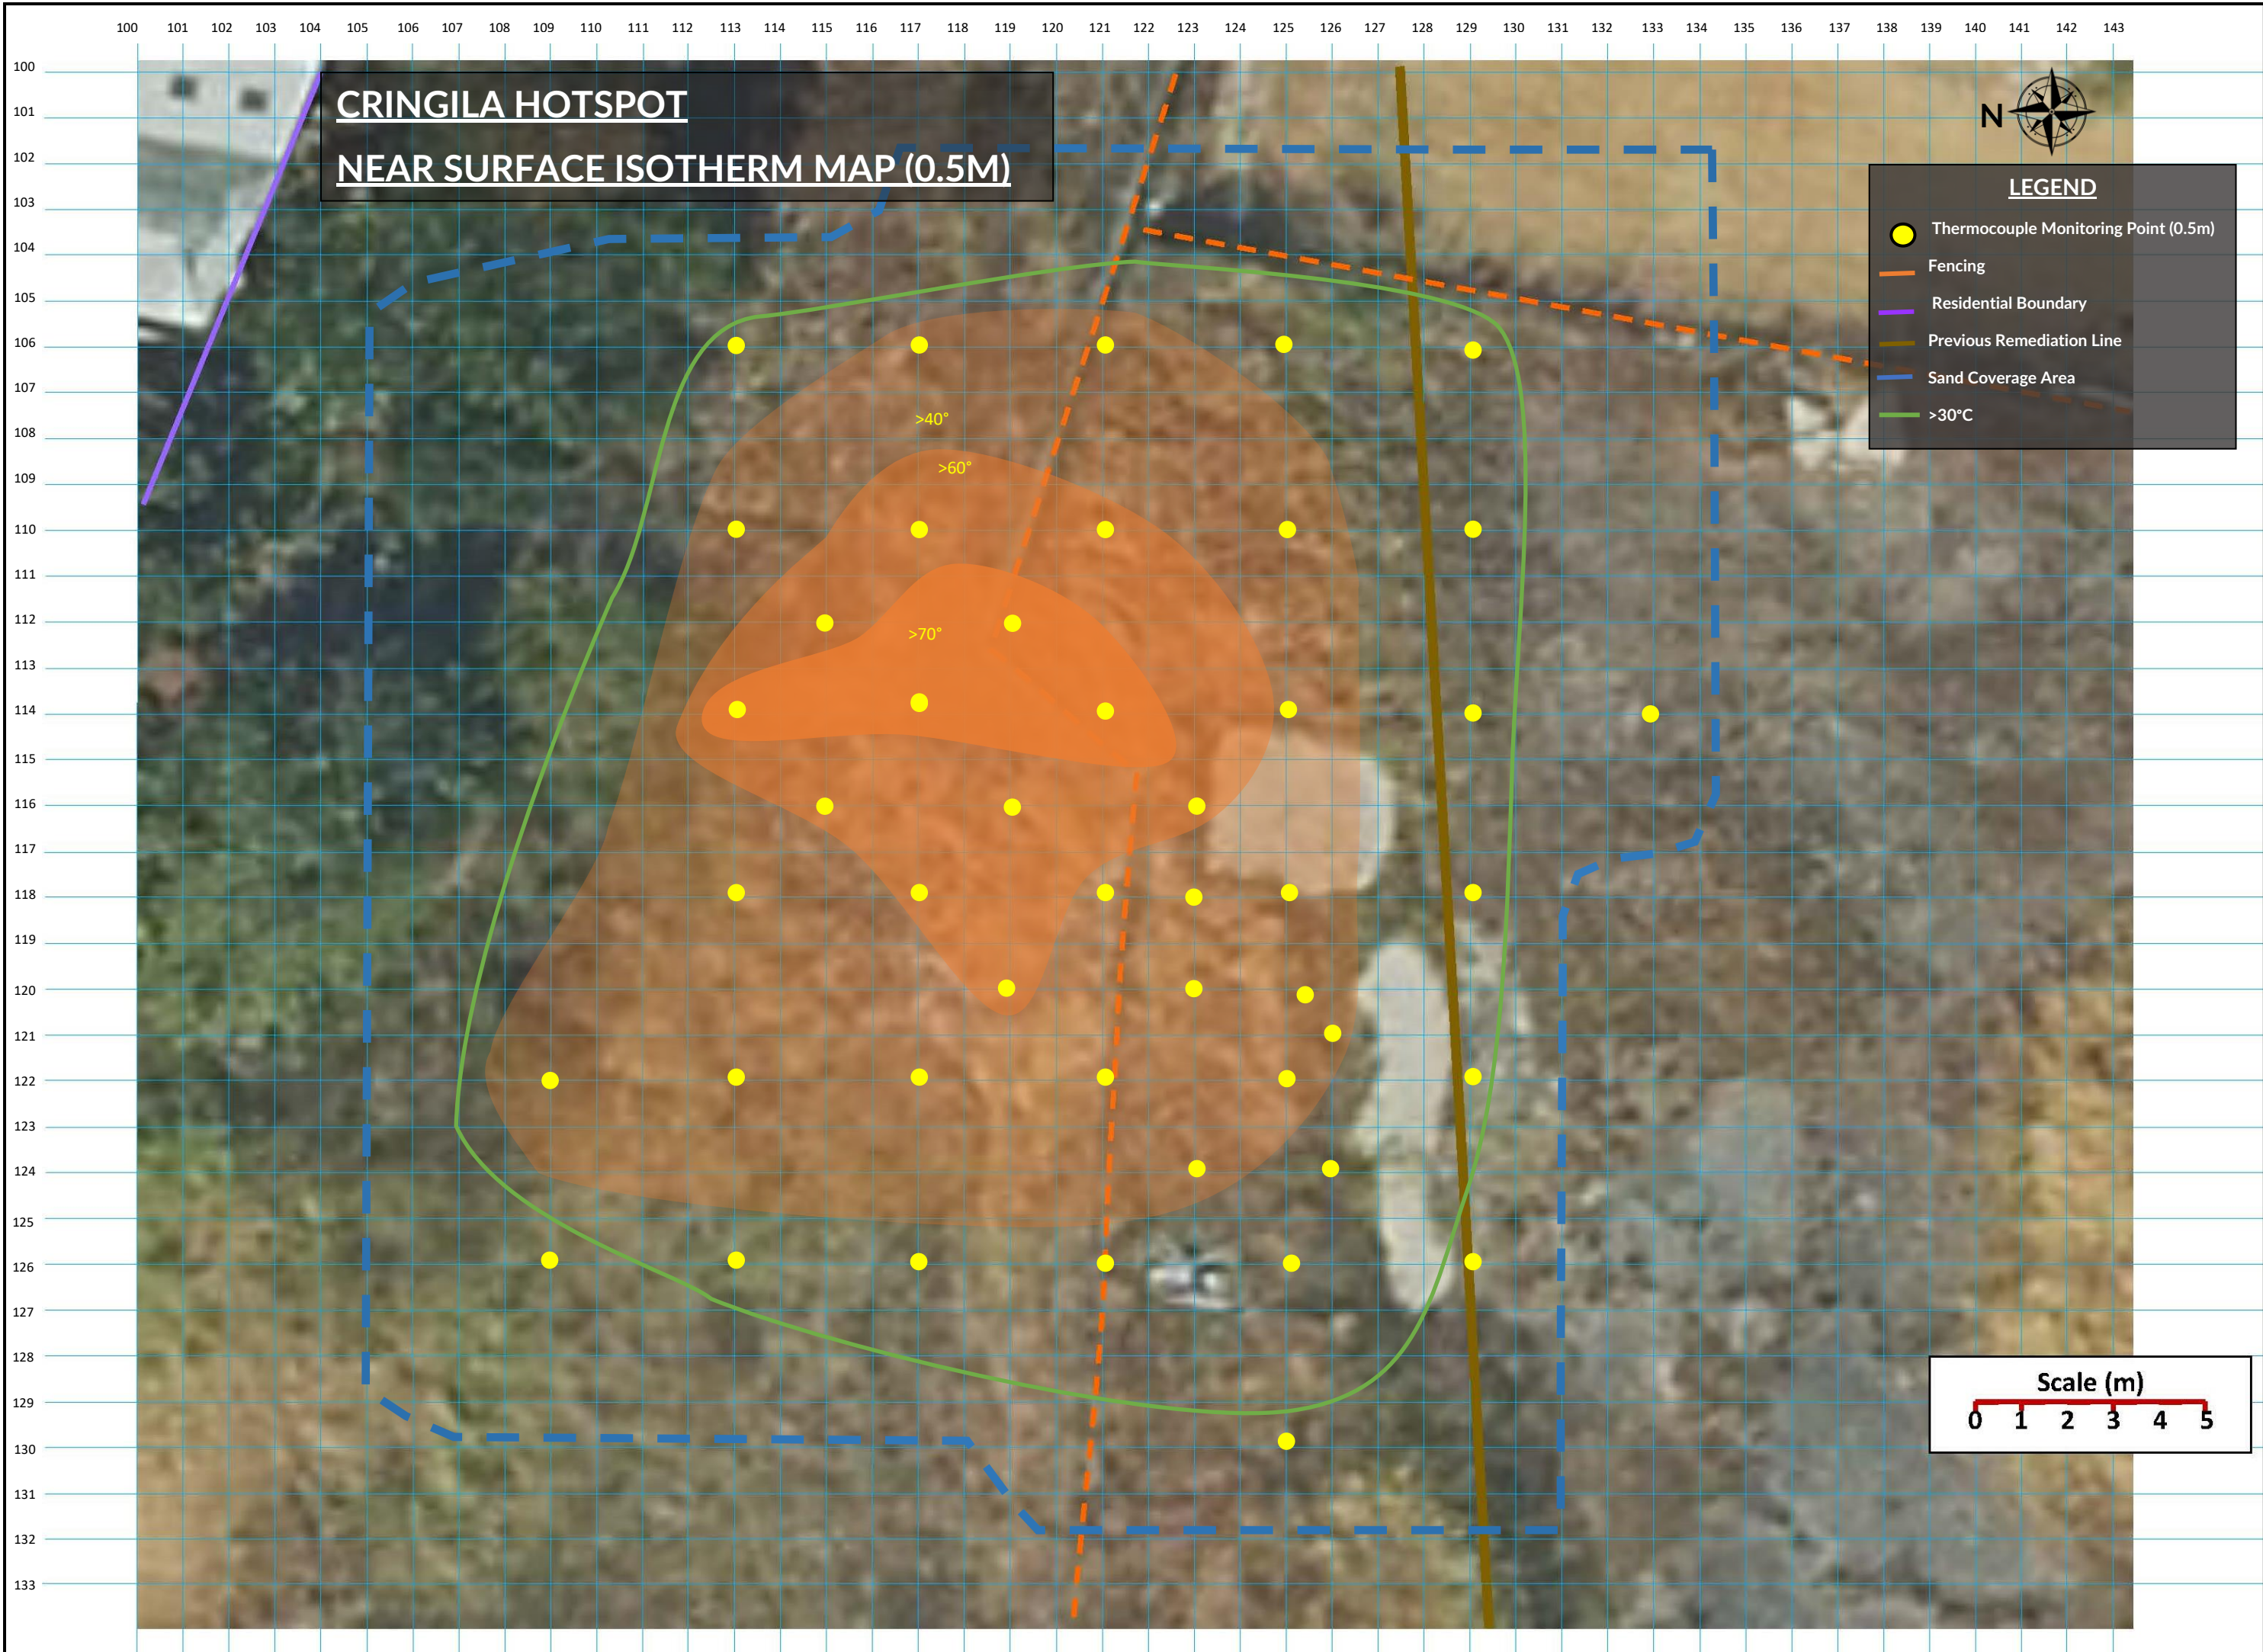
# CRINGILA HOTSPOT NEAR SURFACE ISOTHERM MAP (0.5M)

The isotherm map shows the general zone of influence for temperatures between 30°C and 70°C at 0.5m, coloured orange. The isotherm map suggests that the hotspot may extend deeper than 0.5m and that the increased temperature in these areas is a result of heat venting to the surface.

It is noted that temperature at the near-surface may be variable across the hotspot due to inconsistencies in the consolidation and compaction of subsurface materials.

The near-surface temperatures for representative monitoring locations, spread across the northwest Hotspot, are presented in the tables below. Temperature isotherms have been plotted on a site map to show an illustration of the near-surface temperatures in a spatial context. Refer to **Appendix B: Near Surface Temperature Isotherm Map (0.5m)**.
