CRINGILA PUBLIC SCHOOL NEAR-SURFACE TEMPERATURE MONITORING INVESTIGATION

Summary Report
10/02/2020 – 21/02/2020

Cringila Public School

Cringila Public School – Northwest Hotspot

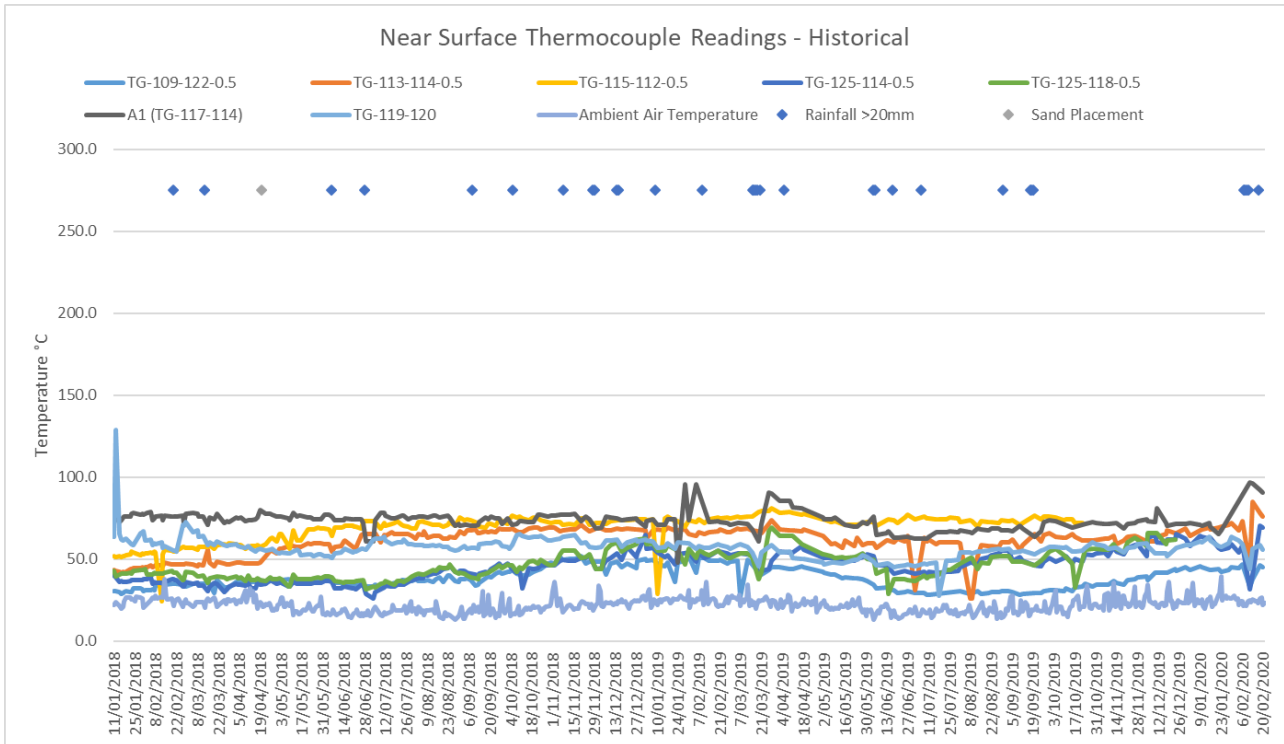
3.1. Near-Surface Temperature Graph – Selected Points (Historical)

Near surface temperature measurements for key thermocouple locations, progressive from Thursday 11th January 2018 to present.

The near-surface temperature appears to fluctuate seasonally across the surface of the northwest hotspot grid monitoring area.

Fluctuations in near-surface temperature are also evident following significant rain events (i.e. over 20mm rain).

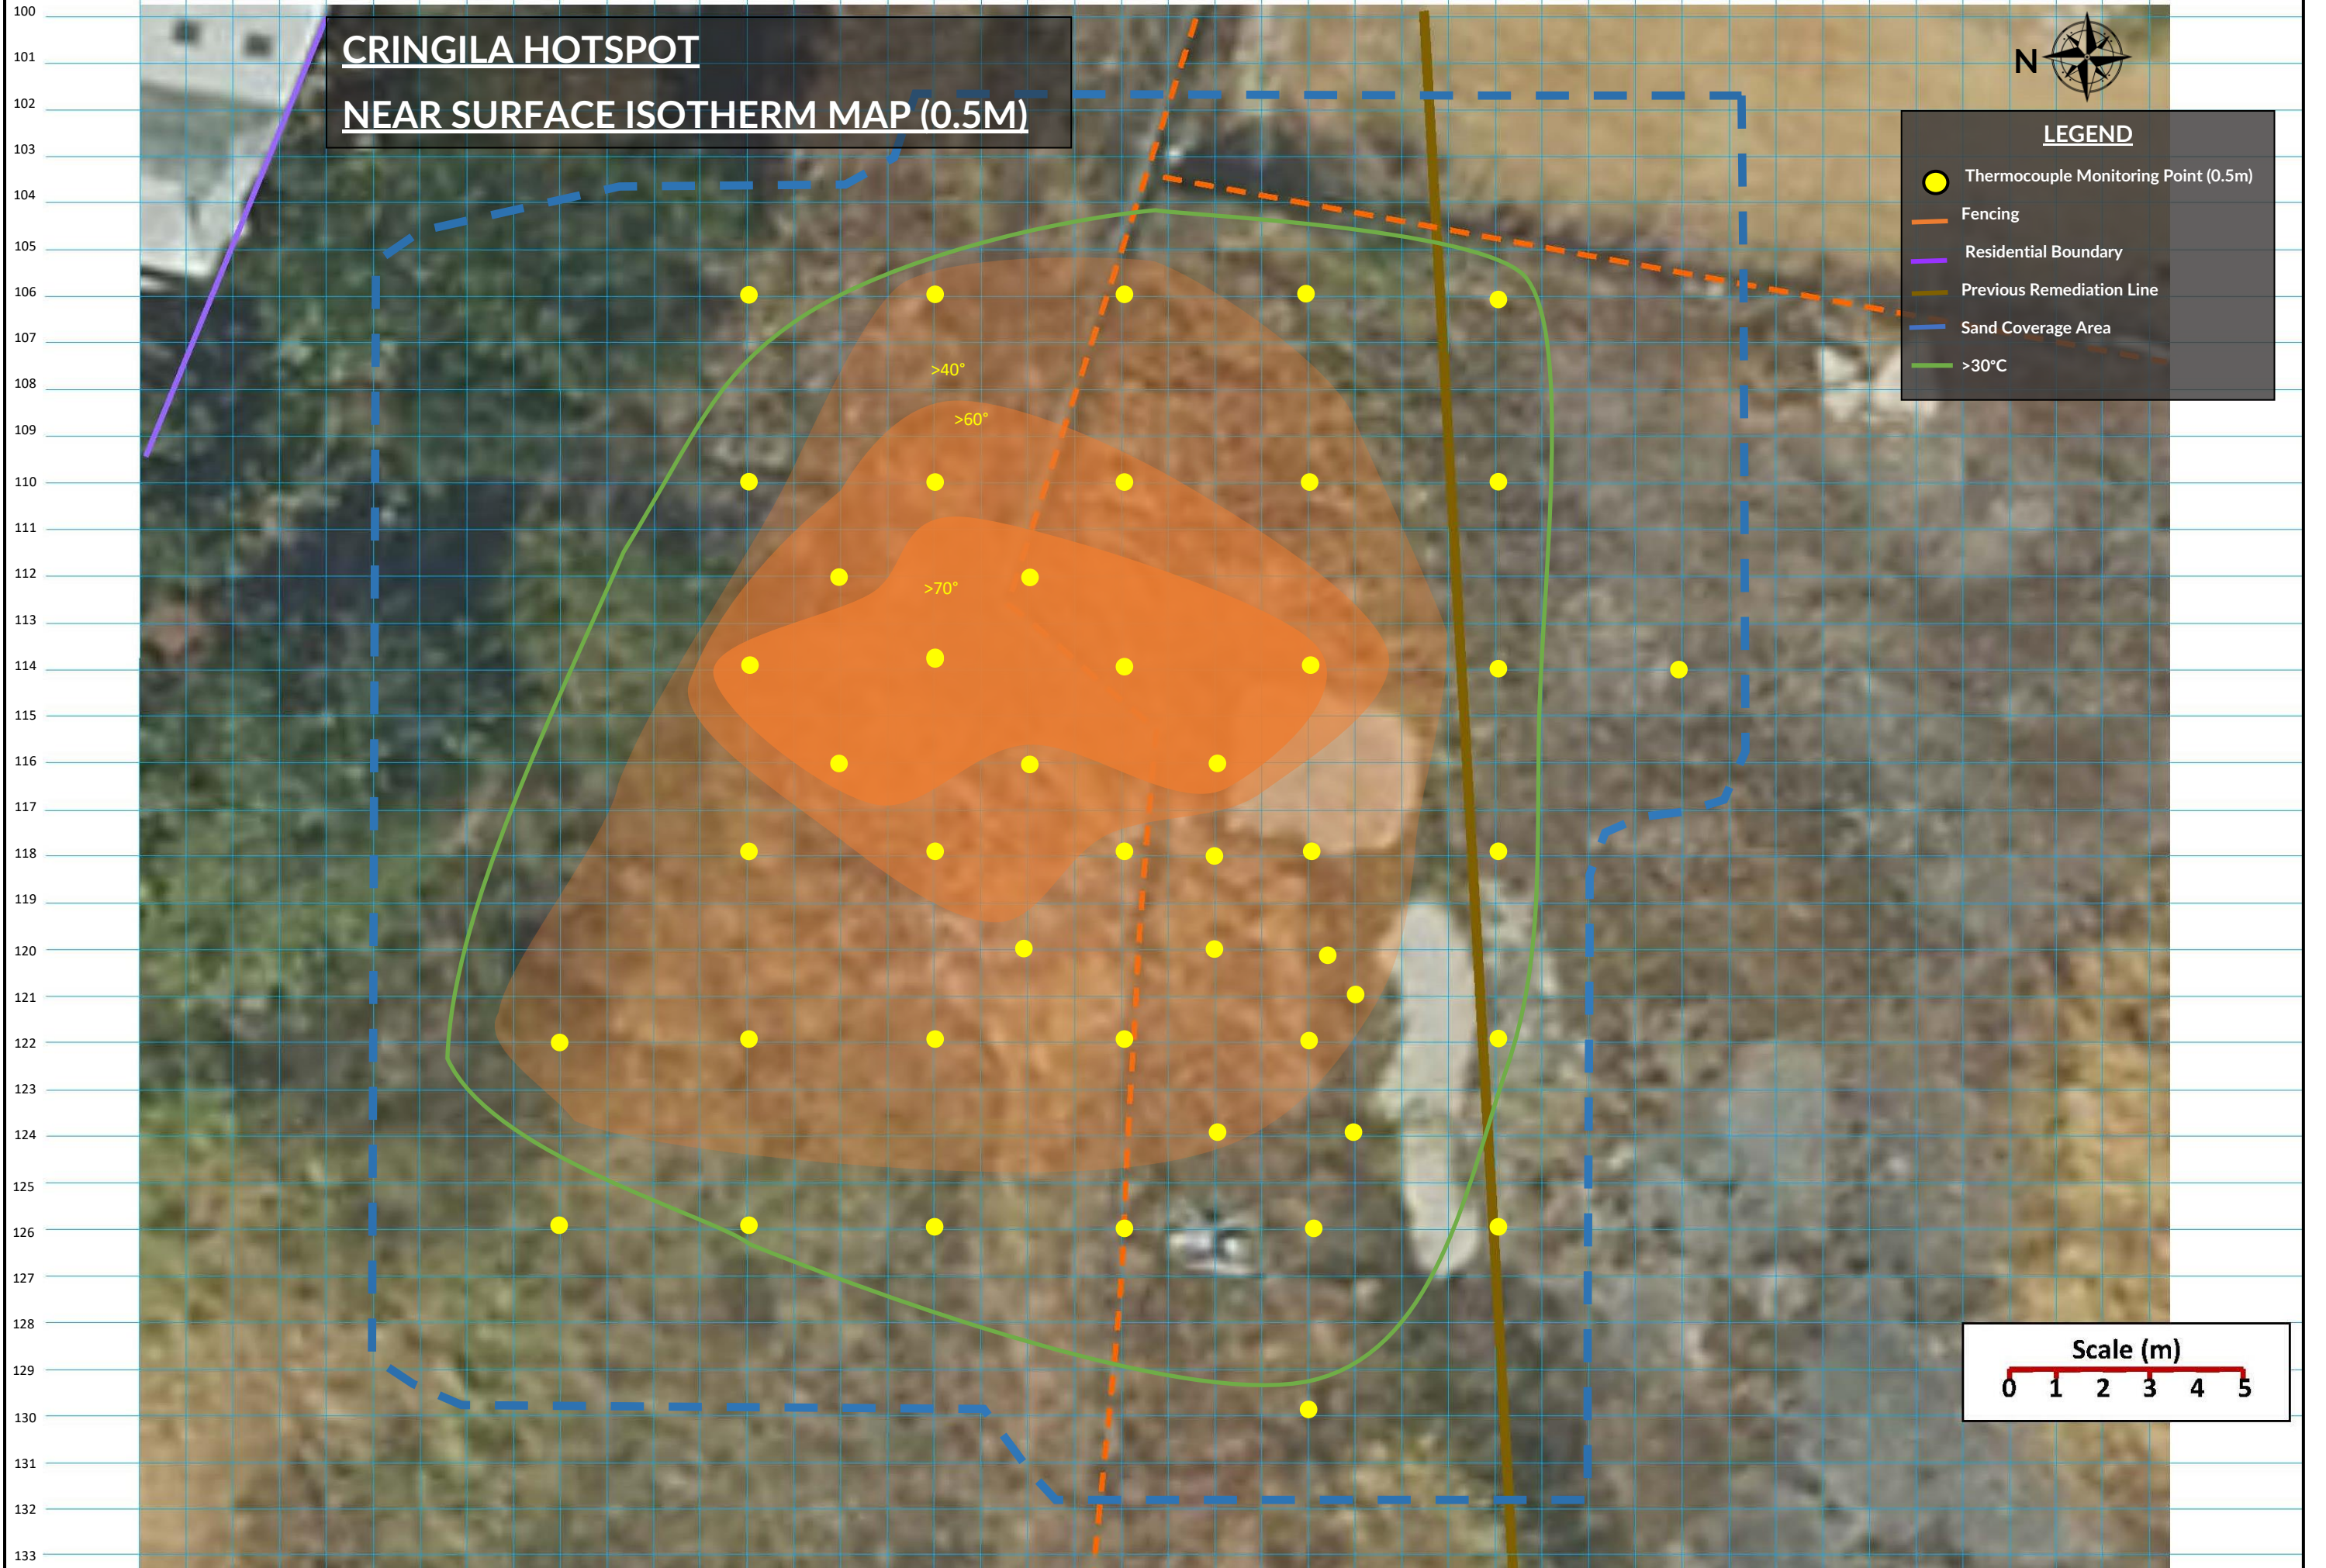
Appendix B: Near-Surface Temperature Isotherm Map (0.5m)

The isotherm map shows the general zone of influence for temperatures between 30°C and 70°C at 0.5m, coloured orange. The isotherm map suggests that the hotspot may extend deeper than 0.5m and that the increased temperature in these areas is a result of heat venting to the surface.

It is noted that temperature at the near-surface may be variable across the hotspot due to inconsistencies in the consolidation and compaction of subsurface materials.

CRINGILA HOTSPOT NEAR SURFACE ISOTHERM MAP (0.5M)

The near-surface temperature monitoring conducted between 10th February 2020 and 21st February 2020 indicates that the spatial extent of the northwest hotspot appears to remain localised.

It is recommended that weekly site inspections and recording are continued to monitor the near-surface temperatures surrounding the subsurface hotspot identified at the site.
