CRINGILA PUBLIC SCHOOL NEAR-SURFACE TEMPERATURE MONITORING INVESTIGATION

Summary Report
24/02/2020 – 06/03/2020

Cringila Public School

March 2020
C107471: J153825-03: TO/RC

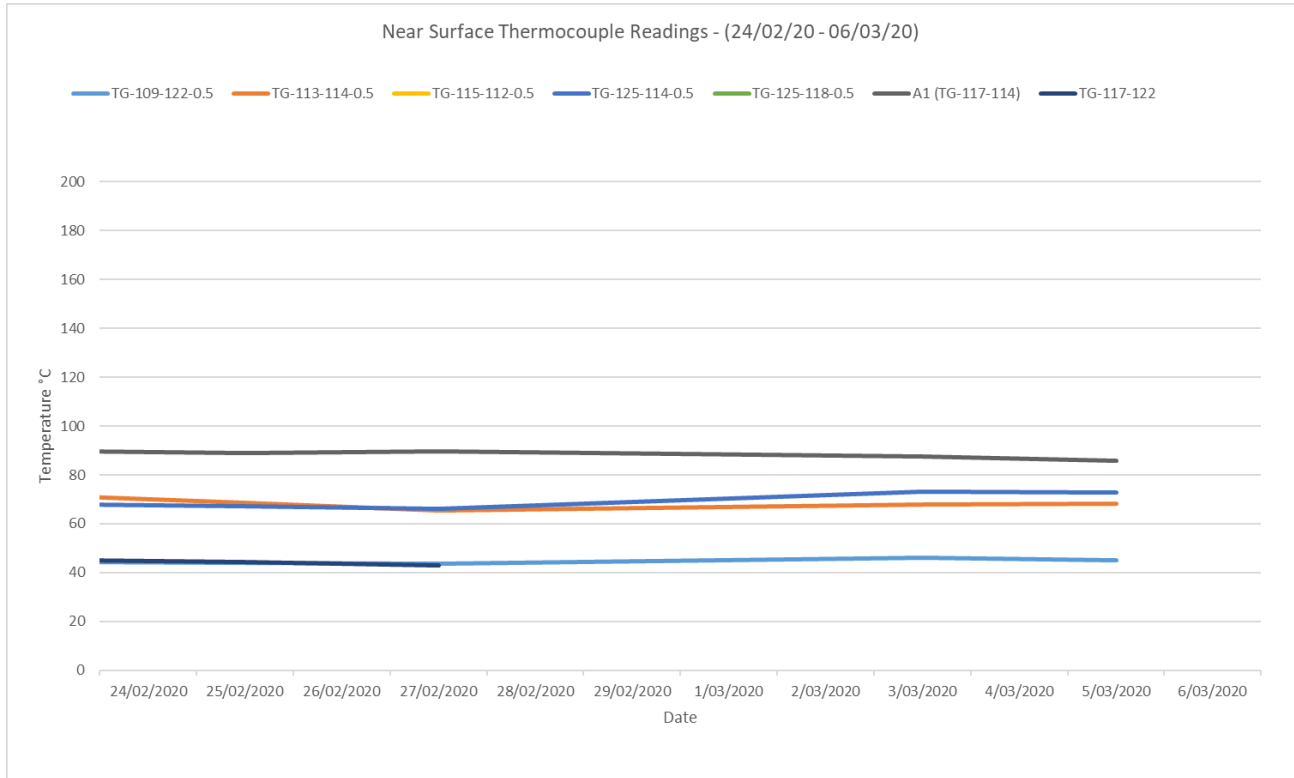
3.2. Near-Surface Temperature Graph – Selected Points (Fortnightly)

Near-surface temperature measurements for key thermocouple locations, over the monitoring period – between 24th February 2020 and 6th March 2020. Please note – data from certain points was not available within this date range due to technical constraints.

Variations in the near-surface temperature at selected points across the northwest hotspot over the period of monitoring appear to coincide with the high rainfall events during the period.

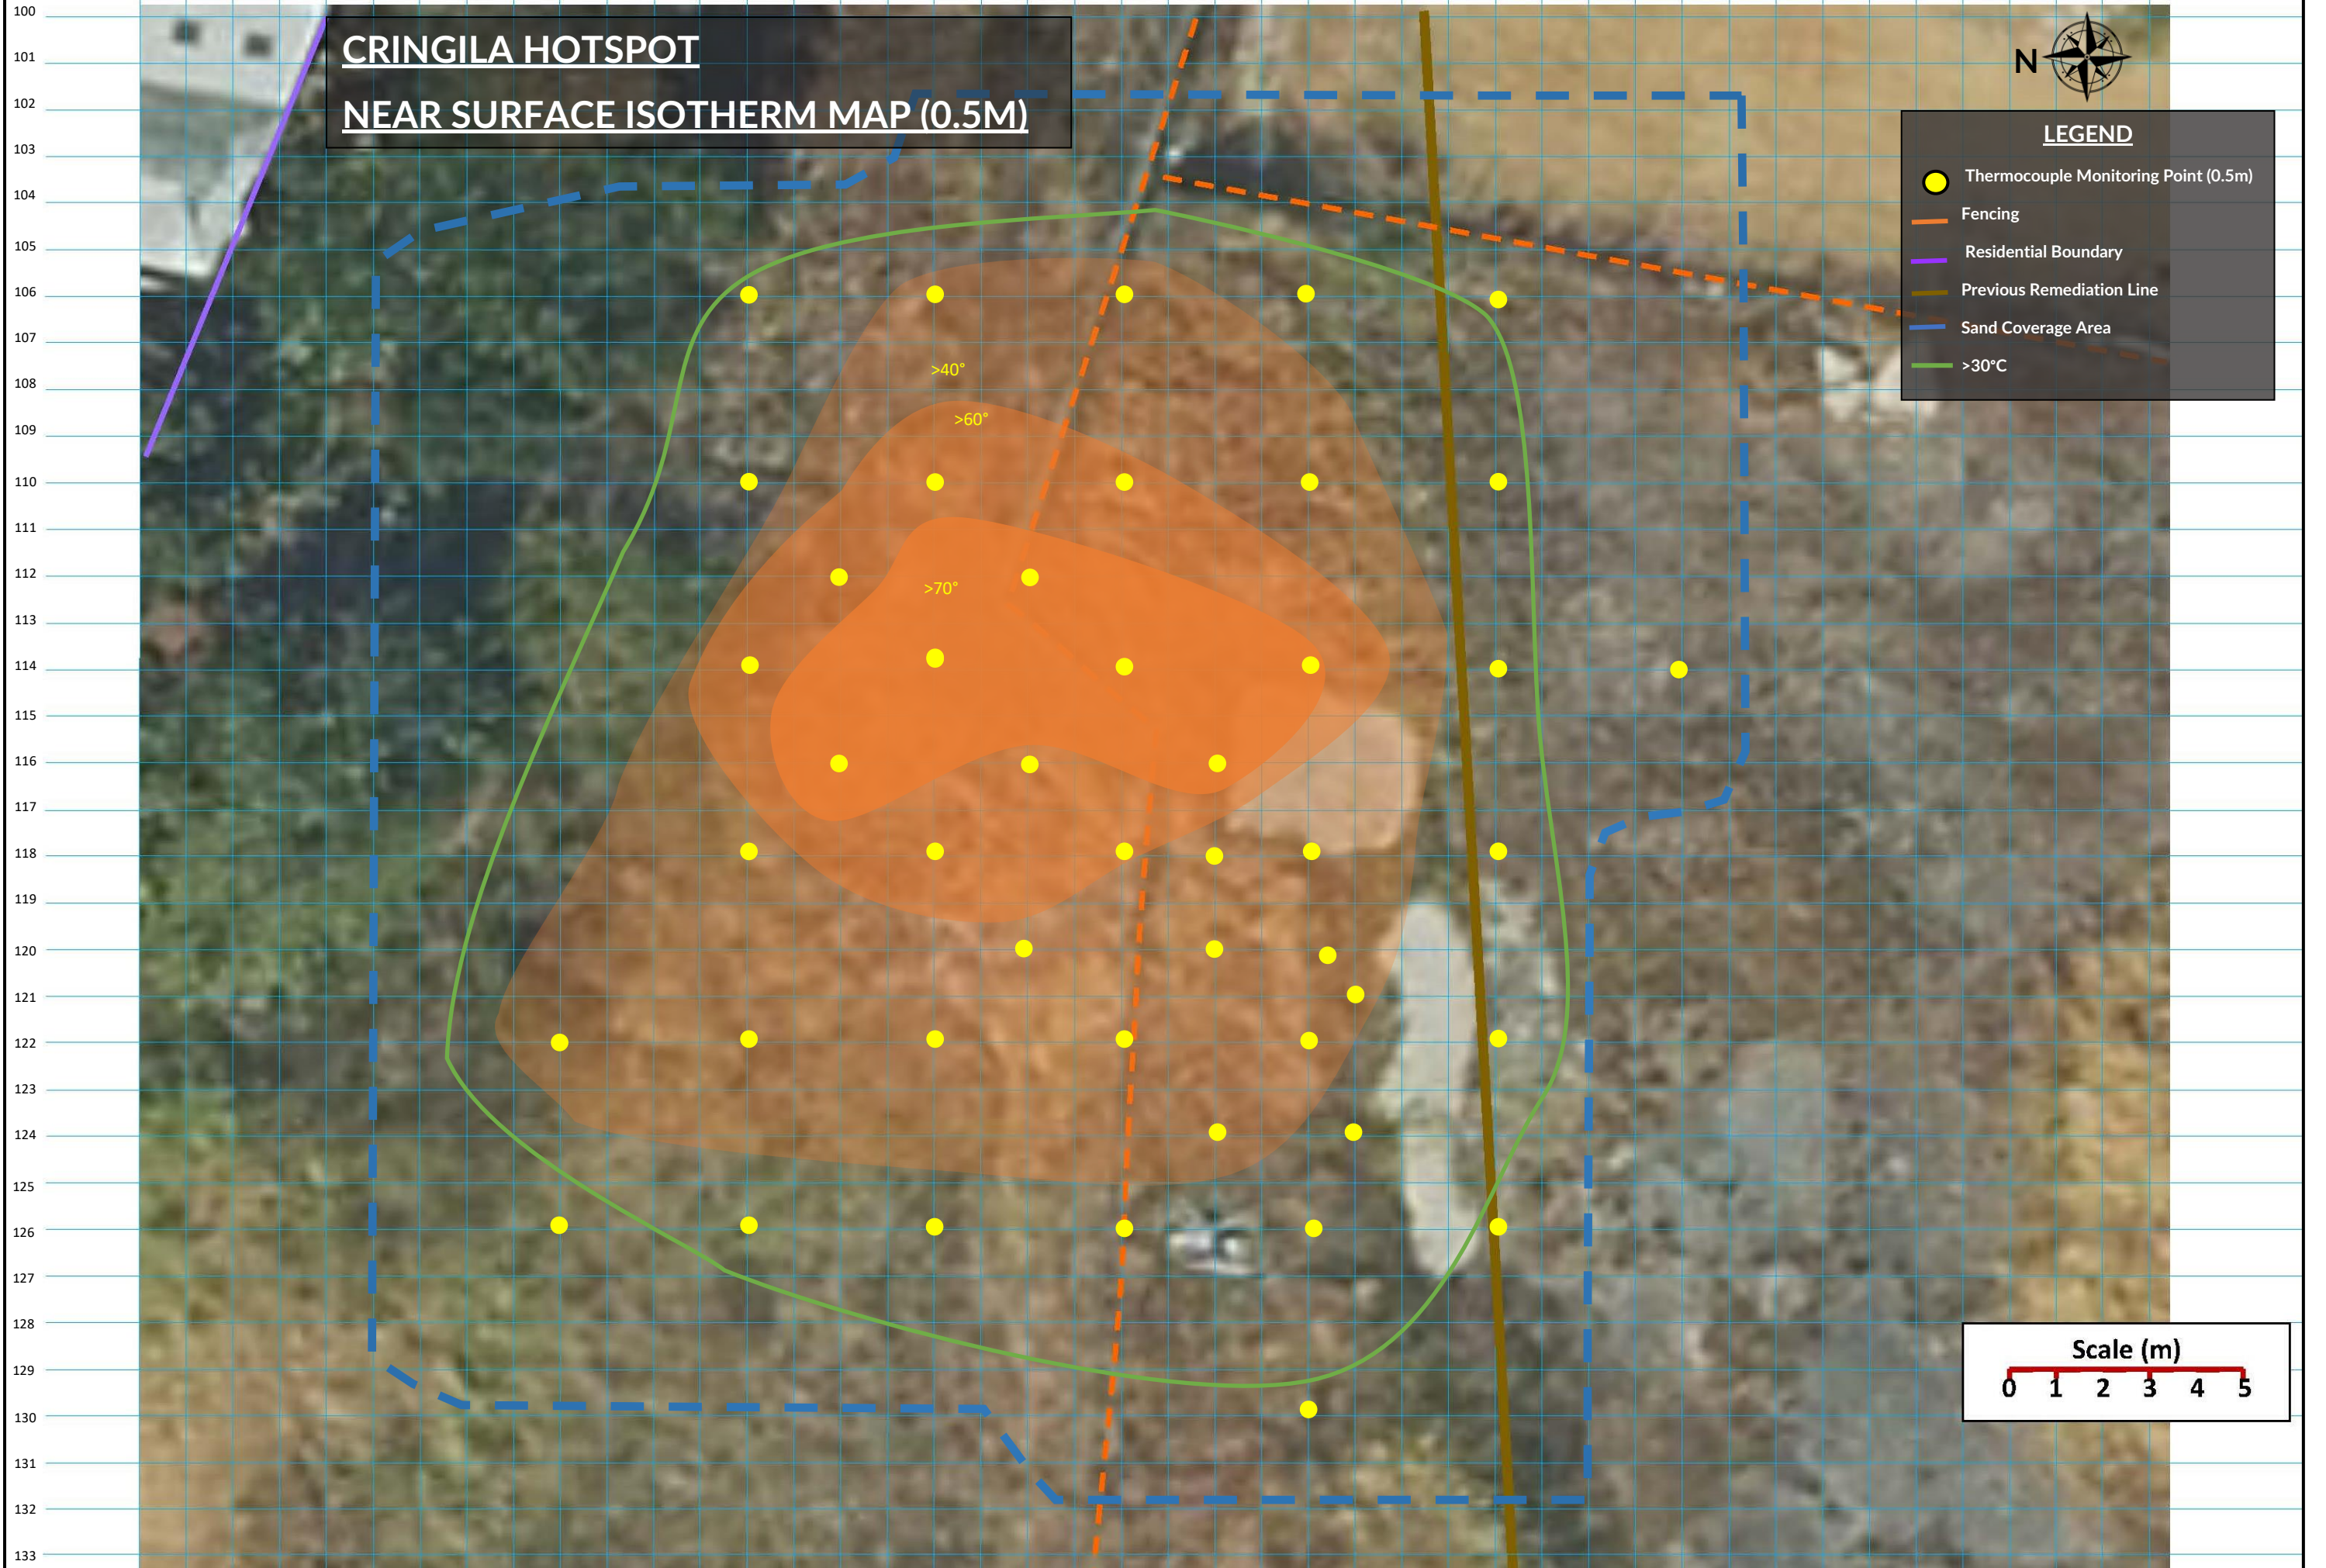
Appendix B: Near-Surface Temperature Isotherm Map (0.5m)

The isotherm map shows the general zone of influence for temperatures between 30°C and 70°C at 0.5m, coloured orange. The isotherm map suggests that the hotspot may extend deeper than 0.5m and that the increased temperature in these areas is a result of heat venting to the surface.

It is noted that temperature at the near-surface may be variable across the hotspot due to inconsistencies in the consolidation and compaction of subsurface materials.

CRINGILA HOTSPOT NEAR SURFACE ISOTHERM MAP (0.5M)

It is recommended that weekly site inspections and recording are continued to monitor the near-surface temperatures surrounding the subsurface hotspot identified at the site.
