CRINGILA PUBLIC SCHOOL NEAR-SURFACE TEMPERATURE MONITORING INVESTIGATION

Summary Report
09/03/2020 – 20/03/2020

Cringila Public School

March 2020
C107471: J153825-03: TO/RC

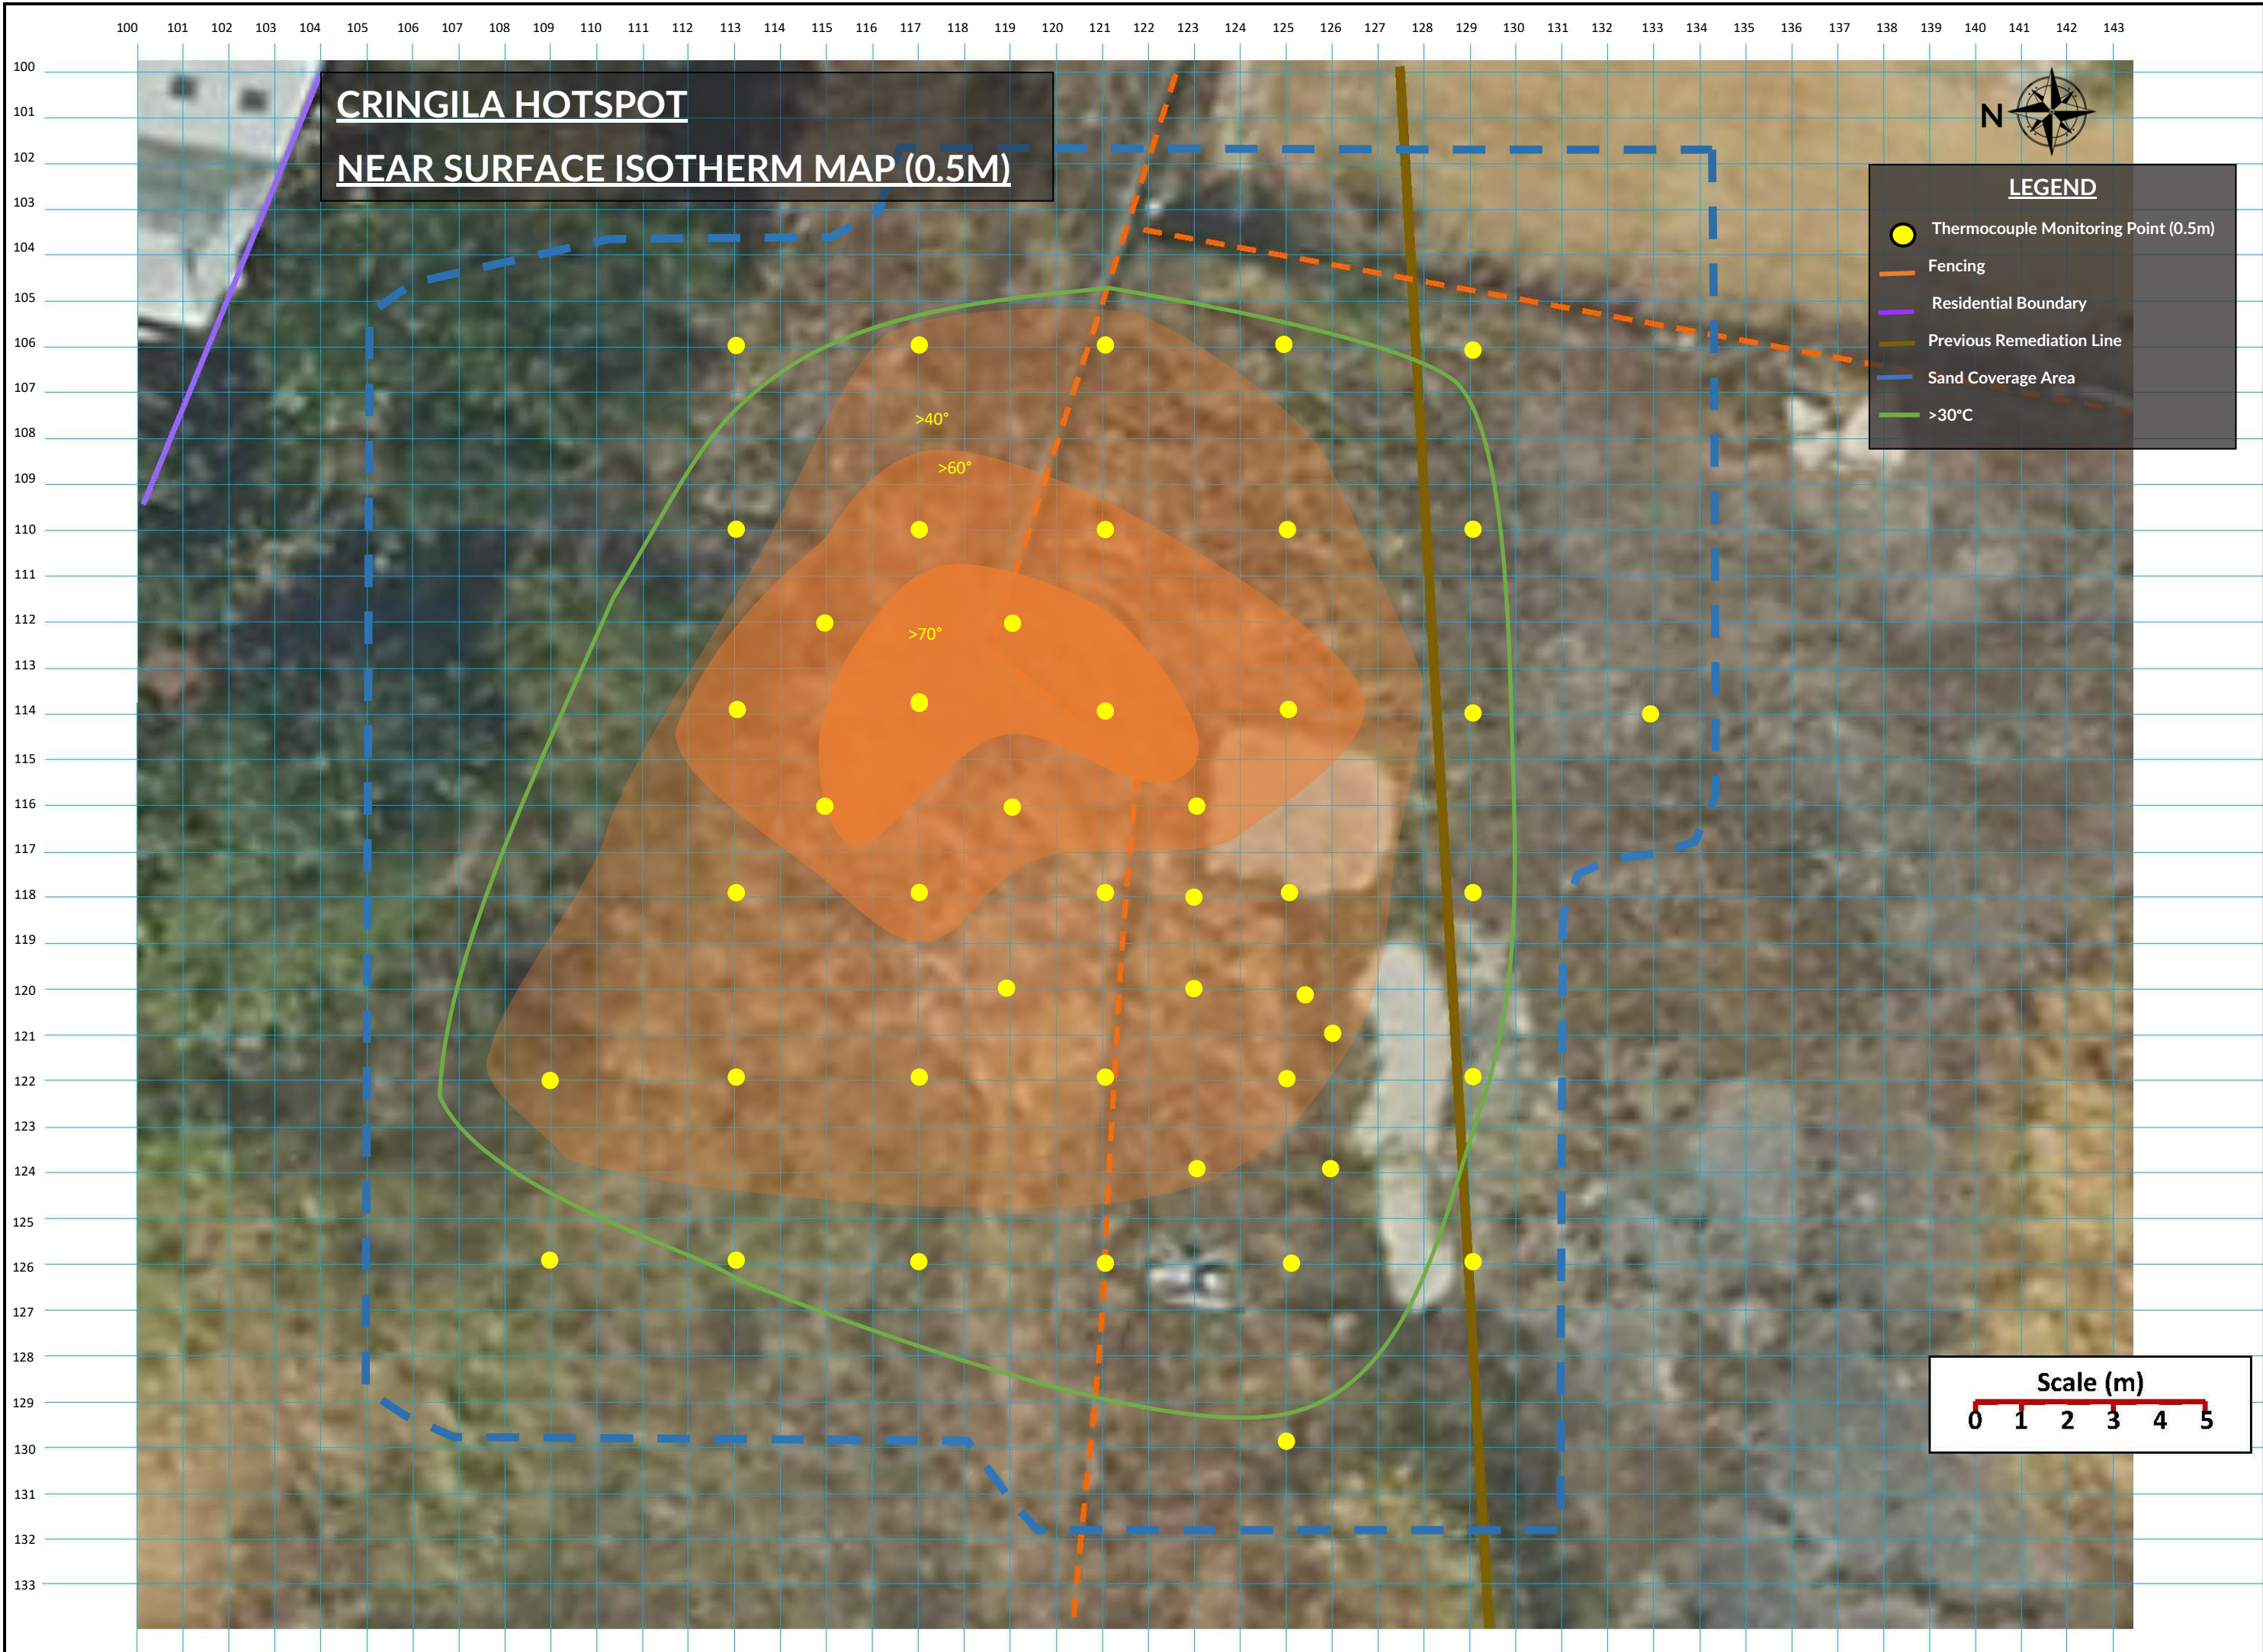
CRINGILA HOTSPOT NEAR SURFACE ISOTHERM MAP (0.5M)

The isotherm map shows the general zone of influence for temperatures between 30°C and 70°C at 0.5m, coloured orange. The isotherm map suggests that the hotspot may extend deeper than 0.5m and that the increased temperature in these areas is a result of heat venting to the surface.

It is noted that temperature at the near-surface may be variable across the hotspot due to inconsistencies in the consolidation and compaction of subsurface materials.

The near-surface temperatures for representative monitoring locations, spread across the northwest Hotspot, are presented in the tables below. Temperature isotherms have been plotted on a site map to show an illustration of the near-surface temperatures in a spatial context. Refer to **Appendix B: Near Surface Temperature Isotherm Map (0.5m)**.

The near-surface temperature monitoring conducted between 9th March 2020 and 20th March 2020 indicates that the spatial extent of the northwest hotspot appears to remain localised.
