CRINGILA PUBLIC SCHOOL NEAR-SURFACE TEMPERATURE MONITORING INVESTIGATION

Summary Report
23/03/2020 – 03/04/2020

Cringila Public School

Near-Surface Temperature Monitoring

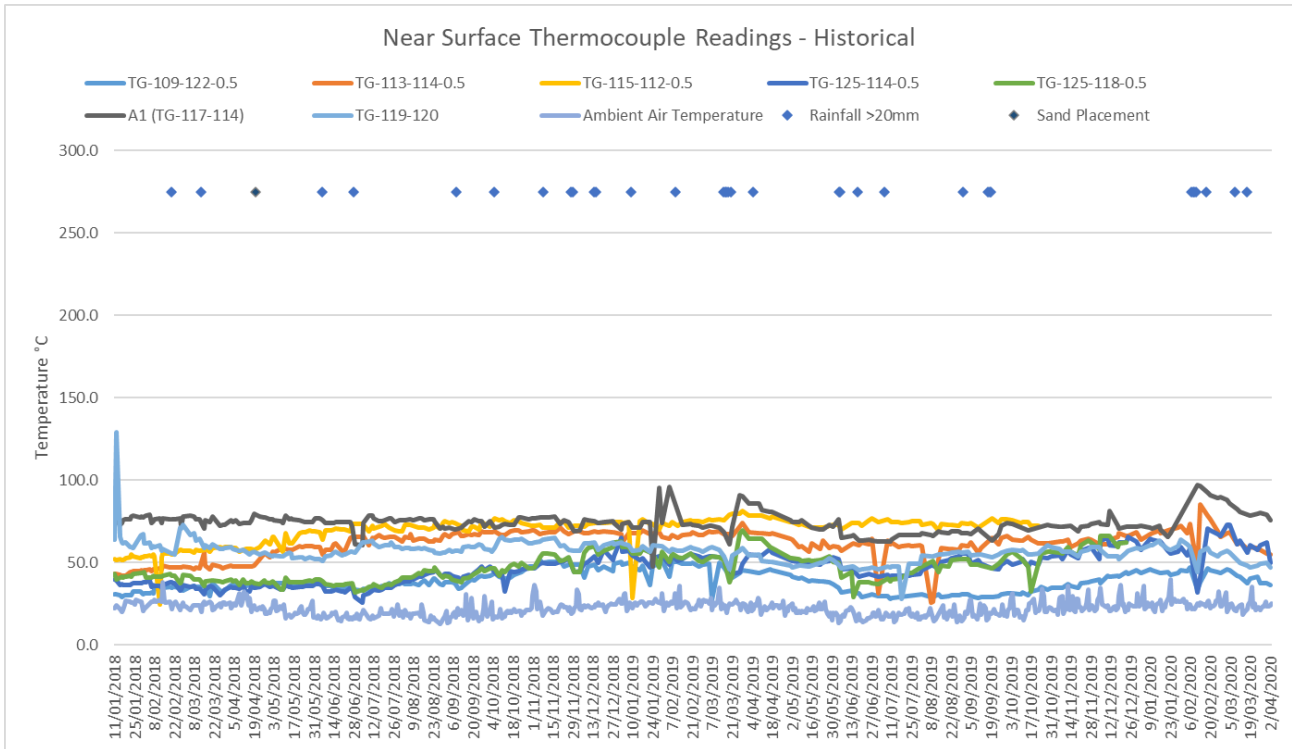
3.1. Near-Surface Temperature Graph – Selected Points (Historical)

Near surface temperature measurements for key thermocouple locations, progressive from Thursday 11th January 2018 to present.

The near-surface temperature appears to fluctuate seasonally across the surface of the northwest hotspot grid monitoring area.

Fluctuations in near-surface temperature are also evident following significant rain events (i.e. over 20mm rain).

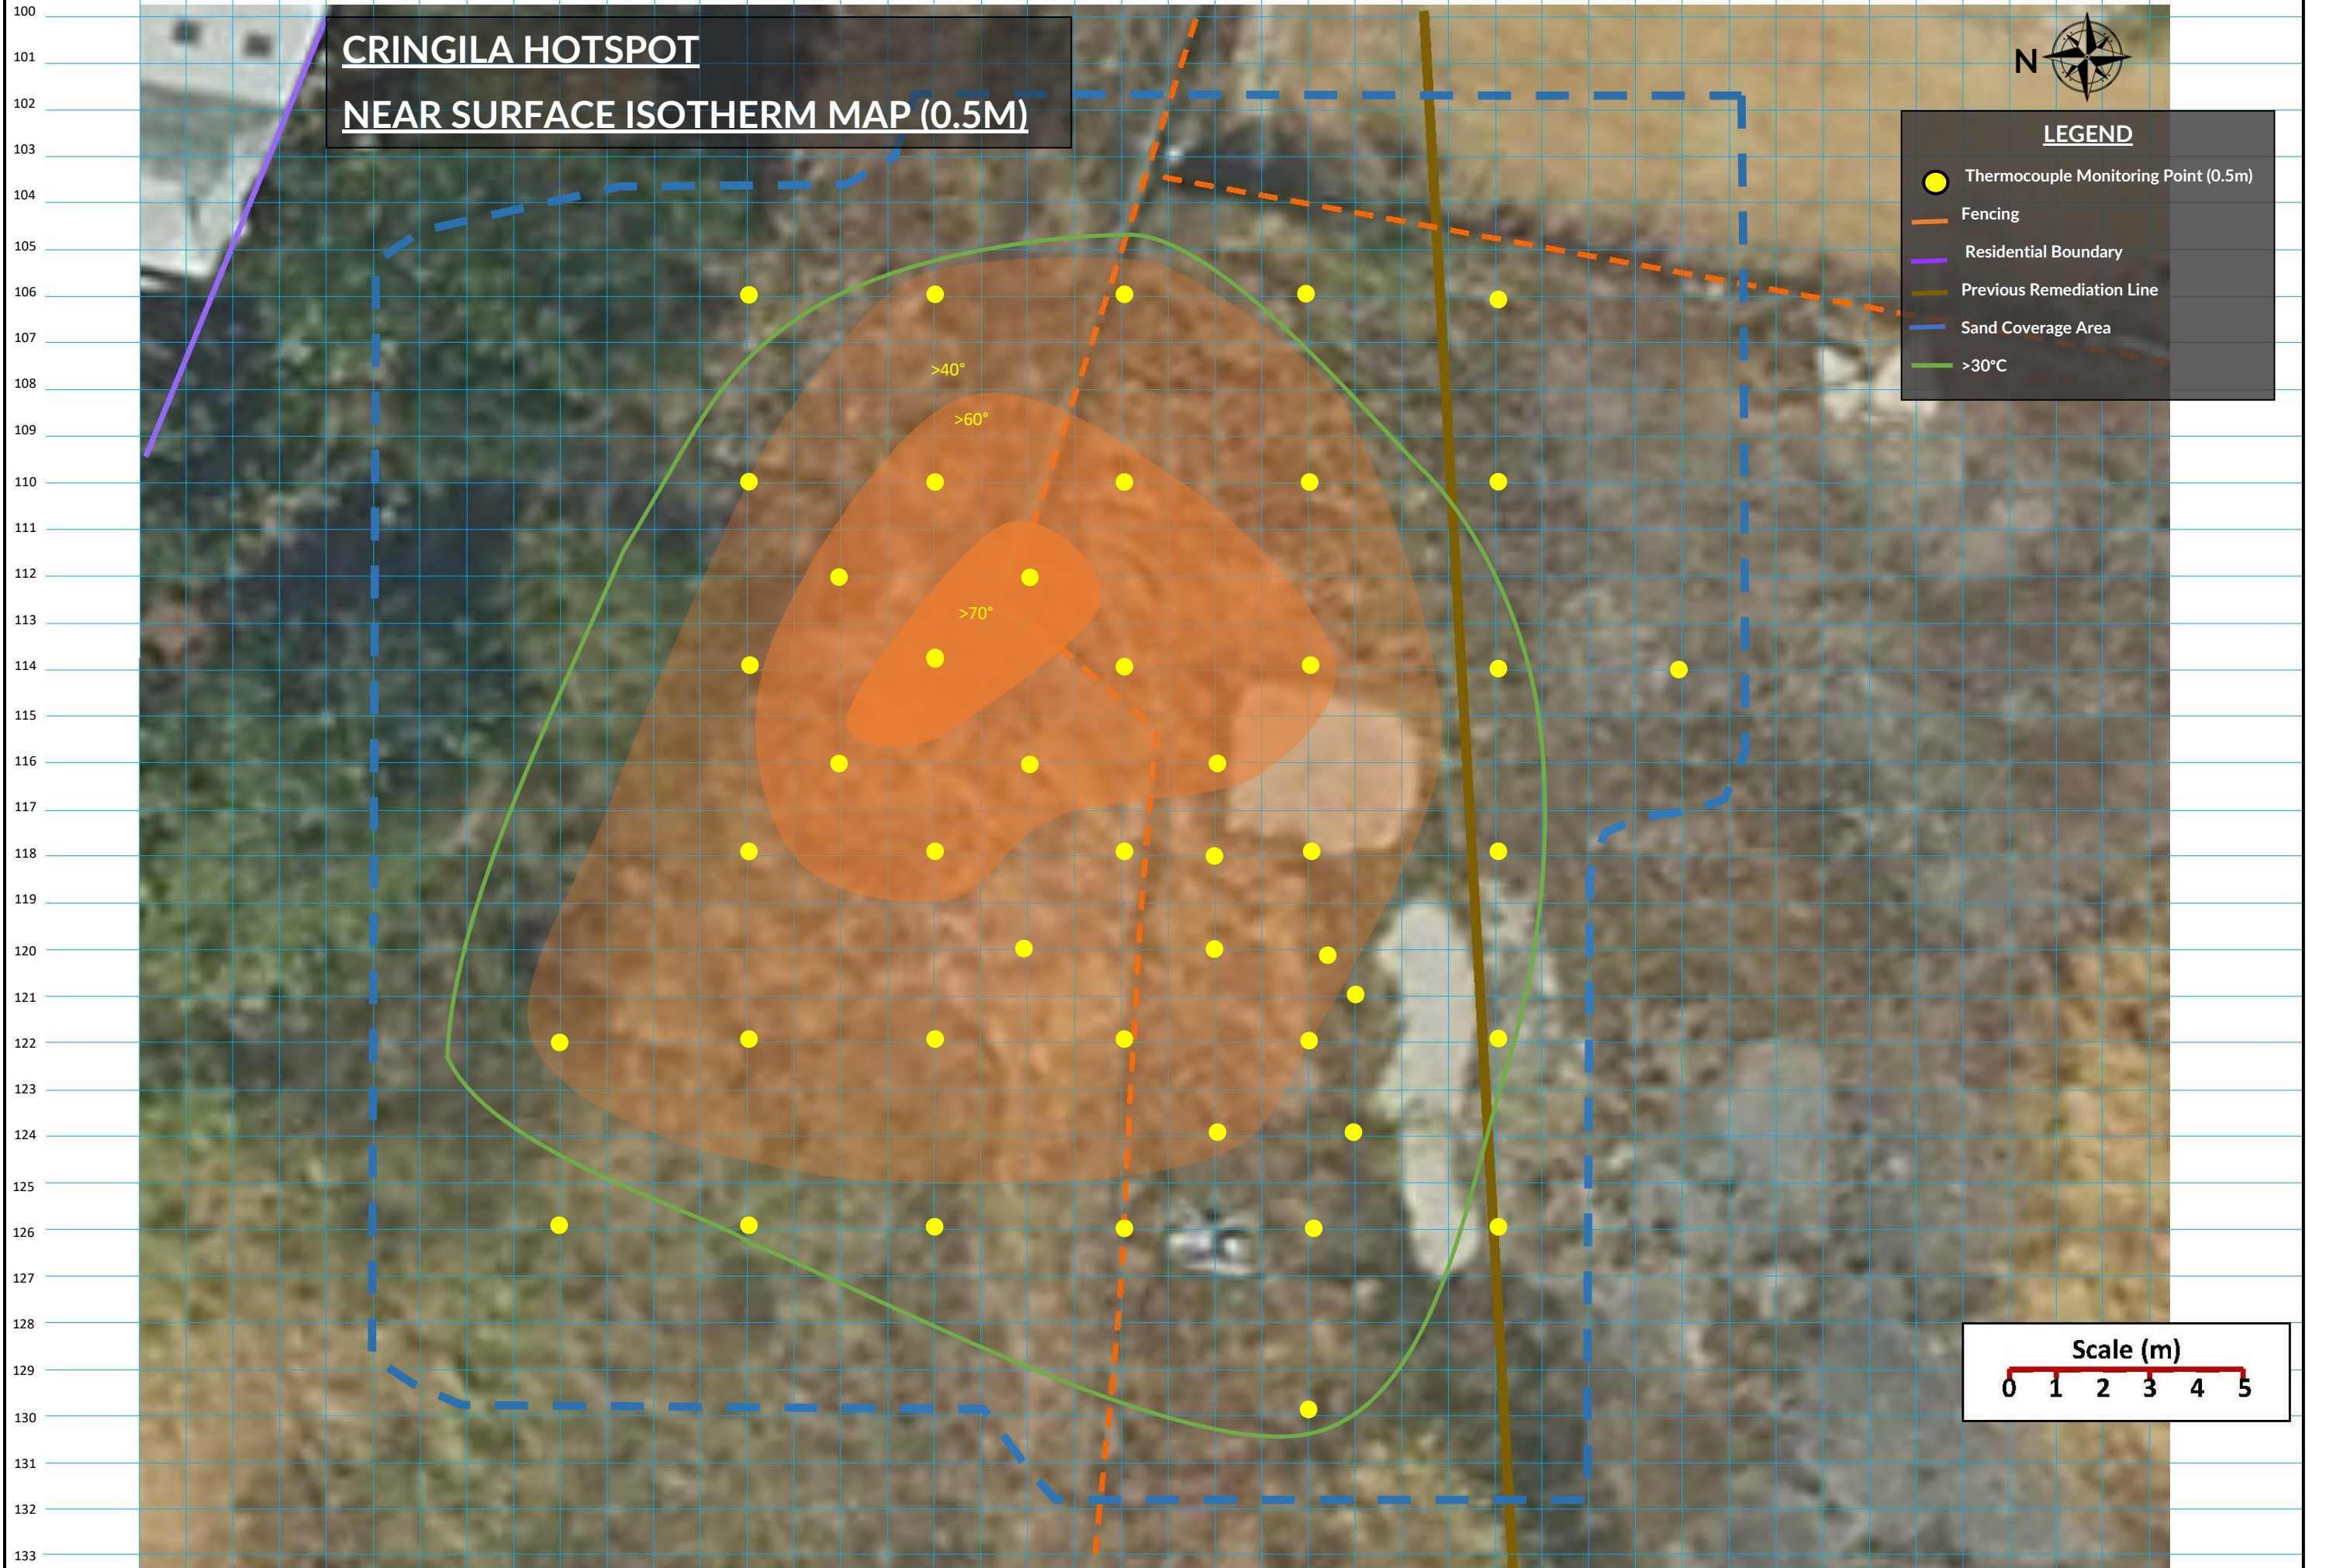
Appendix B: Near-Surface Temperature Isotherm Map (0.5m)

The isotherm map shows the general zone of influence for temperatures between 30°C and 70°C at 0.5m, coloured orange. The isotherm map suggests that the hotspot may extend deeper than 0.5m and that the increased temperature in these areas is a result of heat venting to the surface.

It is noted that temperature at the near-surface may be variable across the hotspot due to inconsistencies in the consolidation and compaction of subsurface materials.

CRINGILA HOTSPOT NEAR SURFACE ISOTHERM MAP (0.5M)

It is recommended that weekly site inspections and recording are continued to monitor the near-surface temperatures surrounding the subsurface hotspot identified at the site.
