CRINGILA PUBLIC SCHOOL NEAR-SURFACE TEMPERATURE MONITORING INVESTIGATION

Summary Report
06/04/2020 – 17/04/2020

Cringila Public School

April 2020
C107471: J153825-03: TO/RC

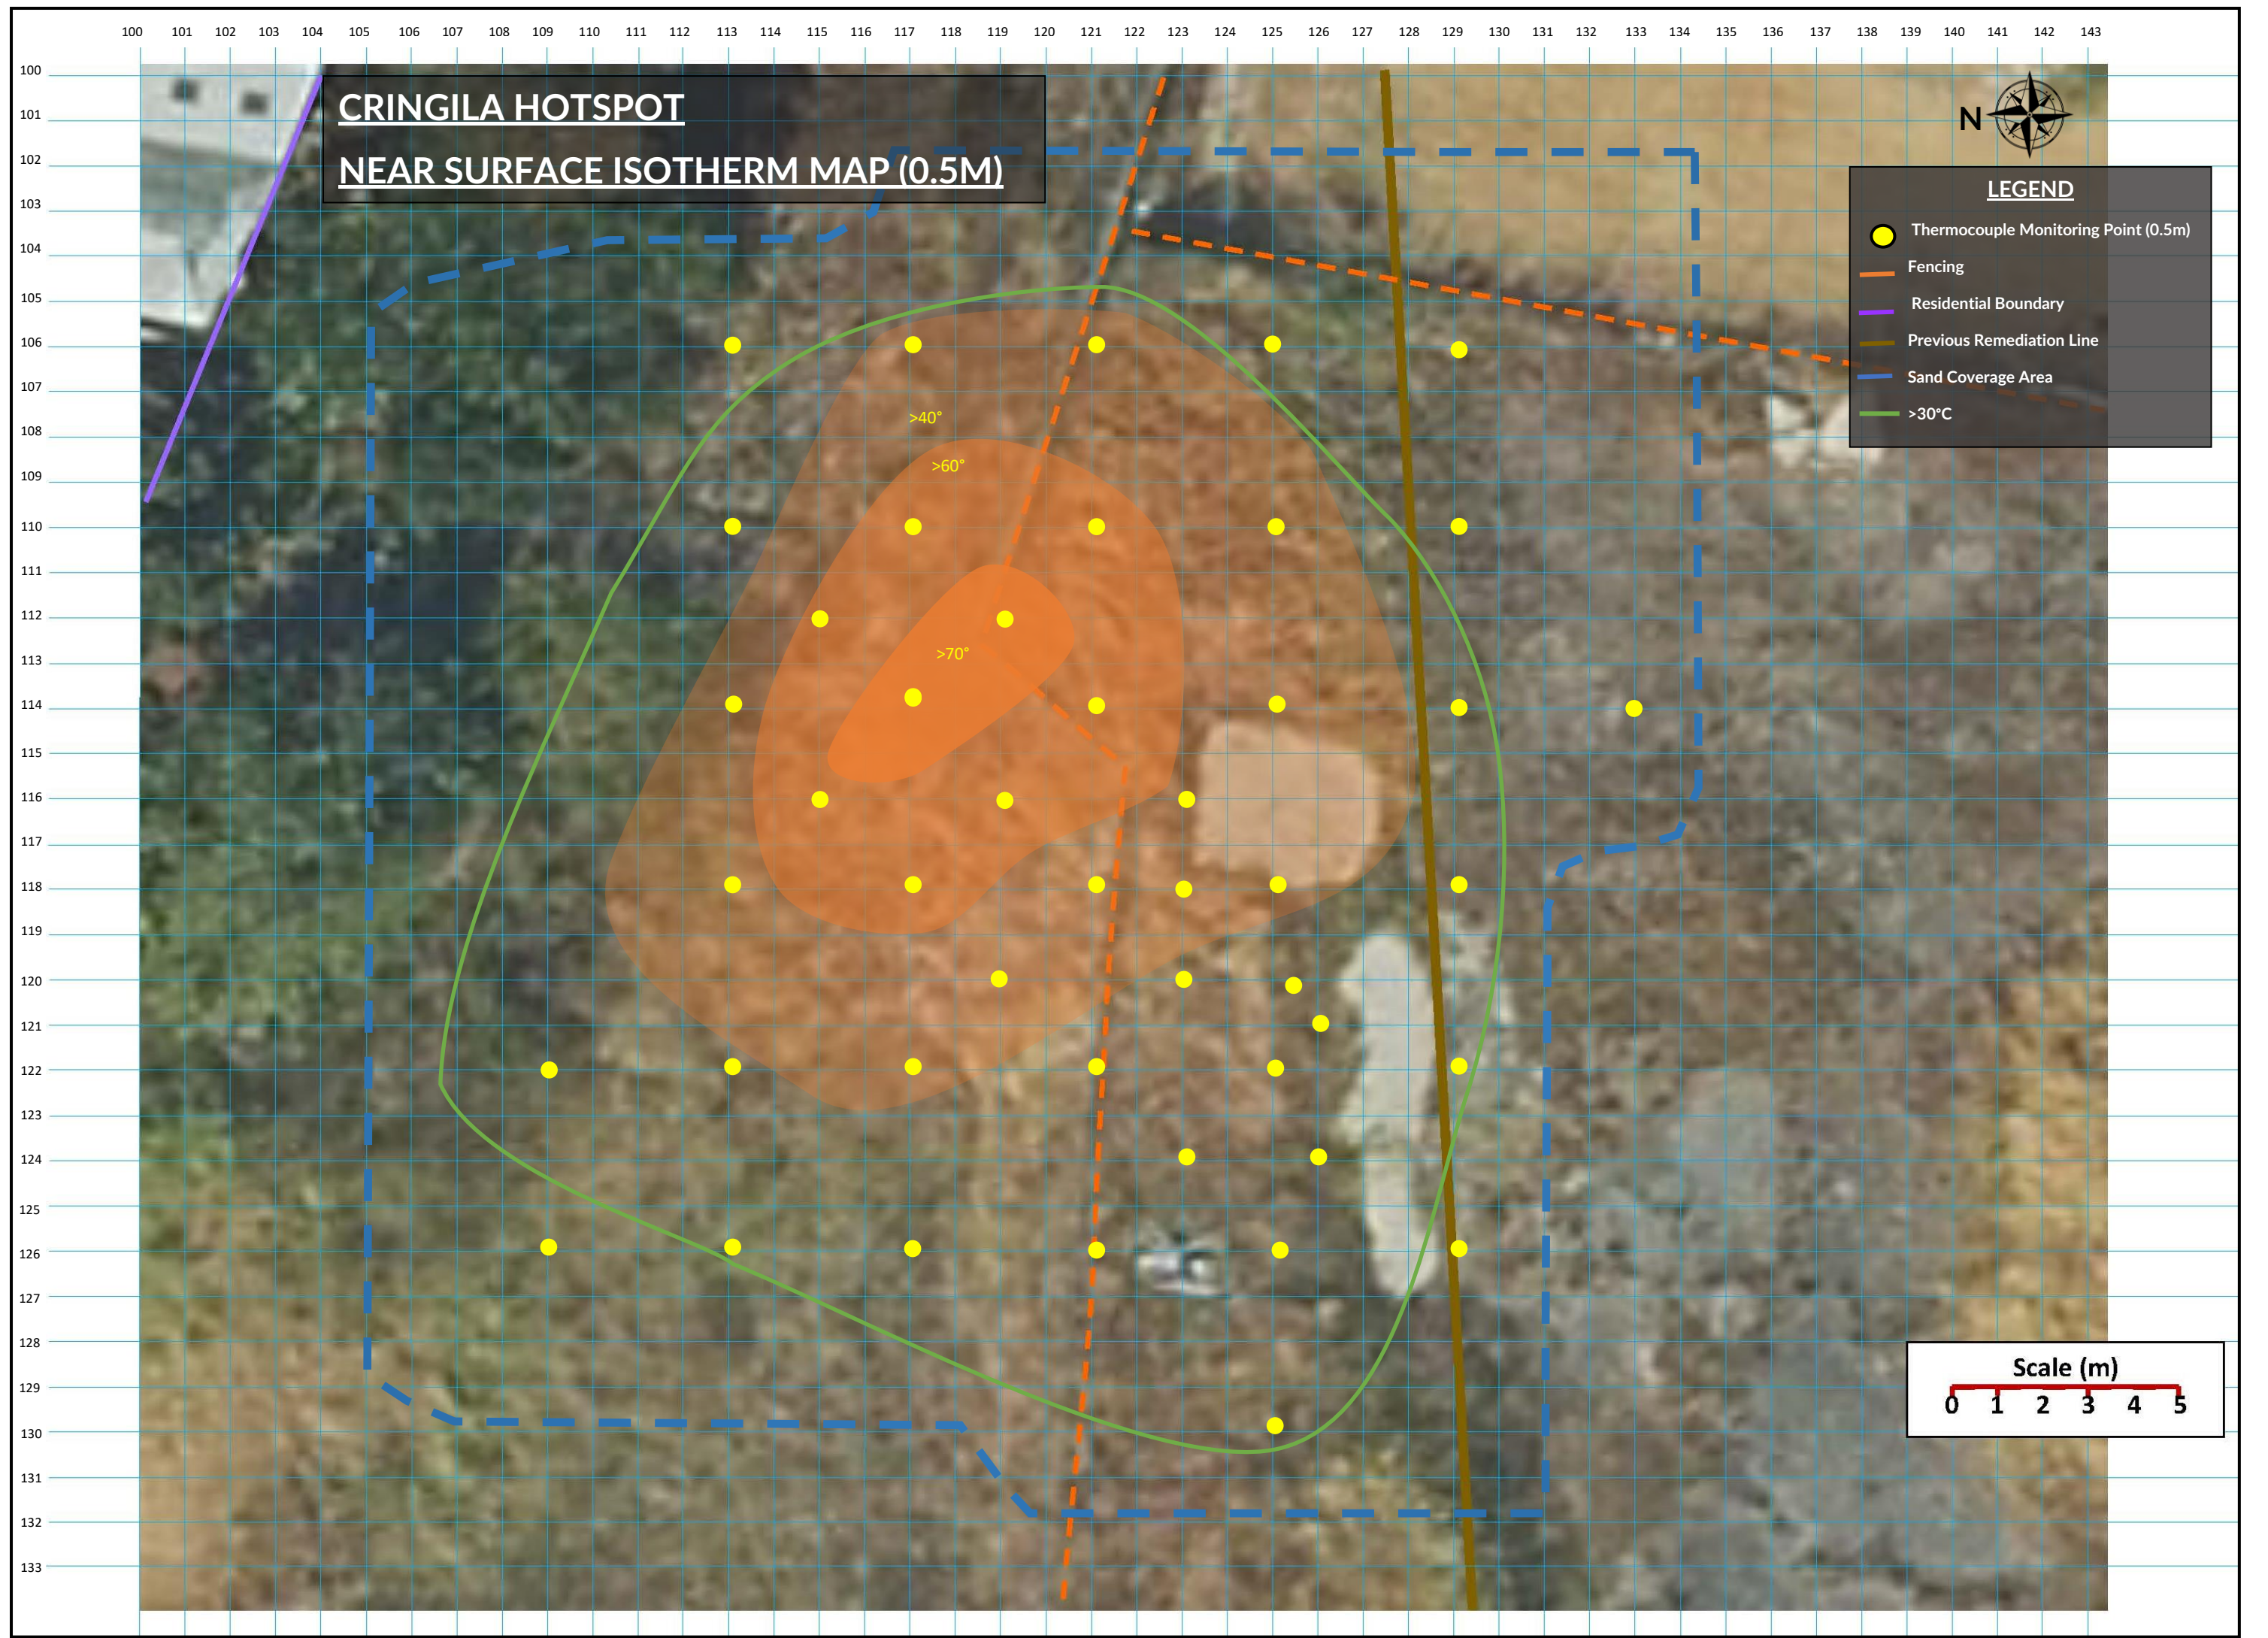
CRINGILA HOTSPOT NEAR SURFACE ISOTHERM MAP (0.5M)

The isotherm map shows the general zone of influence for temperatures between 30°C and 70°C at 0.5m, coloured orange. The isotherm map suggests that the hotspot may extend deeper than 0.5m and that the increased temperature in these areas is a result of heat venting to the surface.

It is noted that temperature at the near-surface may be variable across the hotspot due to inconsistencies in the consolidation and compaction of subsurface materials.

It is recommended that weekly site inspections and recording are continued to monitor the near-surface temperatures surrounding the subsurface hotspot identified at the site.
