CRINGILA PUBLIC SCHOOL NEAR-SURFACE TEMPERATURE MONITORING INVESTIGATION

Summary Report
20/04/2020 – 01/05/2020

Cringila Public School

May 2020
C107471: J153825-03: GR/TO

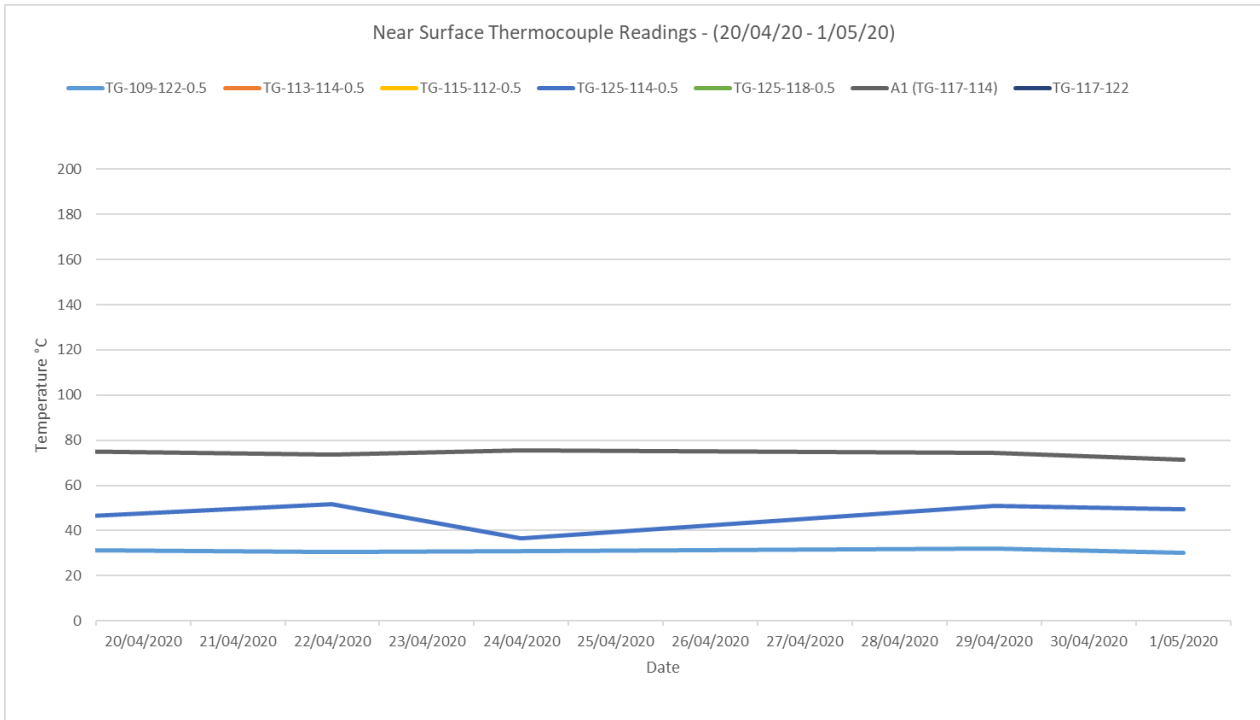
3.2. Near-Surface Temperature Graph – Selected Points (Fortnightly)

Near-surface temperature measurements for key thermocouple locations, over the monitoring period – between 20th April 2020 and 1st May 2020 in the northwest Hotspot, situated on the Cringila Public School grounds. Please note – data from certain points was not available within this date range due to technical constraints.

Variations in the near-surface temperature at selected points across the northwest hotspot over the period of monitoring appear to coincide with the high rainfall events during the period.

The near-surface temperature monitoring conducted between 20th April 2020 and 1st May 2020 indicates that the spatial extent of the northwest hotspot appears to remain localised.

There were no significant near-surface temperature variations identified during the period of monitoring.

It is recommended that weekly site inspections and recording are continued to monitor the near-surface temperatures surrounding the subsurface hotspot identified at the site.

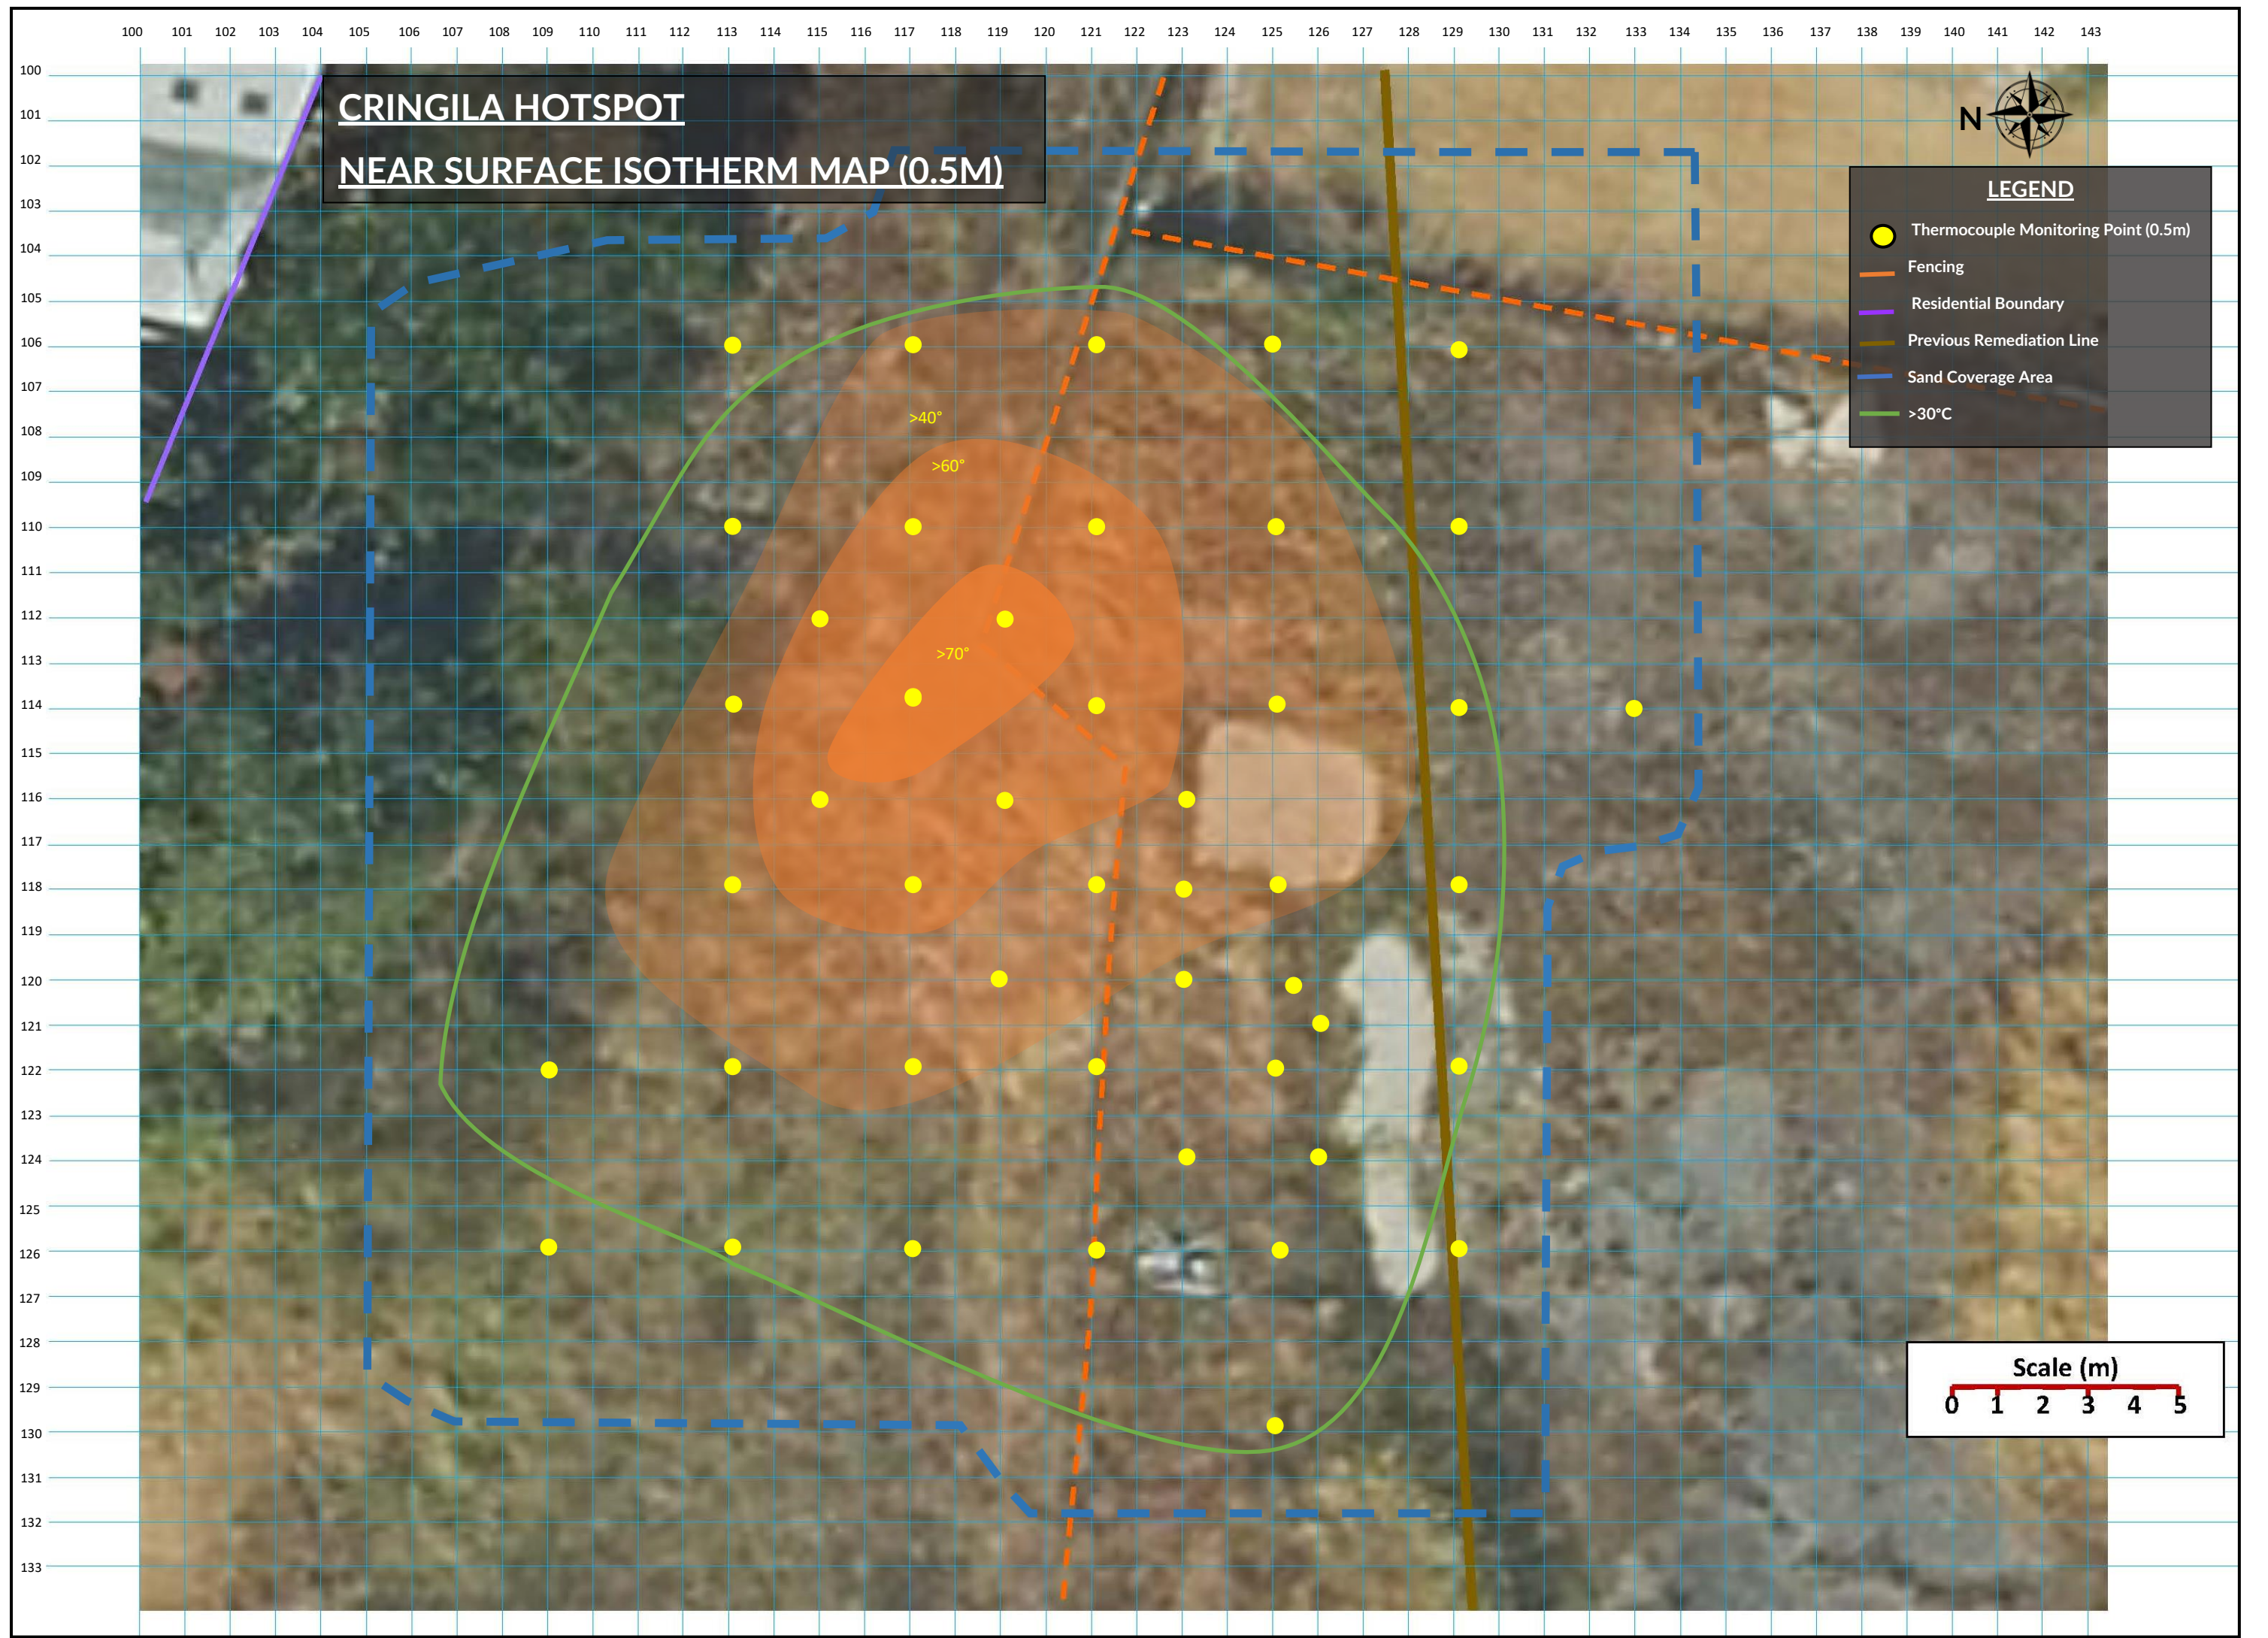
Appendix B: Near-Surface Temperature Isotherm Map (0.5m)

The isotherm map shows the general zone of influence for temperatures between 30°C and 70°C at 0.5m, coloured orange. The isotherm map suggests that the hotspot may extend deeper than 0.5m and that the increased temperature in these areas is a result of heat venting to the surface.

It is noted that temperature at the near-surface may be variable across the hotspot due to inconsistencies in the consolidation and compaction of subsurface materials.

The near-surface temperatures for representative monitoring locations, spread across the northwest Hotspot, are presented in the tables below. Temperature isotherms have been plotted on a site map to show an illustration of the near-surface temperatures in a spatial context. Refer to **Appendix B: Near Surface Temperature Isotherm Map (0.5m)**.
