CRINGILA PUBLIC SCHOOL NEAR-SURFACE TEMPERATURE MONITORING INVESTIGATION

Summary Report
04/05/2020 – 15/05/2020

Cringila Public School

Near-Surface Temperature Monitoring

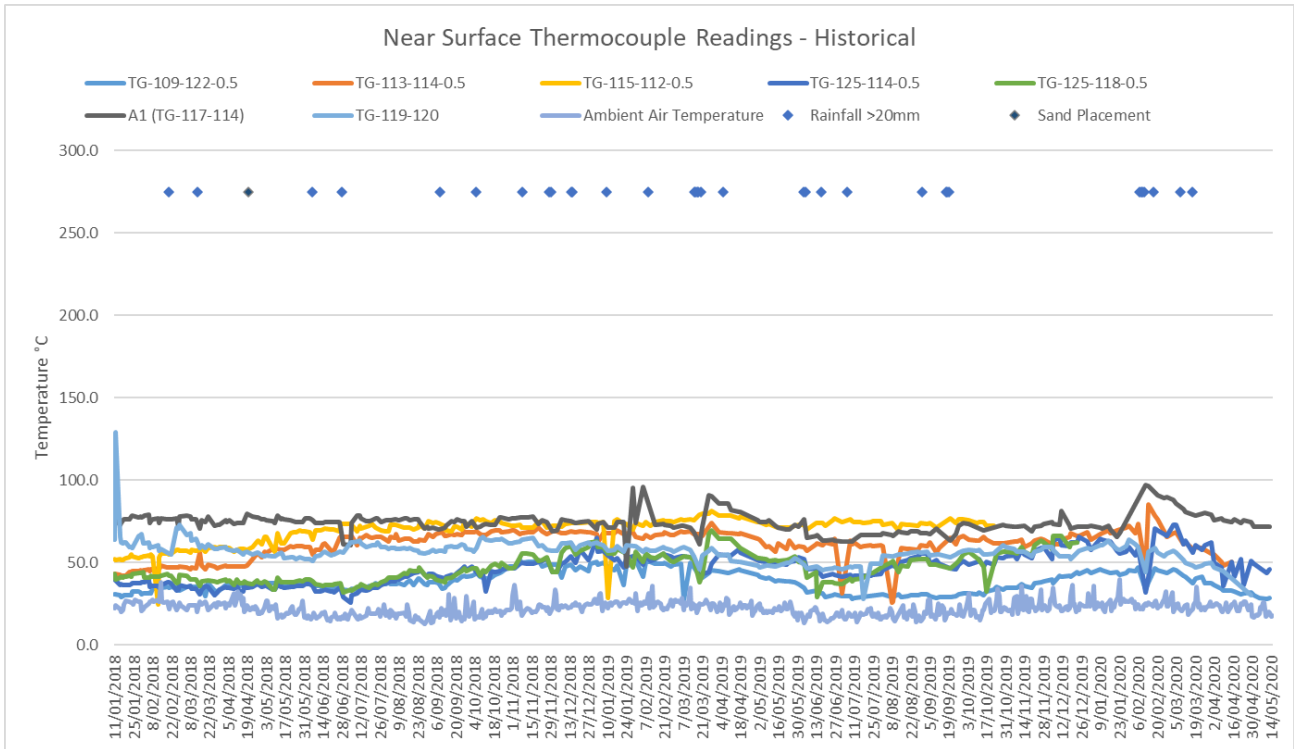
3.1. Near-Surface Temperature Graph – Selected Points (Historical)

Near surface temperature measurements for key thermocouple locations, progressive from Thursday 11th January 2018 to present.

The near-surface temperature appears to fluctuate seasonally across the surface of the northwest hotspot grid monitoring area.

Fluctuations in near-surface temperature are also evident following significant rain events (i.e. over 20mm rain).

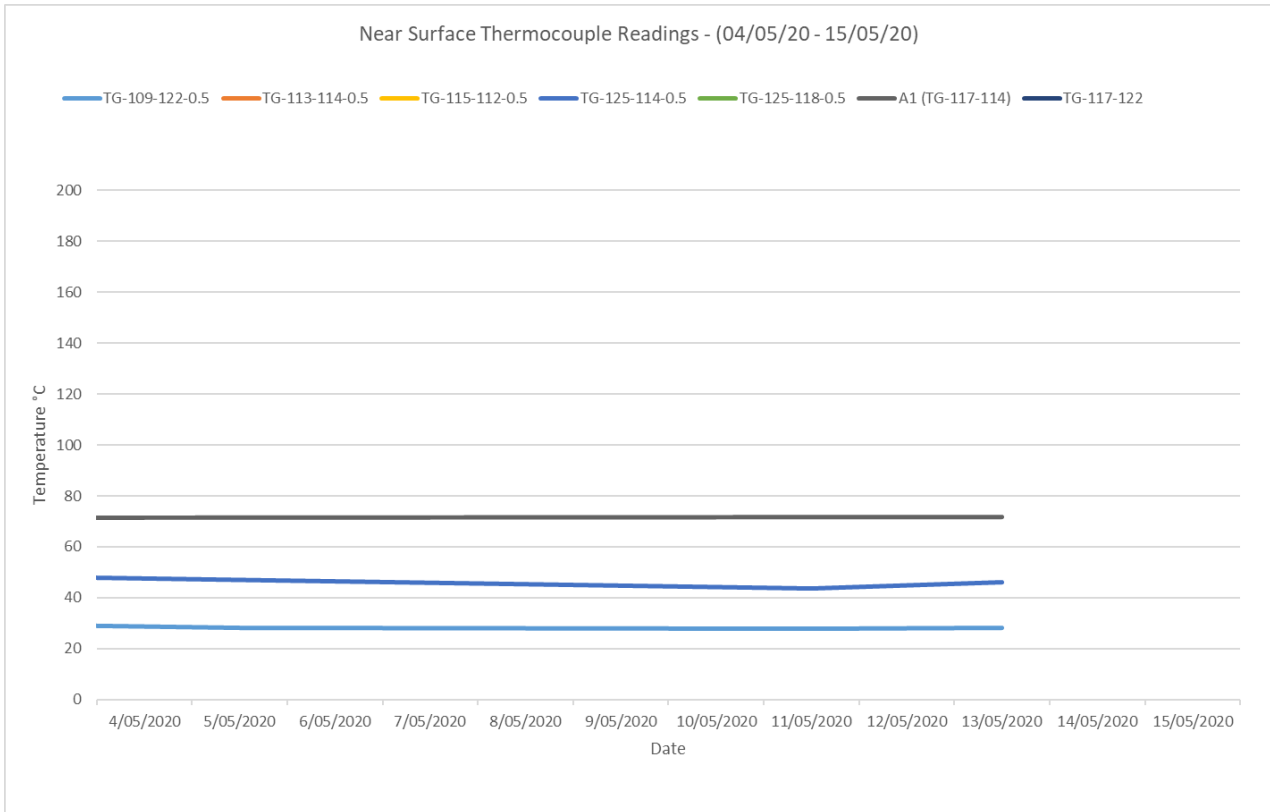
3.2. Near-Surface Temperature Graph – Selected Points (Fortnightly)

Near-surface temperature measurements for key thermocouple locations, over the monitoring period – between 4th May 2020 and 15th May 2020 in the northwest Hotspot, situated on the Cringila Public School grounds.

Please note – data from certain points was not available within this date range due to technical constraints.

Variations in the near-surface temperature at selected points across the northwest hotspot over the period of monitoring appear to coincide with the high rainfall events during the period.

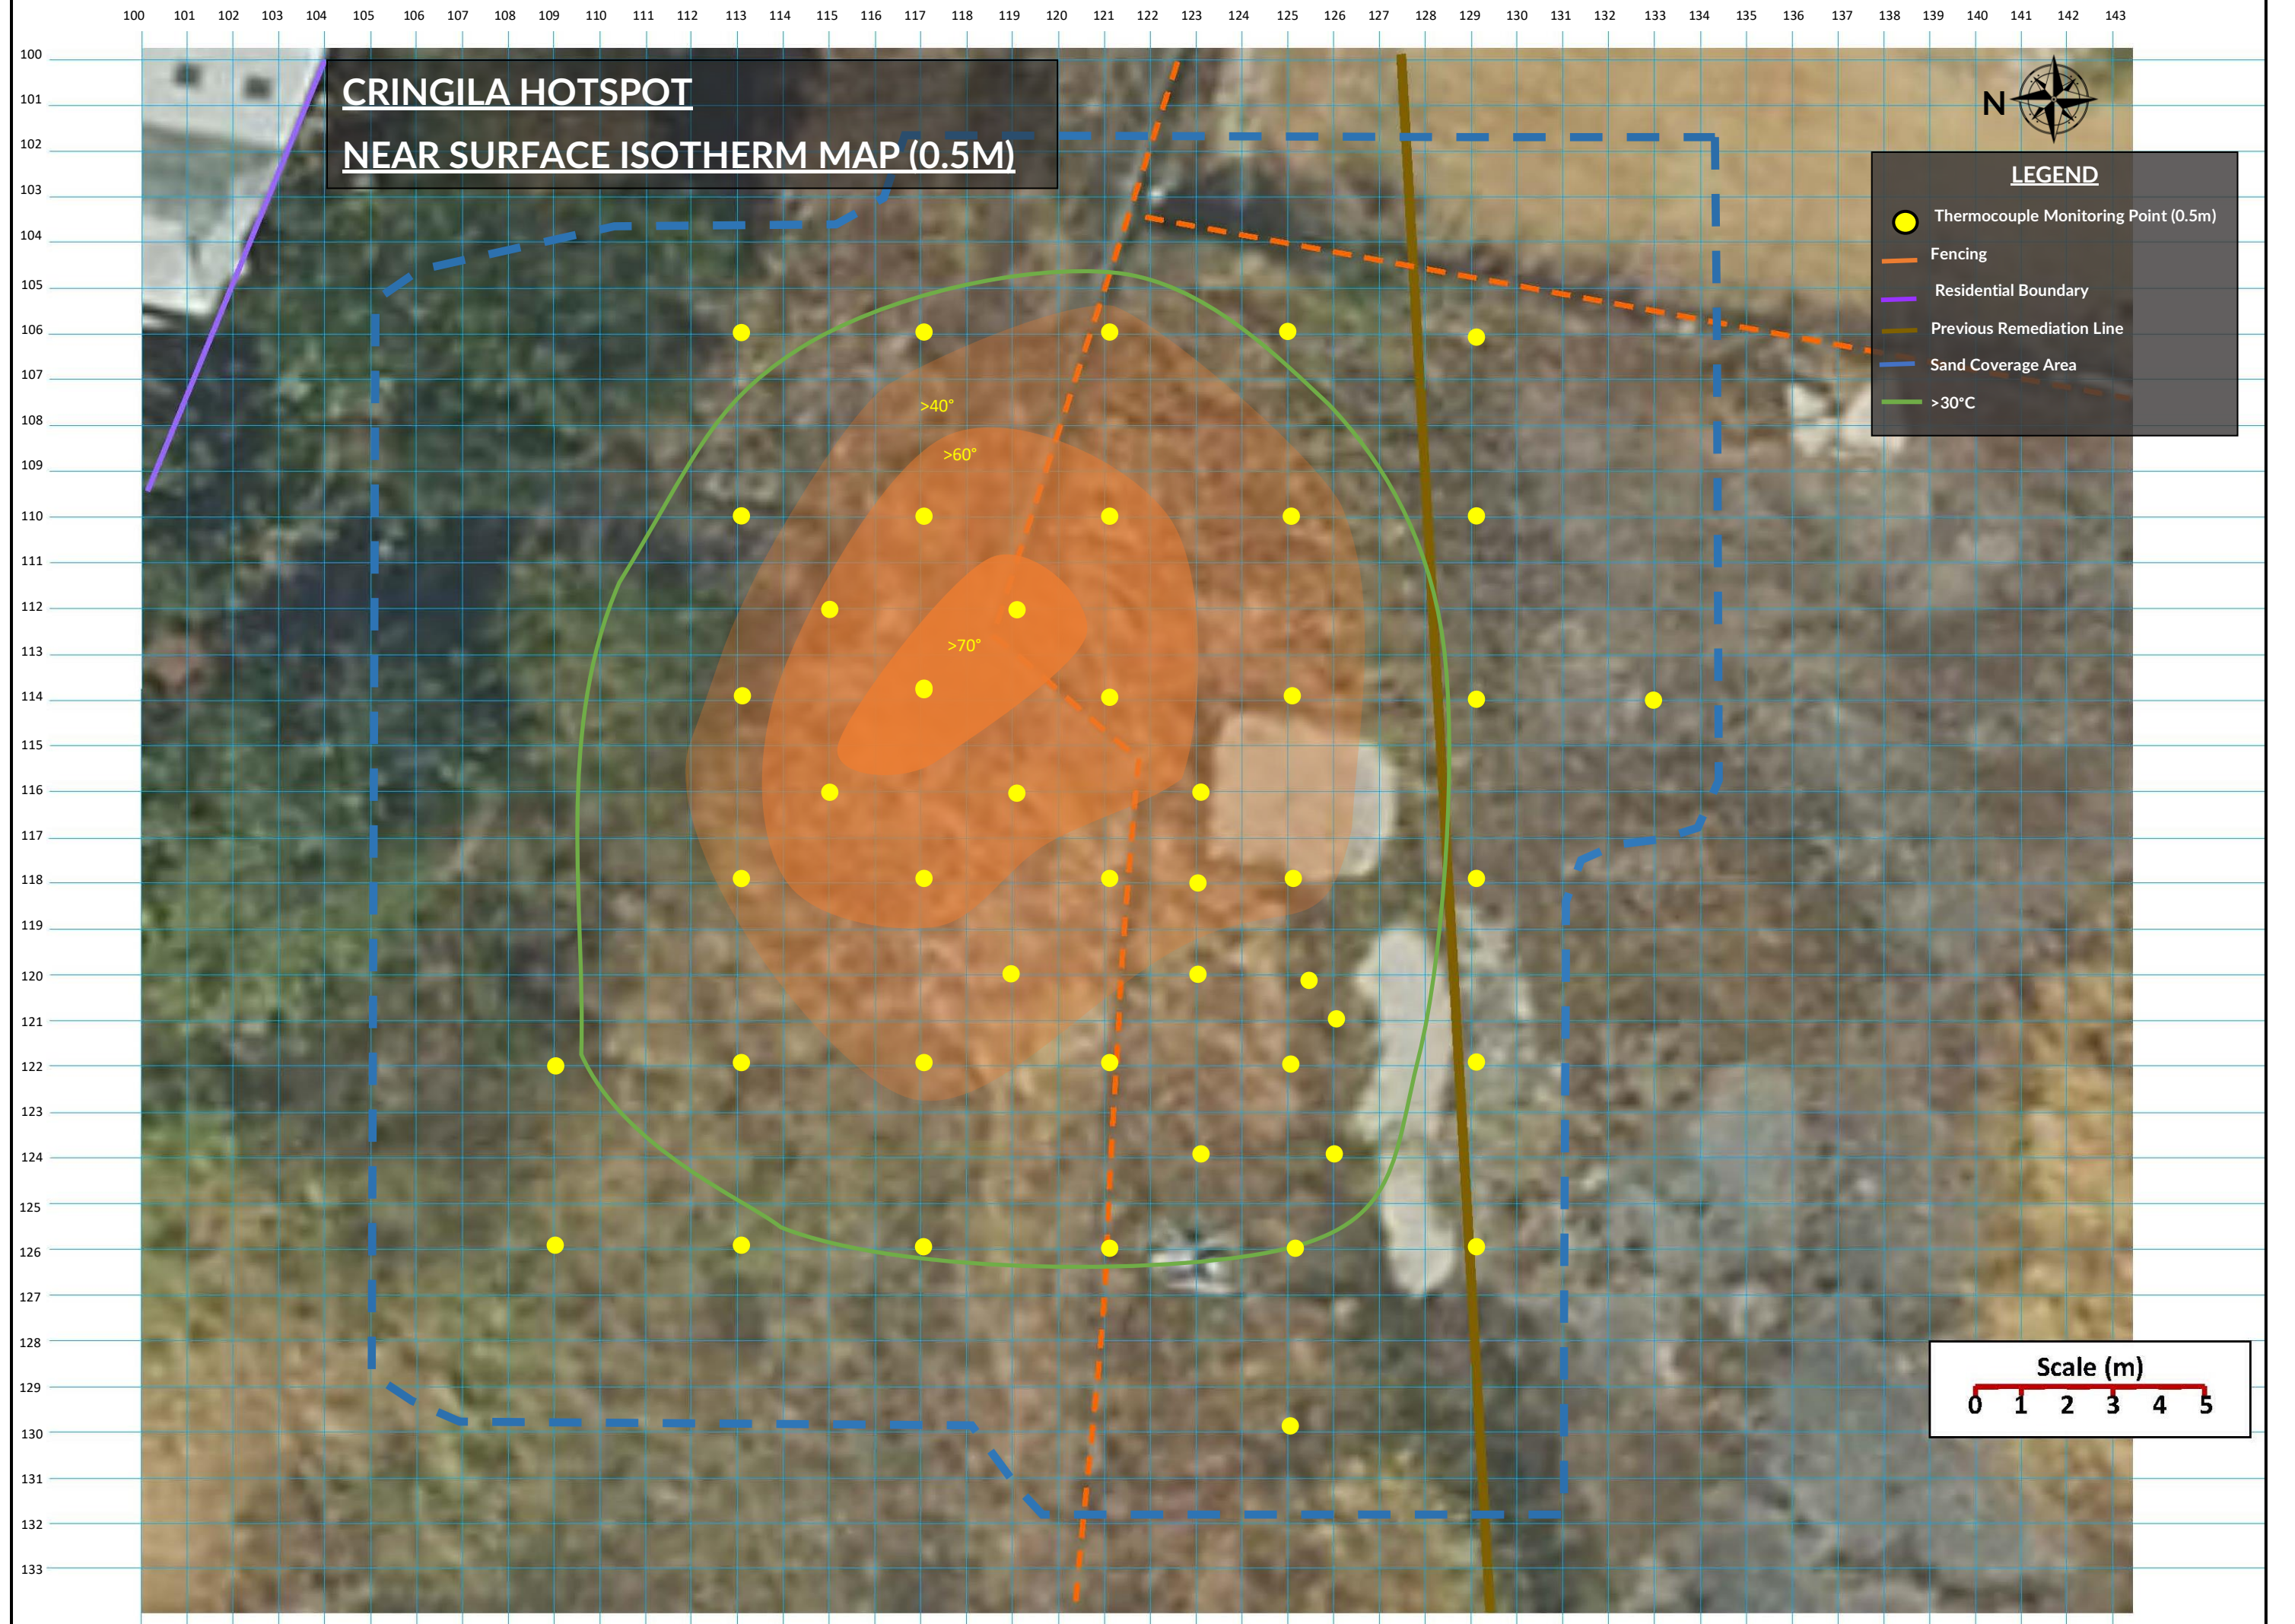
Appendix B: Near-Surface Temperature Isotherm Map (0.5m)

The isotherm map shows the general zone of influence for temperatures between 30°C and 70°C at 0.5m, coloured orange. The isotherm map suggests that the hotspot may extend deeper than 0.5m and that the increased temperature in these areas is a result of heat venting to the surface.

It is noted that temperature at the near-surface may be variable across the hotspot due to inconsistencies in the consolidation and compaction of subsurface materials.

CRINGILA HOTSPOT NEAR SURFACE ISOTHERM MAP (0.5M)

It is recommended that weekly site inspections and recording are continued to monitor the near-surface temperatures surrounding the subsurface hotspot identified at the site.
