CRINGILA PUBLIC SCHOOL  
NEAR-SURFACE TEMPERATURE  
MONITORING INVESTIGATION

Summary Report  
18/05/2020 – 29/05/2020

Cringila Public School

May 2020  
C107471: J153825-03: TO/RC

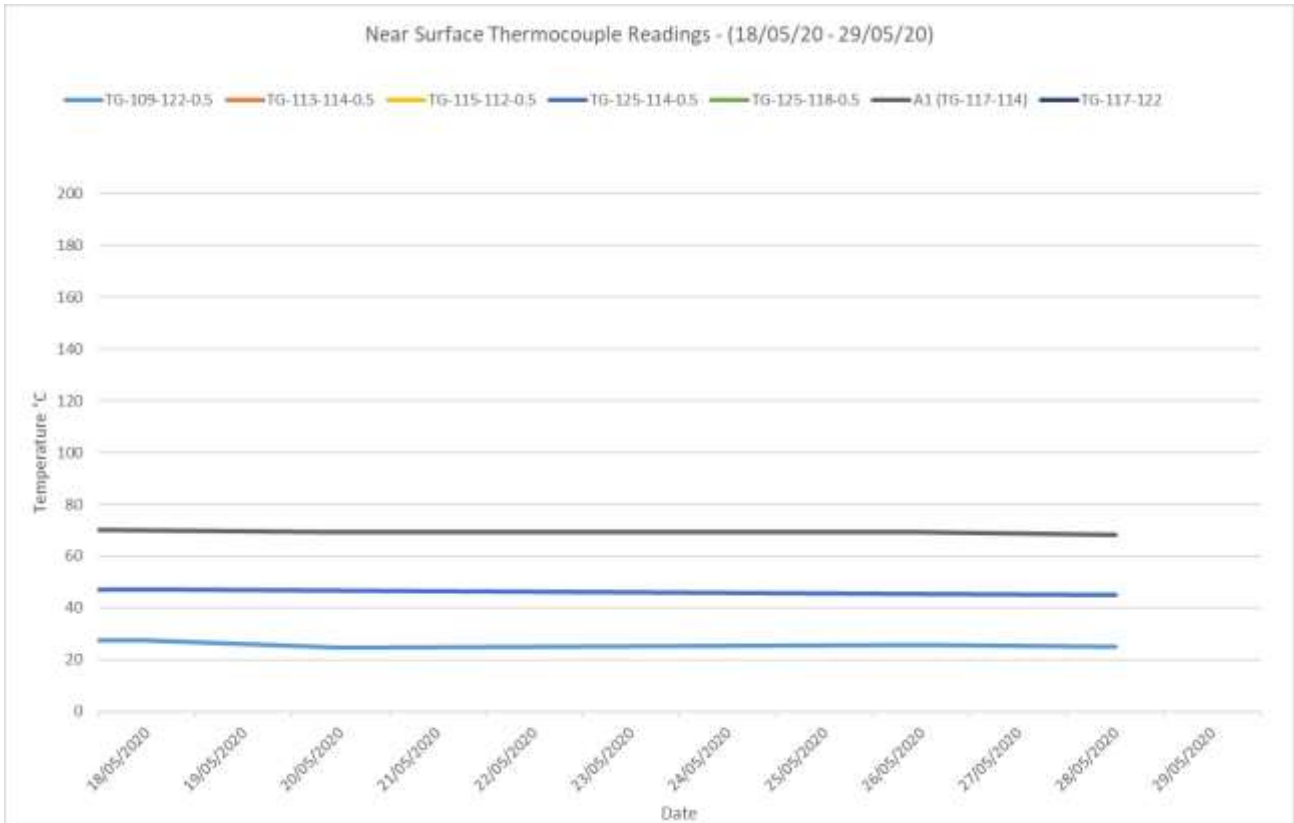
### 3.2. Near-Surface Temperature Graph – Selected Points (Fortnightly)

Near-surface temperature measurements for key thermocouple locations, over the monitoring period – between 18<sup>th</sup> May 2020 and 29<sup>th</sup> May 2020 in the northwest Hotspot, situated on the Cringila Public School grounds.

Please note – data from certain points was not available within this date range due to technical constraints.

Variations in the near-surface temperature at selected points across the northwest hotspot over the period of monitoring appear to coincide with the high rainfall events during the period.
